PROPERTY INSPECTION REPORT

Prepared For:	<u>Craig Hawes</u>	
		(Name of Client)
Concerning:	<u>1005 FM 2571 Smithville, TX 78957</u>	
		(Address or Other Identification of Inspected Property)
By:	<u>Chris Nowling; License #2123</u>	<u>11/11/2009</u>
	(Name and License Number of Inspector)	(Date)
	<u>(Name, License Number and Signature of Sponsoring Inspector, if required)</u>

Exclusions - This is a thermal imaging report only. Mechanical equipment & structure not inspected. Thermal/infrared Imaging is a technology that allows Chris Nowling (Level 1 Thermographer) to show you things about a building that no one can show you using other inspection methods. Thermal imaging produces images of invisible heat energy emitted from objects and systems in the building and allows me to measure it. Thermal imaging helps to diagnose the problem rather than merely identify symptoms and can sometimes, but not always identify and document: missing, damaged, and/or wet insulation or materials, heat loss and air infiltration in walls, ceilings, floors, windows and doors; water and moisture intrusion that could lead to mold, possible pest infestation, hidden roof leaks, unknown plumbing leaks, befo

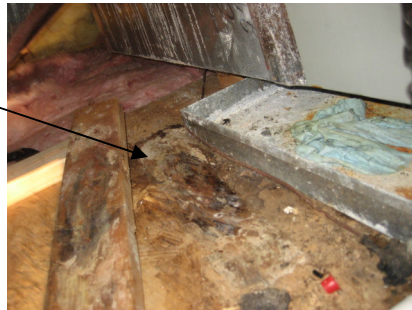
Attic Accessed at: - bathroom. Water damage observed @ the plywood platform in the attic for the furnace. The area was wet at the time of the inspection. It appears to be from leaking around the furnace flue. Further investigation and repairs recommended.

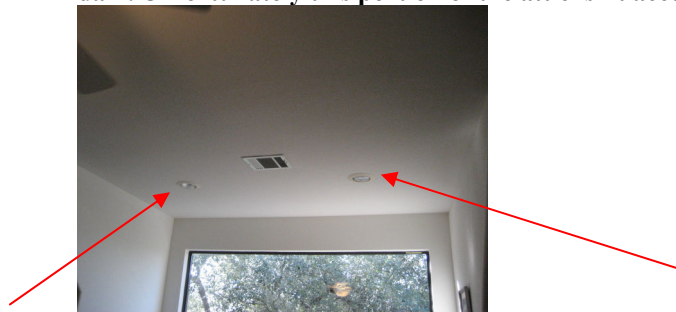
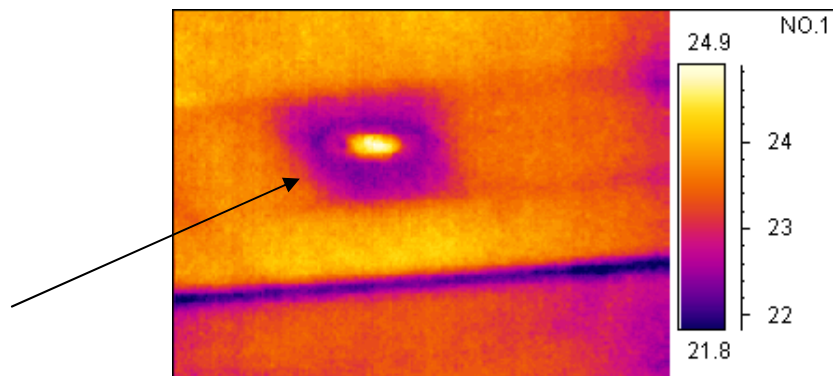
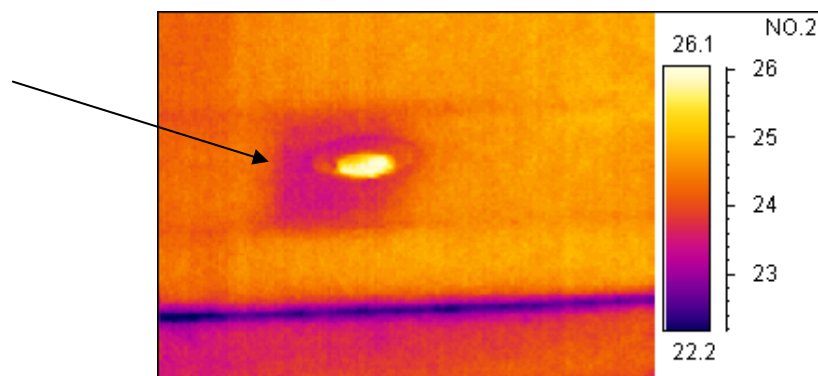
Attic Electrical Conditions - Minimal insulation observed around the recessed light boxes in the master bedroom. A box (light dam) should be installed around the fixture to keep insulation away from the fixture while providing air space around the fixture to minimize overheating of the fixture, then insulation can be installed up to the light dam. Unfortunately this portion of the attic isn't accessible.
