## PROPERTY INSPECTION REPORT

Concerning: 102 Mesa Dr.; Leander, TX 78641

By: Doyle Williamson # 4494 President and Inspector  
(Name and License Number of Inspector)

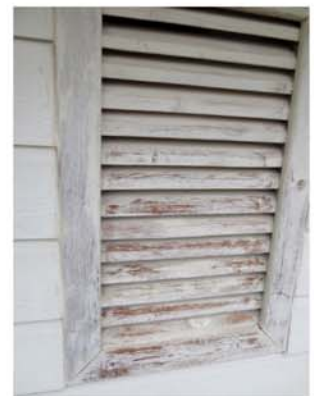
Paint deteriorated on gable vent

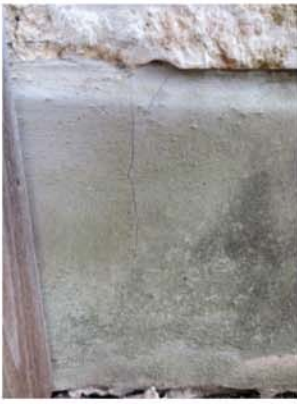
There are several cracks in the slab plaster coat at that appear to be evidence of substantial structural/foundation movement. Several grade beam cracks transfer up through the masonry work. Recommend further evaluation by a registered structural engineer or qualified foundation repair company and repair as necessary. [\(see photo on the last few pages of this report\)](#)

Left side front grade beam fracture

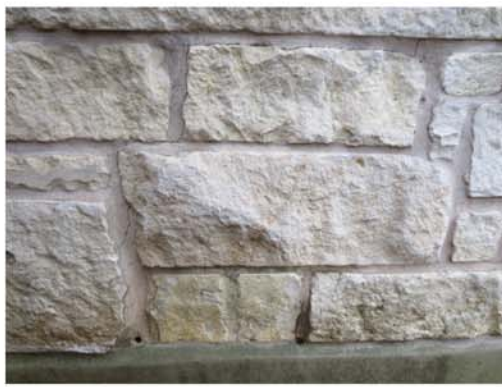
Slight cracking above fracture

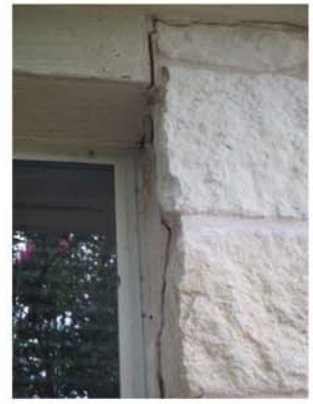
Transferrance of crack along left side front window

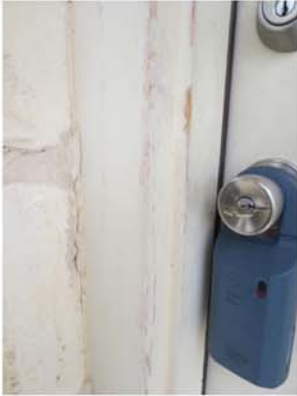
Paint deterioration at front door trim

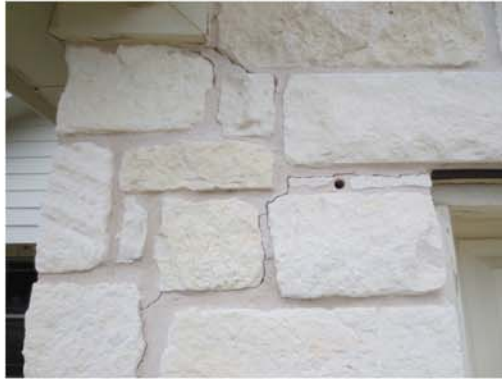
Cracks at left side of garage lintel

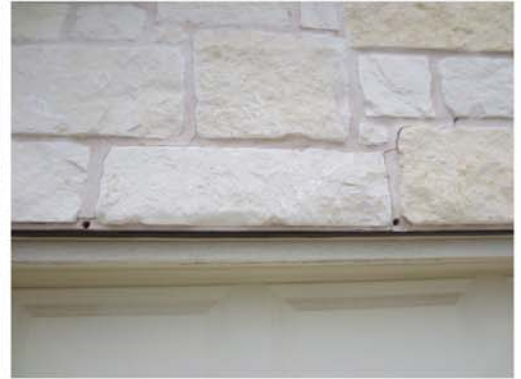
Crack at left side of garage header

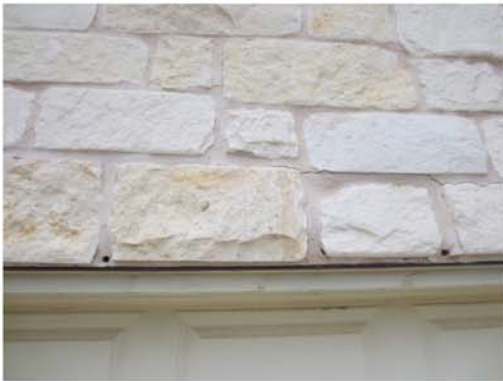
Cracks at center of header

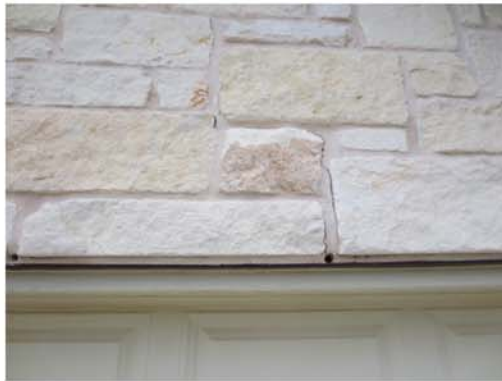
Cracks at right side of garage lintel

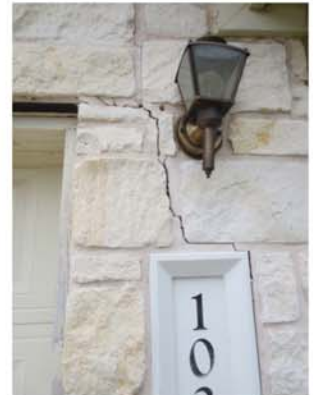
Severe crack at right side of lintel

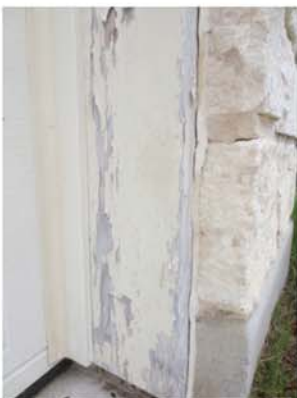
Paint deterioration at garage door trim

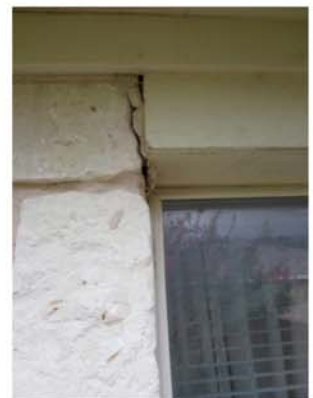
Crack at right front window top

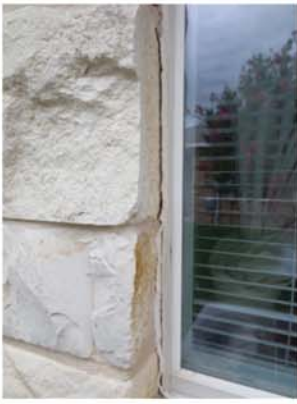
Crack at right front window edge

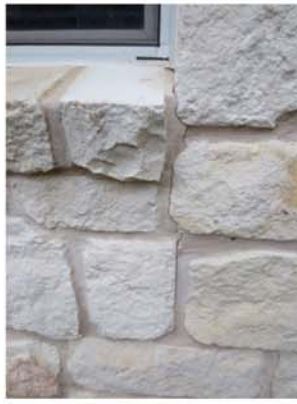
Crack at right front window sill

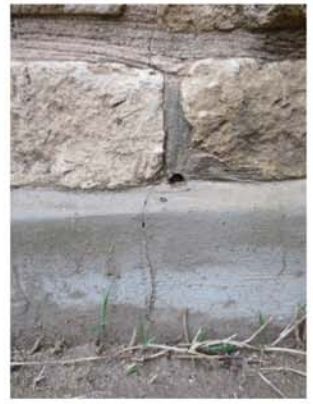
Transferrance of crack below window

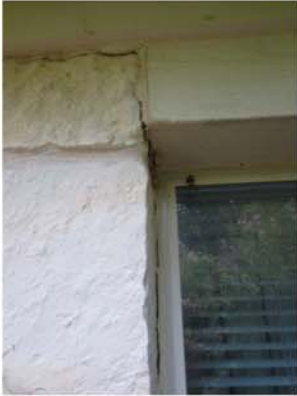
Crack at right rear window top

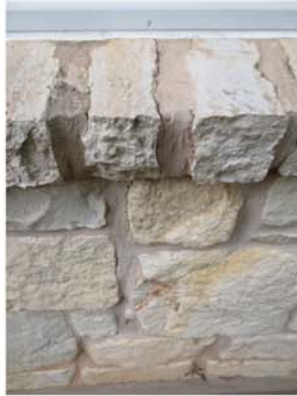
Crack at right rear window sill (center)

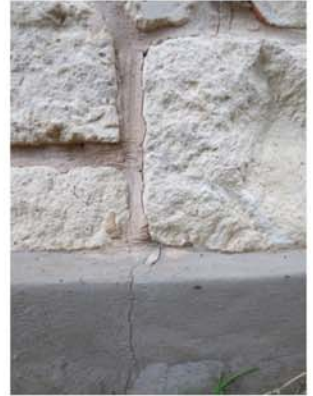
Crack below right rear window

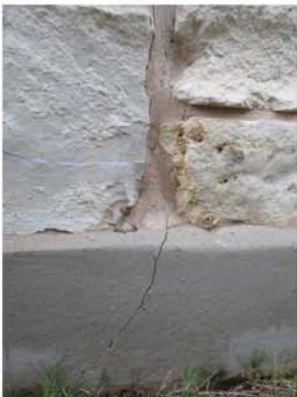
Crack in grade beam

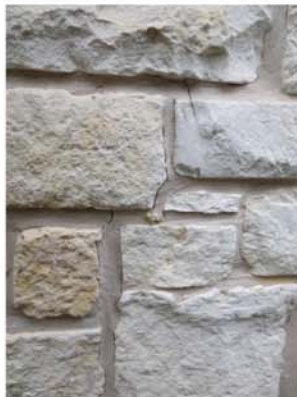
Crack at right rear wall

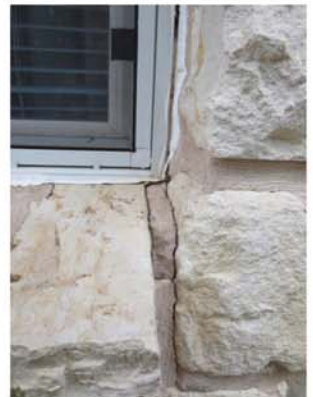
Crack at right rear window corner

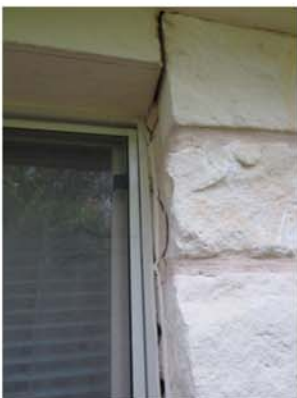
Crack at right rear window top

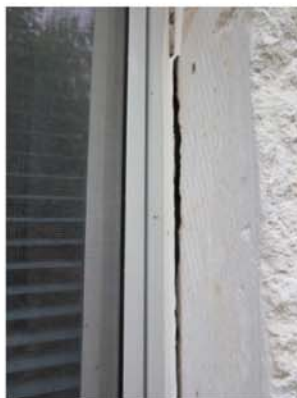
Crack at right rear window edge

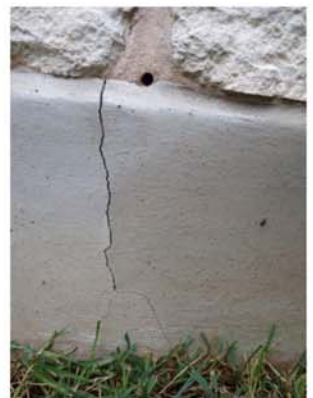
Severe crack in left rear grade beam

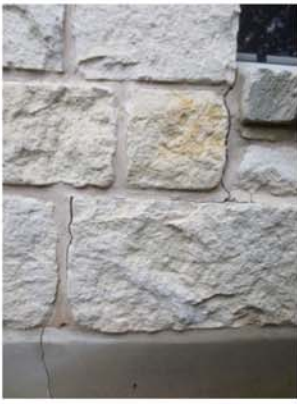
Crack at left rear window bottom

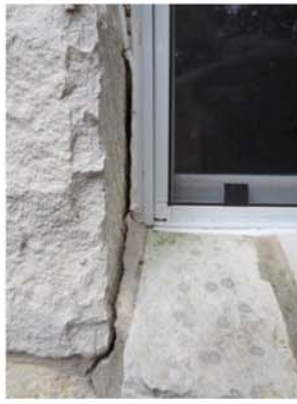
Large gap at left rear window bottom

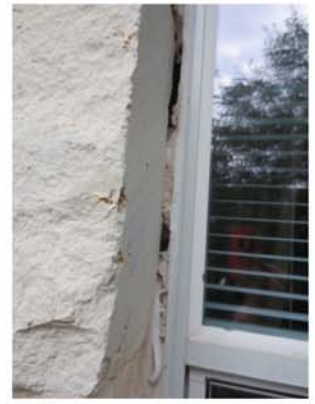
Large gap at left rear window edge

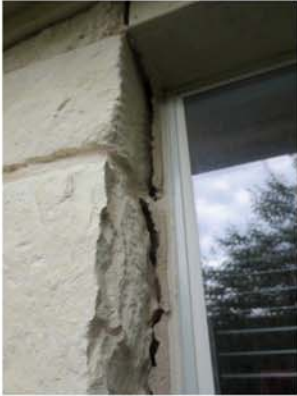
Large gap at left rear window top

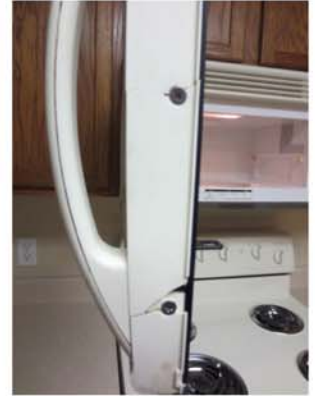
<input checked="" type="checkbox"/>	<input type="checkbox"/>	<input type="checkbox"/>	<input type="checkbox"/>	<b>B. Food Waste Disposer</b> <i>Type of System(s):</i> <i>Disposal 1 - In Sink Erator - model# 1-83A - serial # 05041816213</i>  No comment.
<input checked="" type="checkbox"/>	<input type="checkbox"/>	<input type="checkbox"/>	<input type="checkbox"/>	<b>C. Range Exhaust Vent</b>  No comment.
<input checked="" type="checkbox"/>	<input type="checkbox"/>	<input type="checkbox"/>	<input type="checkbox"/>	<b>D. Ranges, Cooktops and Ovens</b> <i>Type of System(s):</i> <i>Oven Standing range - Whirlpool - model# RF303PXKT2 - serial # RS2011206</i>  No comment.
<input checked="" type="checkbox"/>	<input type="checkbox"/>	<input type="checkbox"/>	<input checked="" type="checkbox"/>	<b>E. Microwave Oven</b> <i>Type of System(s):</i> <i>Microwave 1 - Whirlpool - model# GH4155XPT-0 - serial # TRR4614186</i> <u>General Repair</u> The microwave oven door is cracked. (see photo on the last few pages of this report)

Cracked microwave oven door

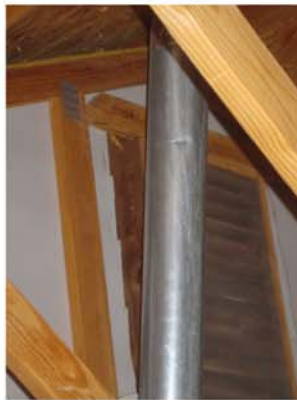
Previous water penetration at dryer vent  
(streaks)
