Report: 082919-shearer

Inspection Address: 18700 182nd St., Tonganoxie, KS 66086

Date: August 29, 2019

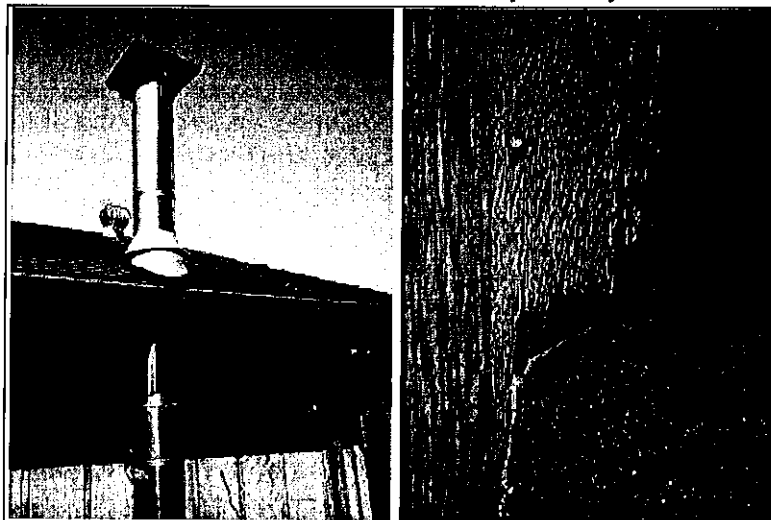
Raised flashing around the wood stove flue was noted. Secure flashing.

The top edge of flashing was exposed which can allow water behind the flashing. Recommend sealing and repairing flashing.

1. Rear side above the breeze way roof by the vertical side wall.

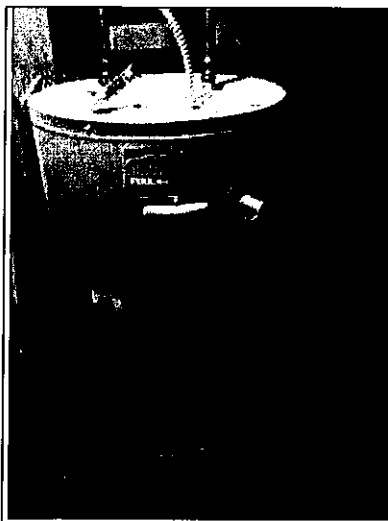
Condition: Appears serviceable
11 years old. The estimated average lifespan for this type of unit is 10-12 years.

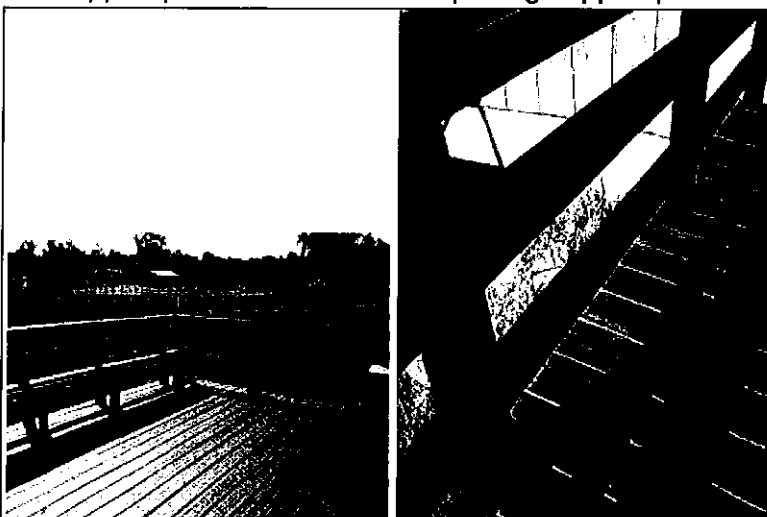
Condition: Wood,
The wood deck is older with weathered and splitting decking boards. The deck is in the maintenance phase and periodic repairs and resealing is to be expected.

The baluster spacing on the railings is wider than 4 1/2 inches as per current codes. This code was not active at the time of construction. Repair railings to the current spacing codes. This would be considered a upgrade.

Deterioration of the bottom of the support post was noted on a few of the deck support posts. Recommend repairing support posts and footings as needed.
