INSPECTION REPORT

420 7th St Somerville TX 77879

William Neinast DECEMBER 20, 2019

PROPERTY INSPECTION REPORT

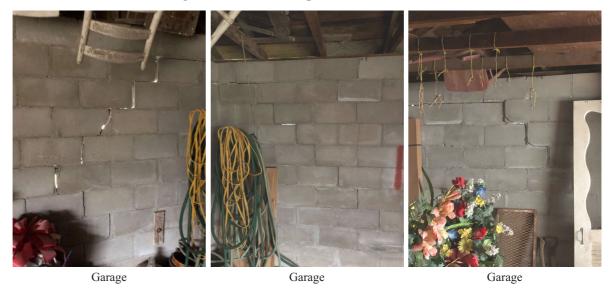
1: Evidence of Structural Damage

Evidence of structural damage was found in the wall structure. Recommend a structural engineer evaluate and advise on how to repair.

Recommendation: Contact a qualified structural engineer.

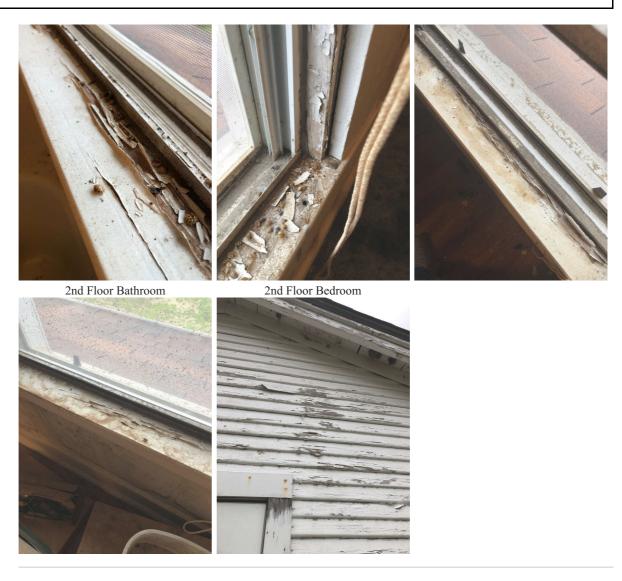
2: Paint Covering Needs Improvement

Excessive chipping or pealing was detected in the paint covering.

Recommendation: Contact a qualified general contractor.

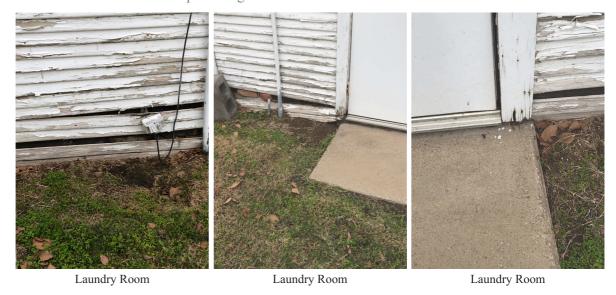
3: Wood Damage

Damaged wood should be repaired or replaced to maintain the integrity of the weather envelope provided by the wall coverings.

Recommendation: Contact a qualified general contractor.

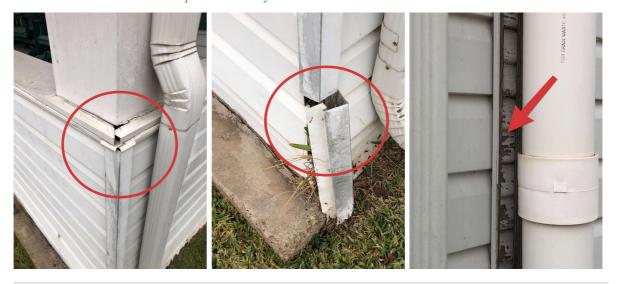
4: Gaps At Exterior Wall

Seal all gaps at joints and/or utility penetrations to prevent moisture and pest intrusion.

Recommendation: Contact a qualified handyman.

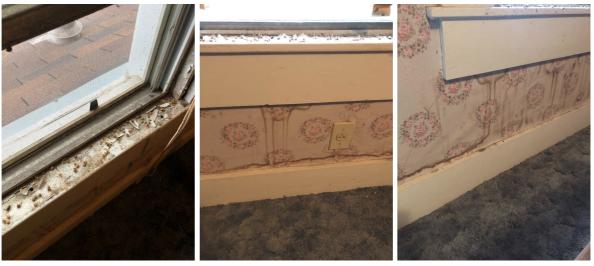
5: Moisture Penetration at Window

Leaking from the window was detected. Source of the leak should be determined and damaged materials repaired/replaced.

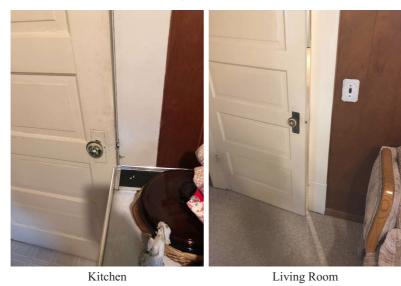
1: Door Doesn't Latch

Door doesn't latch properly. Recommend handyman repair latch and/or strike plate.

Recommendation: Contact a qualified handyman.

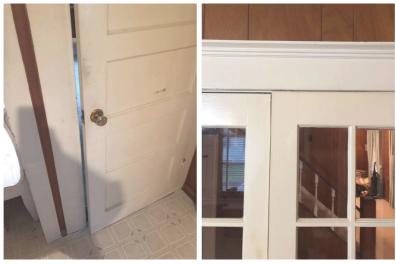
2: Door Sticks

Door sticks and is tough to open. Recommend sanding down offending sides.

Recommendation: Recommended DIY Project

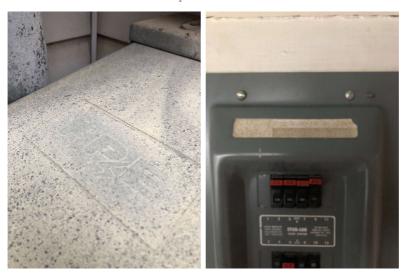
2: Federal Pacific Electric Service Panel

FPE (Federal Pacific Electric) panel installed in the home should be replaced. These units were known to fail and many electricians will not service them.

Recommendation: Contact a qualified electrical contractor.

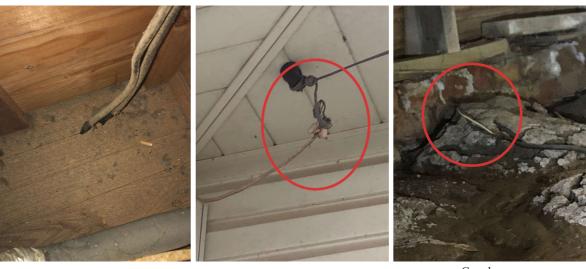
Crawlspace

1: Exposed Ends & Splices

All wire connections & charged wires with exposed ends and splices should be covered in junction boxes for safety. Recommend a qualified electrician correct.

Recommendation: Contact a qualified electrical contractor.

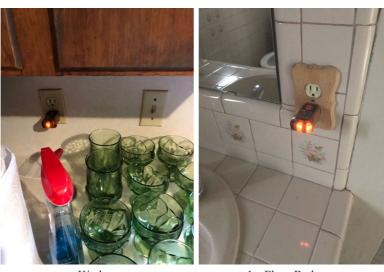
Kitchen

3: Missing GFCI Protection

No GFCI protection present in all locations. Recommend licensed electrician upgrade by installing ground fault receptacles in all locations.

Recommendation: Contact a qualified electrical contractor.

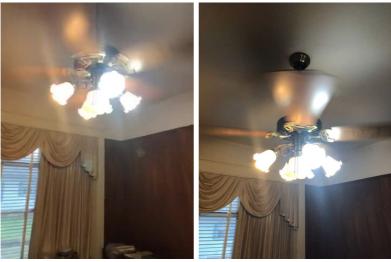
4: Ceiling Fan Defects

Ceiling fan is out of balance and should be serviced/adjusted for proper operation

Slight wobble

Recommendation: Contact a qualified handyman.

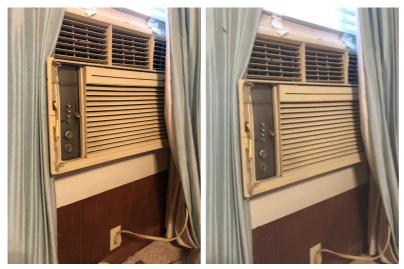
1st Floor Bedroom: older unit but operational at time of inspection

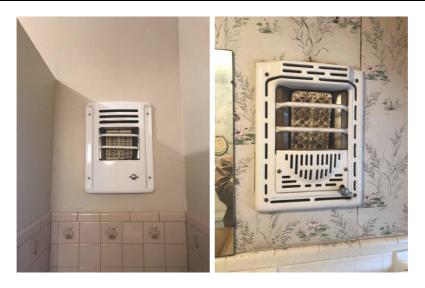
Gas heater is installed. These are typically unvented and considered a safety hazard..
