7/24/2020

Subject: Critical Area Ordinance (CAO) Report Finney Property - Critical Slope Consultation Parcel # 5631500685, 5631500681 and 5631500678, Kenmore, WA

QG Project No.: QG20-021

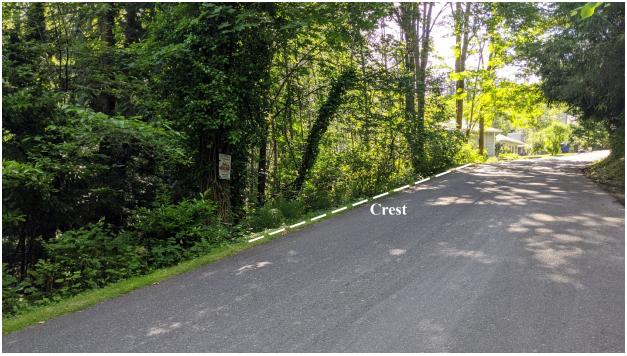
Photo 1. Upland site access from main roadway, crest of slope

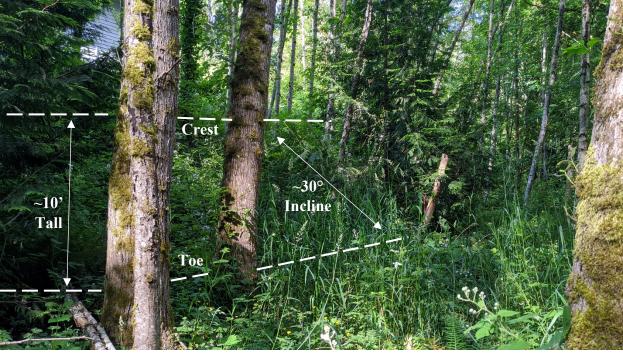
Photo 2. Typical slope conditions.
