September 26, 2012  
Project No. 12031

Subject: Preliminary Geotechnical Engineering Report  
14000 Block of 41<sup>st</sup> Ave NE, Parcel No. 2226049014  
Seattle, Washington – DPD Project No. 6327131

## **SITE AND EXPLORATION PLAN**

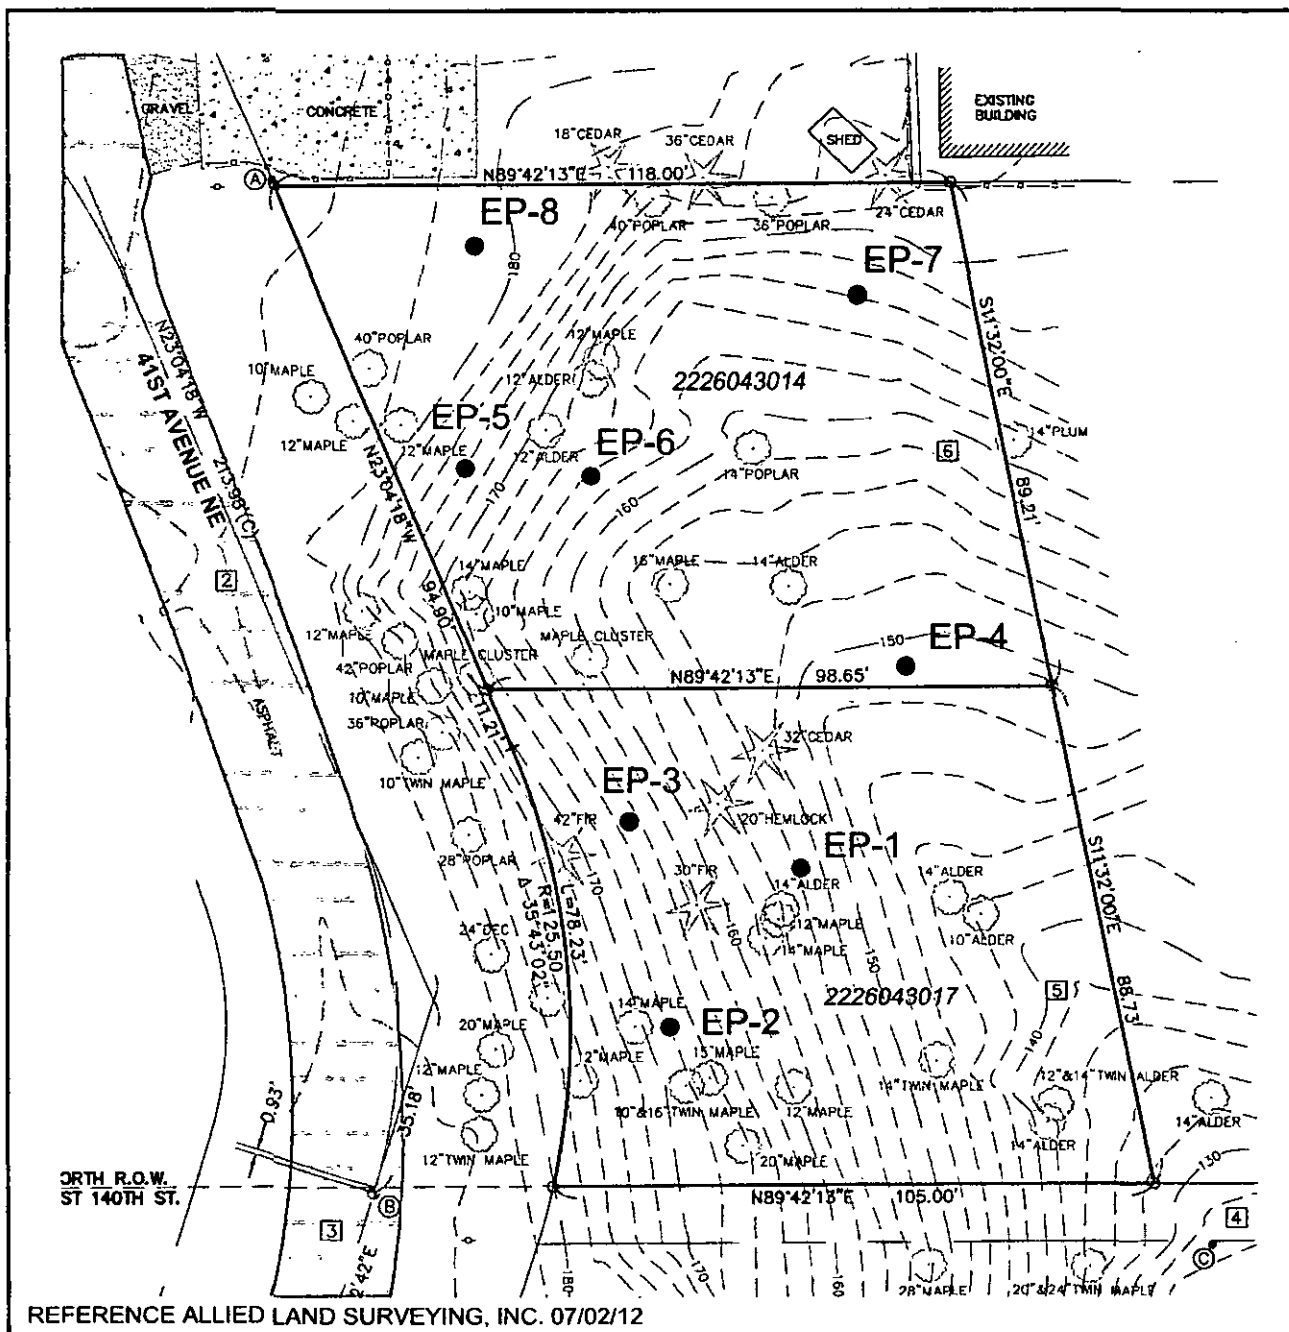
FIGURE 1

In order to characterize the subsurface soil and ground water conditions on the property five exploration pits were excavated on the site on July 18, 2012. The exploration pits (EP-4 through EP-8) were placed at the approximate locations shown on the attached Site & Exploration Plan.
