## 4 Point Insurance Report

Property Address: 3421 Highway 97 Molino, FL

Date of Inspection: 03/08/18 Start Time: 11:30 A.M.

## Wind Mitigation Inspection Report

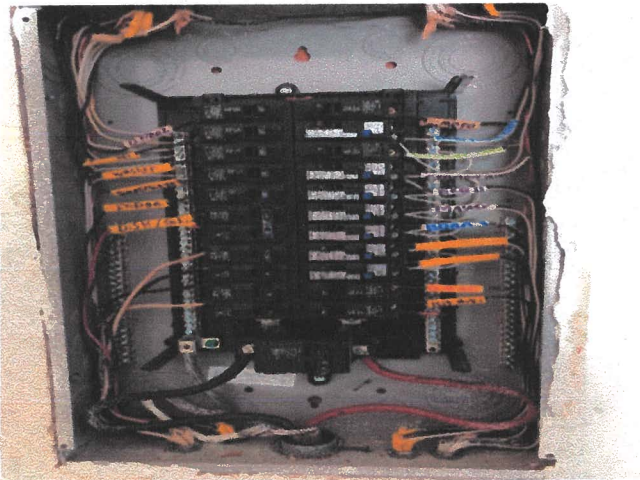
The electrical service is a 200 amp service with circuit breakers and copper branch wiring updated in 2017. Updates between 2008-2018 include new outlets & switches, various new lighting fixtures / fans, and new GFCI outlets in the bathrooms and kitchen. The Siemens circuit breaker subpanel and the copper branch wiring are in good and serviceable condition with an estimated combined remaining life of 70 +/- years.

Siemens subpanel – copper branch wiring

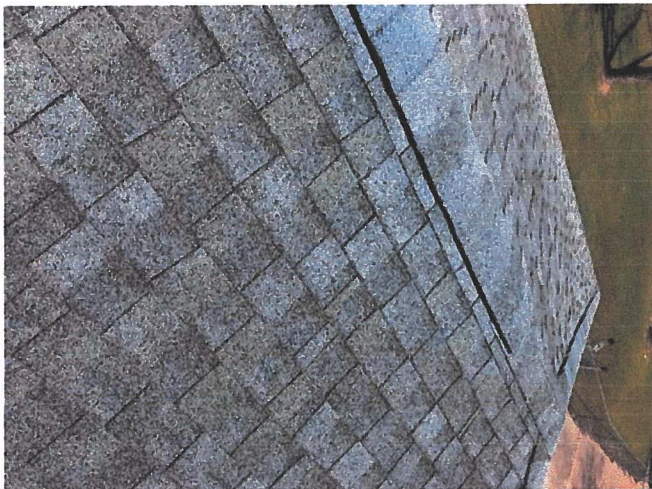
Roof View

The roofing material is a single layer composition shingle type installed on a pitched gable roof in 2004. The roofing material is in good and serviceable condition, with no readily visible leaks observed. The roofing material has an estimated remaining life of 12 +/- years, assuming proper maintenance is performed.

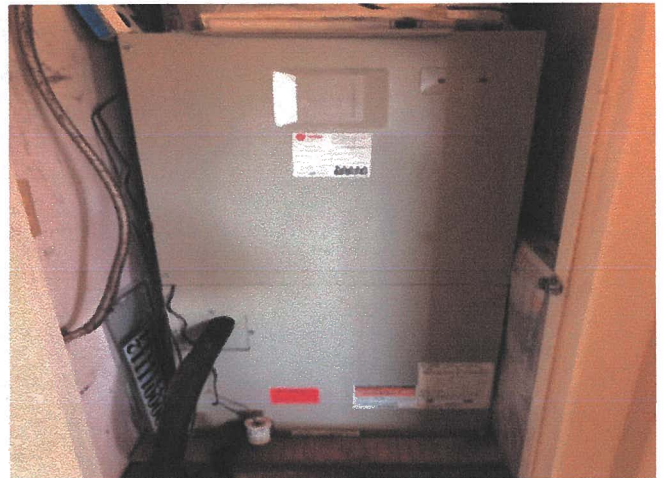
The central HVAC system is a 2001 - 3 ton electric air conditioning with a 2006 - heating unit. The units are in working and serviceable condition at this time with an estimated combined remaining life of 5 +/- years, assuming proper maintenance is performed.

Electric Heating Unit – 2006 – 3 ton

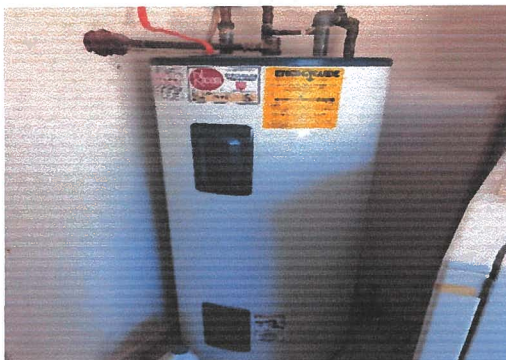
**Electric Water Heater - 2000**

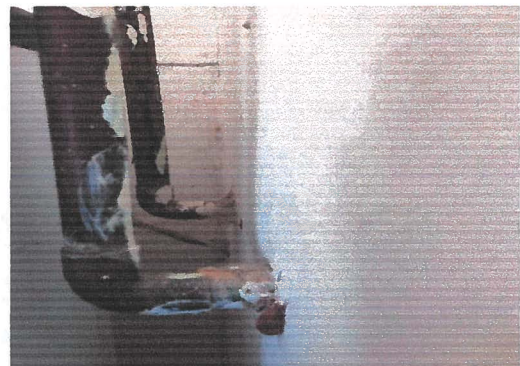
Water service piping where viewable is copper piping. No leaks were observed. Updates include various new kitchen and bath faucets / fixtures between 2008-2018, and an electric water heater in 2000. Any observable repairs to the original plumbing system have been done with newer materials. The plumbing is in good and serviceable condition with an estimated combined remaining life of 20 +/- years.

**Copper Piping**

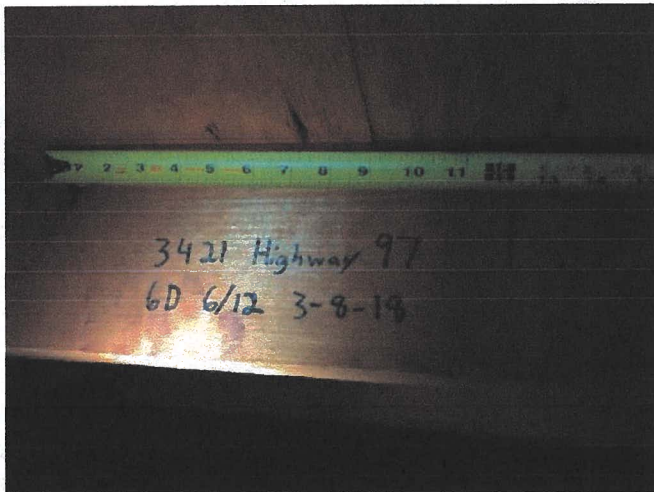
- ☒ B. Plywood/OSB roof sheathing with a minimum thickness of 7/16" inch attached to the roof truss/rafter (spaced a maximum of 24" inches o.c.) by 8d common nails spaced a maximum of 12" inches in the field. -OR- Any system of screws, nails, adhesives, other deck fastening system or truss/rafter spacing that is shown to have an equivalent or greater resistance 8d nails spaced a maximum of 12 inches in the field or has a mean uplift resistance of at least 103 psf.

Roof Deck Attachment – B – 8D Nails 6/12

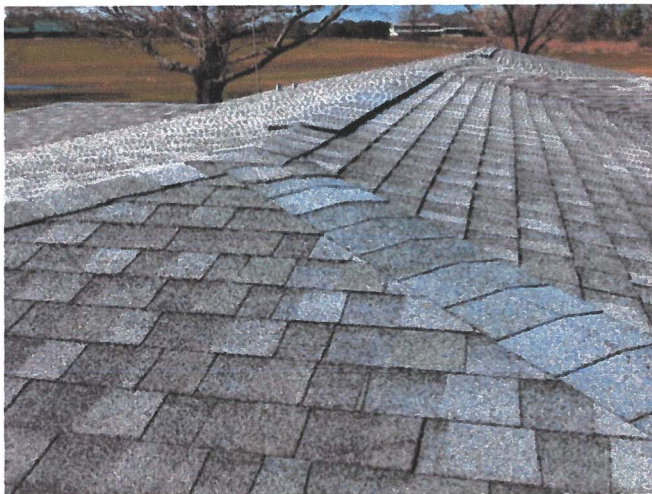
- ☒ A. Hip Roof Hip roof with no other roof shapes greater than 10% of the total roof system perimeter.  
Total length of non-hip features: \_\_\_\_\_ feet; Total roof system perimeter: \_\_\_\_\_ feet
- ☐ B. Flat Roof Roof on a building with 5 or more units where at least 90% of the main roof area has a roof slope of less than 2:12. Roof area with slope less than 2:12 \_\_\_\_\_ sq ft; Total roof area \_\_\_\_\_ sq ft
- ☐ C. Other Roof Any roof that does not qualify as either (A) or (B) above.

Hip Roof Geometry

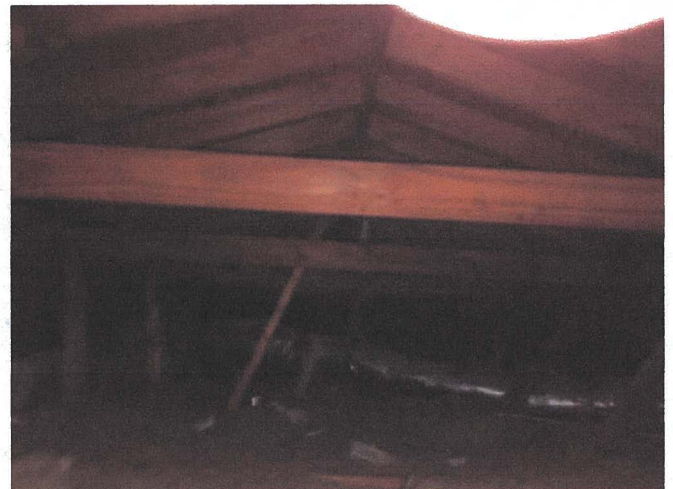
Site Built Roof Framing
