# INSPECTION REPORT

For the Property at:  
**919 MAIN ST**  
BLANCO, TX 78606

Inspection Date: Thursday, May 20, 2021

Prepared by: Monica Baryo, PI# 24287

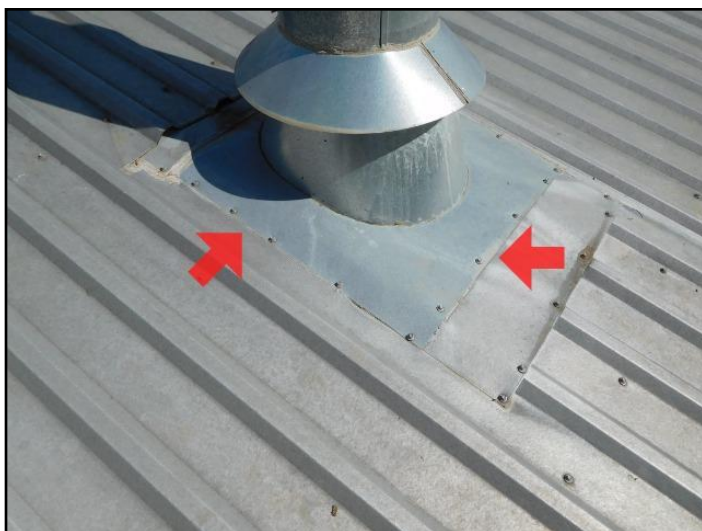
Caulking has deteriorated around the vent stacks, chimney and side wall flashings. This is a maintenance item which should be done at least every two years.

1. deteriorated caulking around flashing

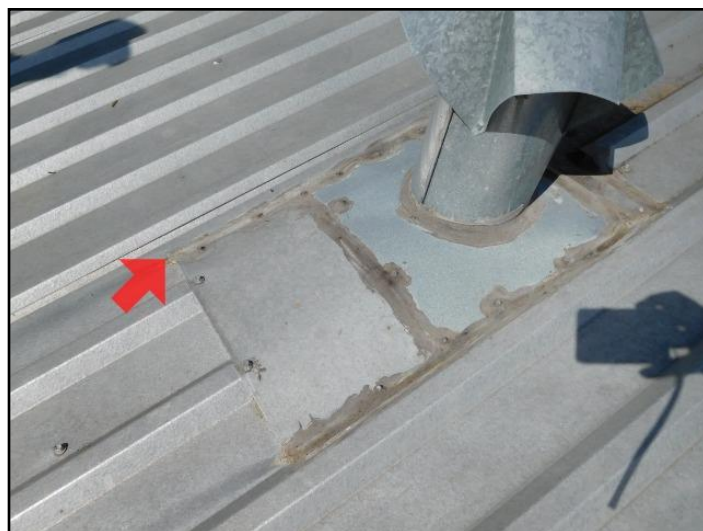
2. deteriorated caulking around flashing

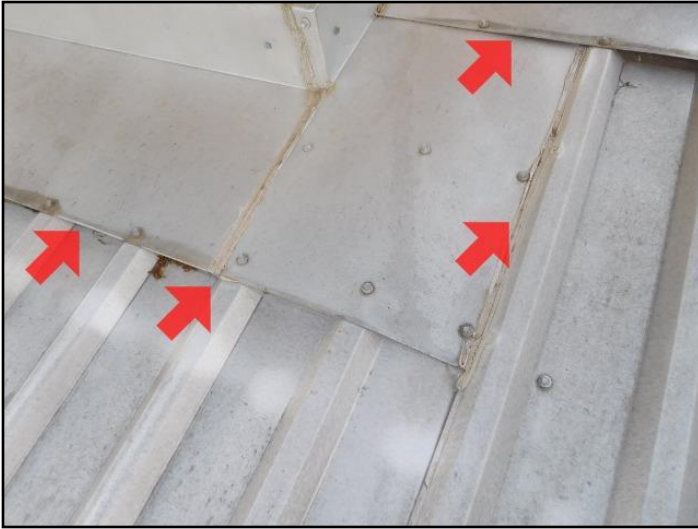
3. deteriorated caulking around flashing

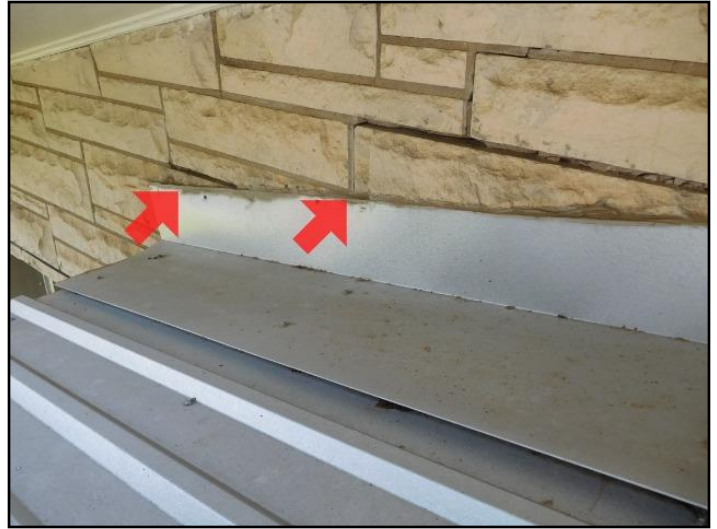
4. deteriorated caulking around flashing

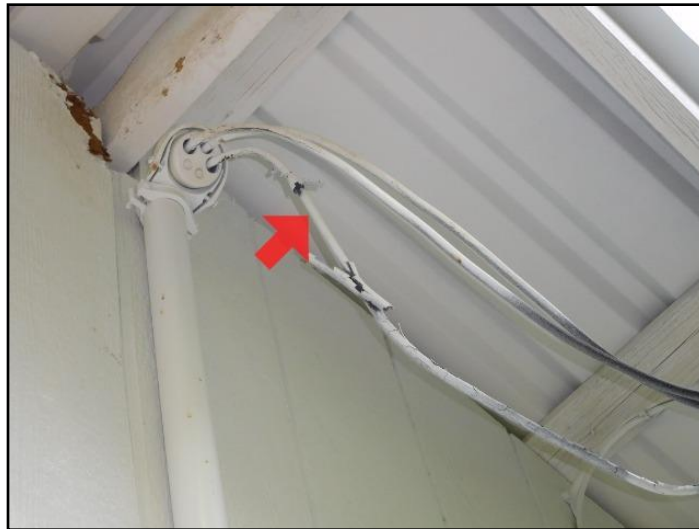
**Condition:** • Insulation missing or damaged

**Implication(s):** Fire hazard

5. Insulation missing or damaged

**Task:** Repair

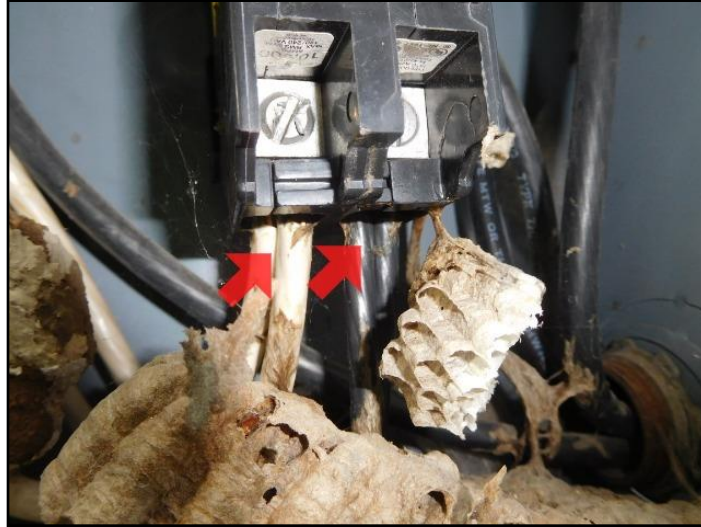
**Condition:** • Double Tap: Only way to fix this double tap is to add another breaker but this box cannot equip another

breaker slot so the service box will have to be replaced.

6. Double Tap

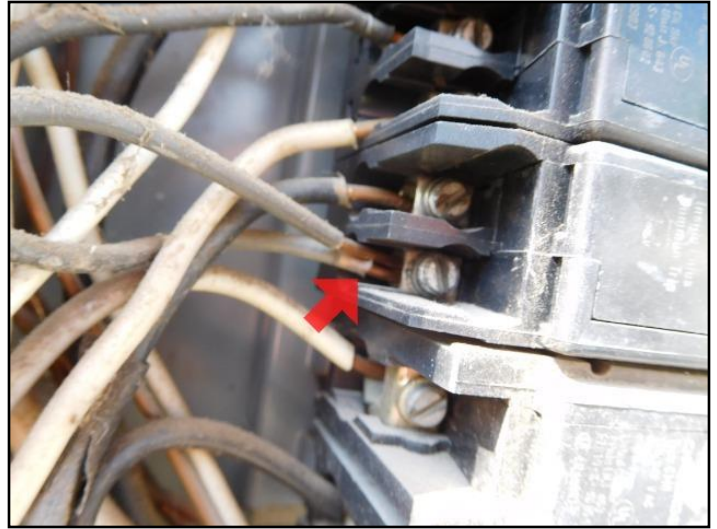
Not only is the main service disconnect a Challenger brand which is considered a fire hazard since they can fail to trip causing fires, there are double taps (two circuits connected to the same breaker or main terminal) there is cloth aluminum wiring going to the range which is also a fire hazard.

8. Double taps

**Task:** Replace

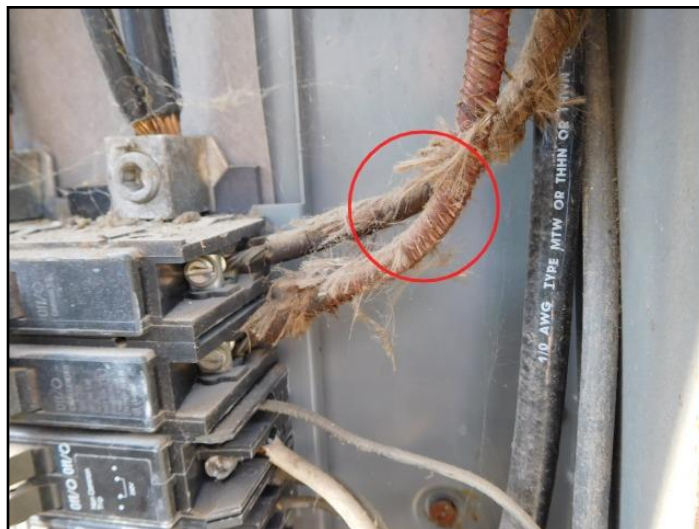
9. cloth aluminum wiring

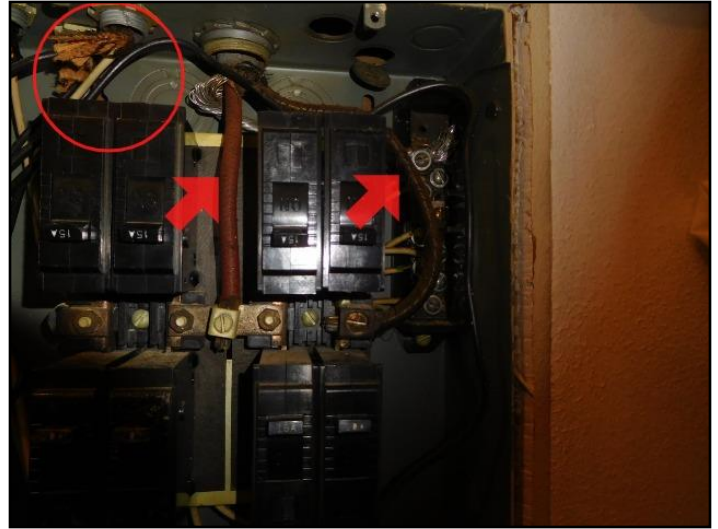
**Condition:** • The entire house is wired with cloth, ungrounded wiring which is outdated and a safety concern.

12. cloth wiring

**Task:** Replace

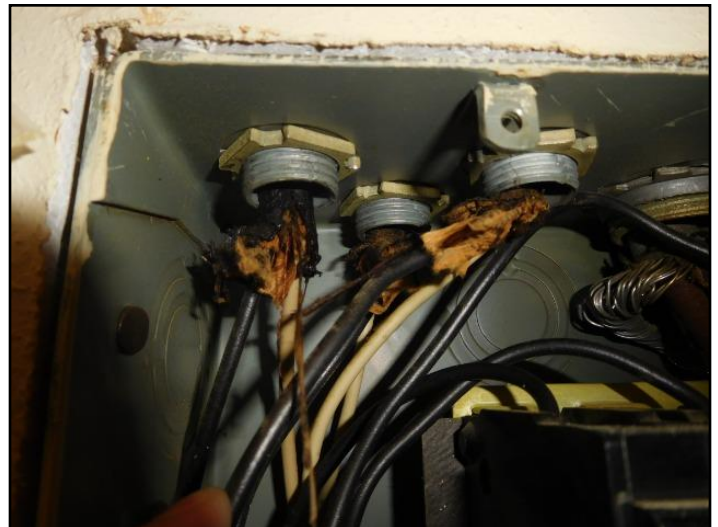
14. cloth wiring

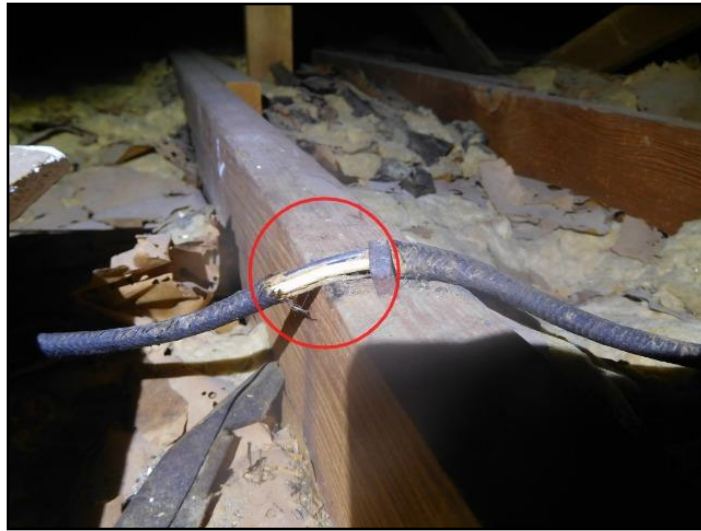
**Condition:** • Damage

Pricing will be reflected in whole house rewire recommendation.

15. Damage

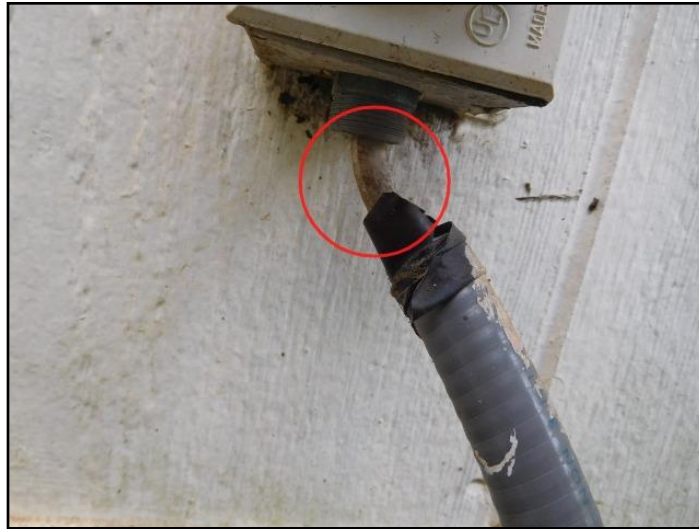
17. Wires not well secured to outlet box

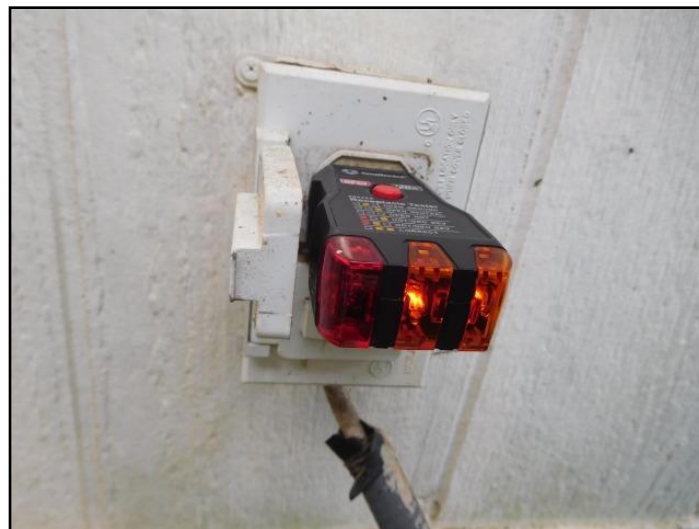
18. No GFCI/GFI (Ground Fault Circuit...

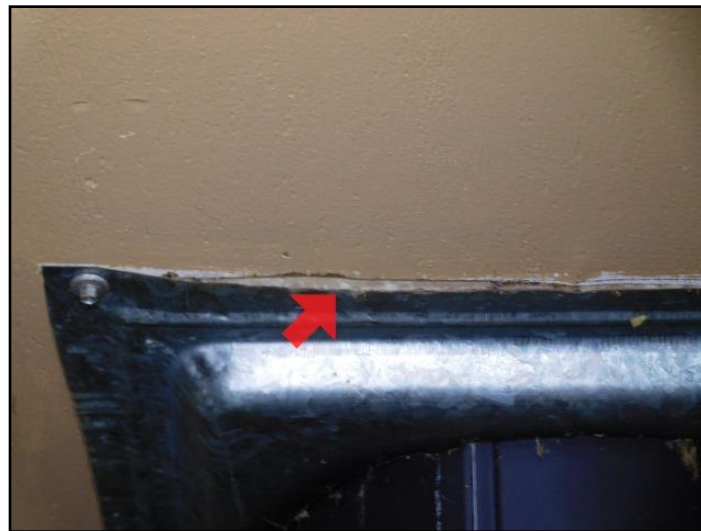
**Condition:** • Poor connection to chimney

Loose seam at the top of the chimney going thru the ceiling into the attic.

20. Poor connection to chimney

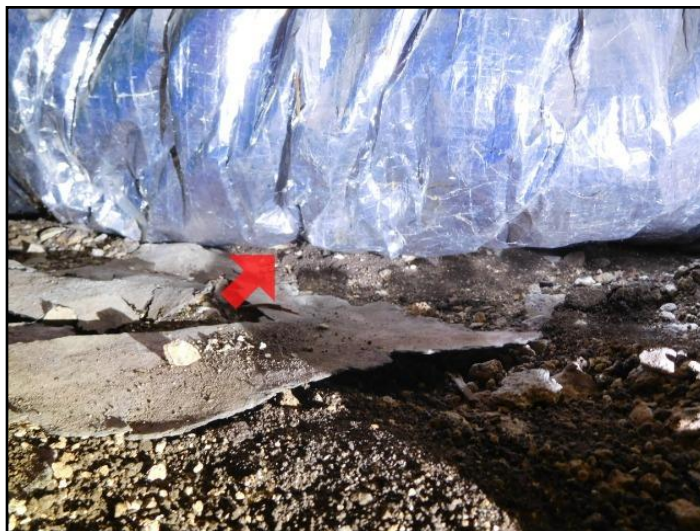
**Condition:** • Poor support

Ductwork should be supported off the ground due to moisture implications.

21. ductwork laying on the ground

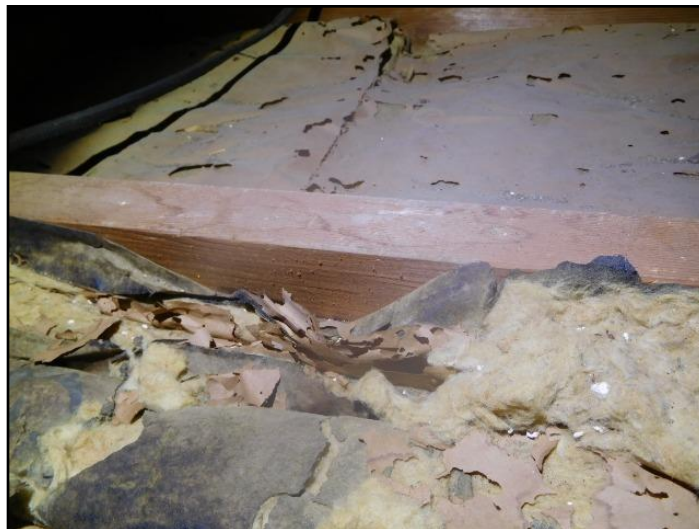
**Condition:** • Compressed

22. Compressed

**Task:** Correct

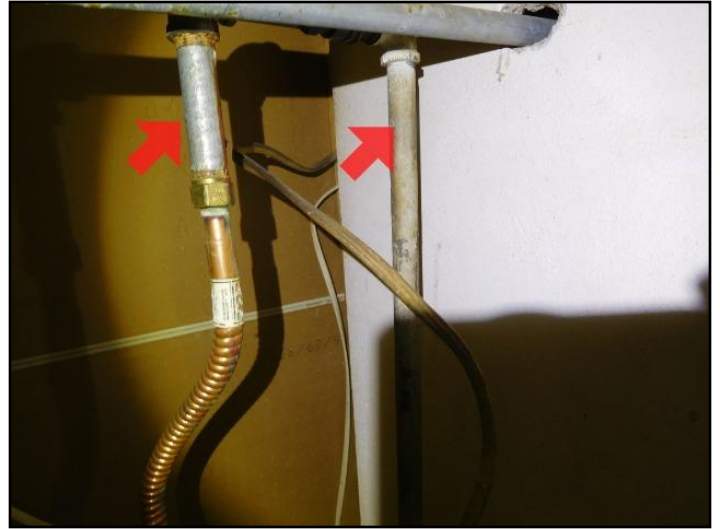
**Condition:** • Galvanized steel

Both homes are plumbed (including the water heaters) with galvanized steel and should be replaced as they also develop pinhole leaks as well as cause poor water pressure.

27. Galvanized steel

**Task:** Replace

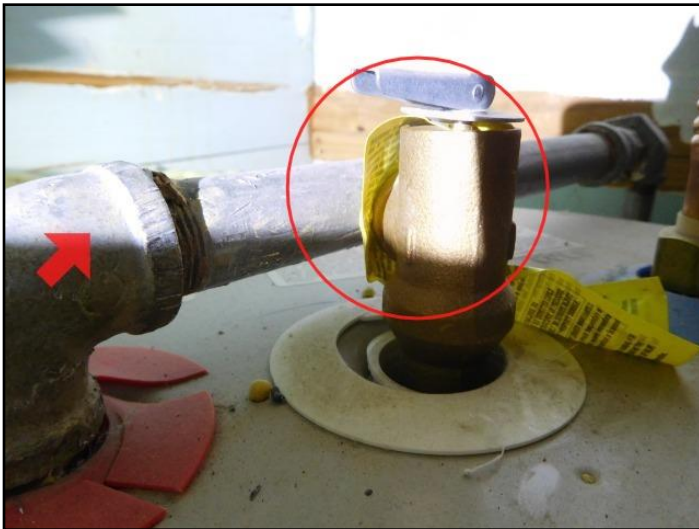
**Condition:** • Discharge tube missing

28. Discharge tube missing

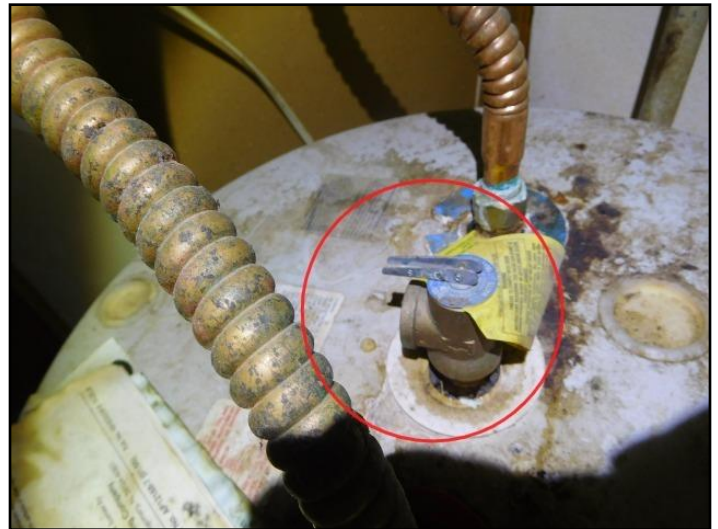
29. Discharge tube missing

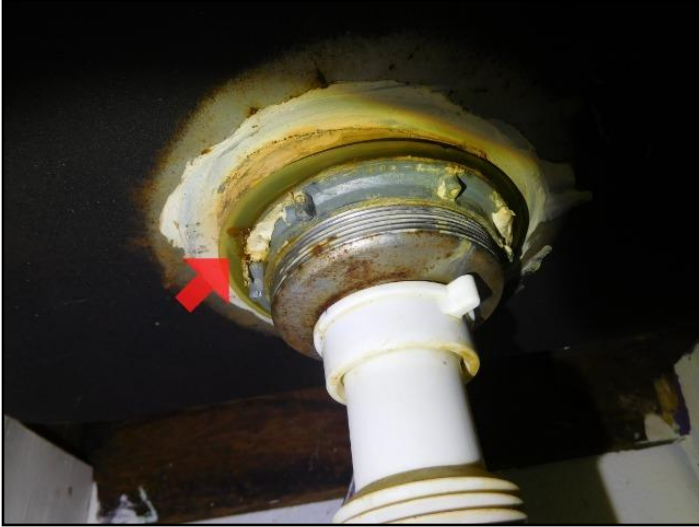
**Condition:** • Leak

32. Leak

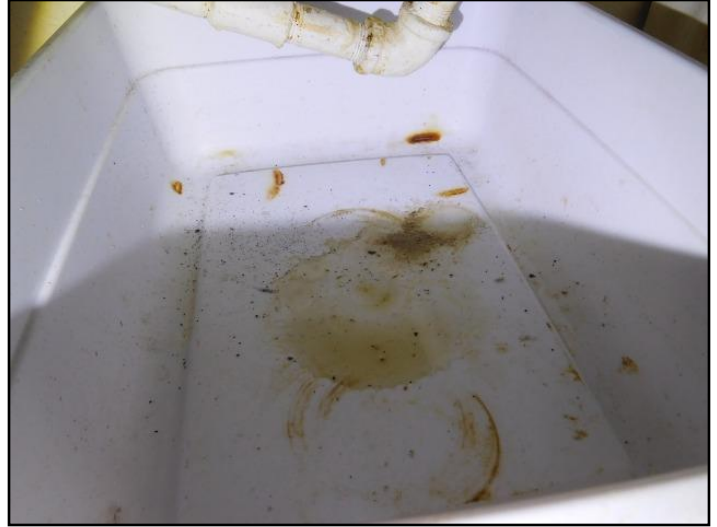
33. Leak

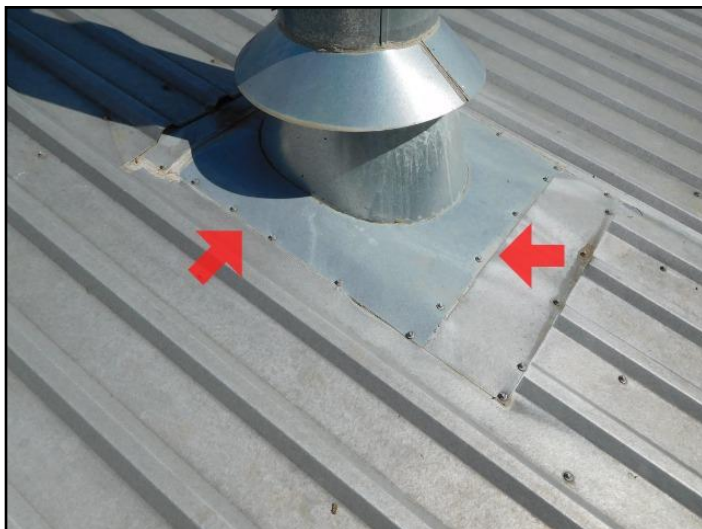
38. deteriorated caulking around flashing

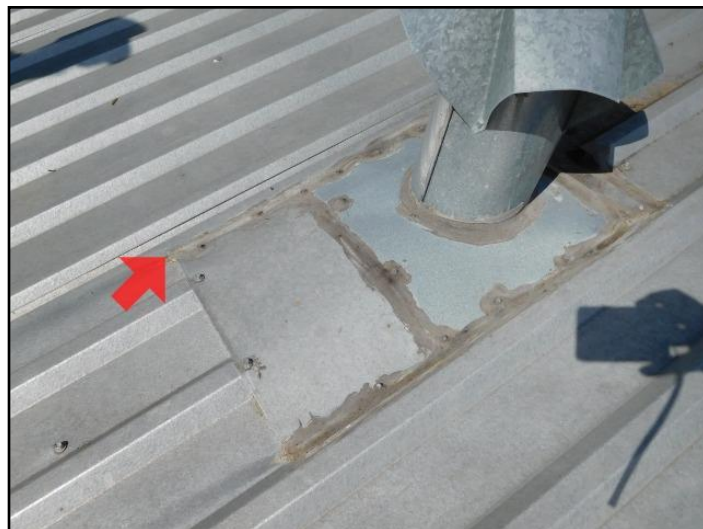
39. deteriorated caulking around flashing

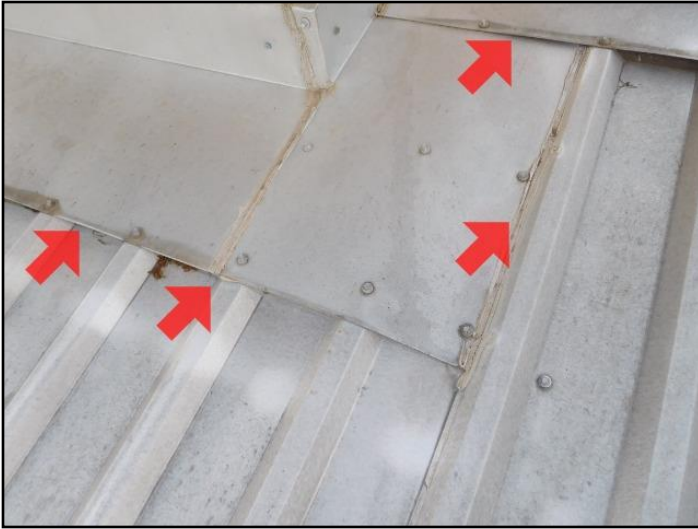
40. deteriorated caulking around flashing

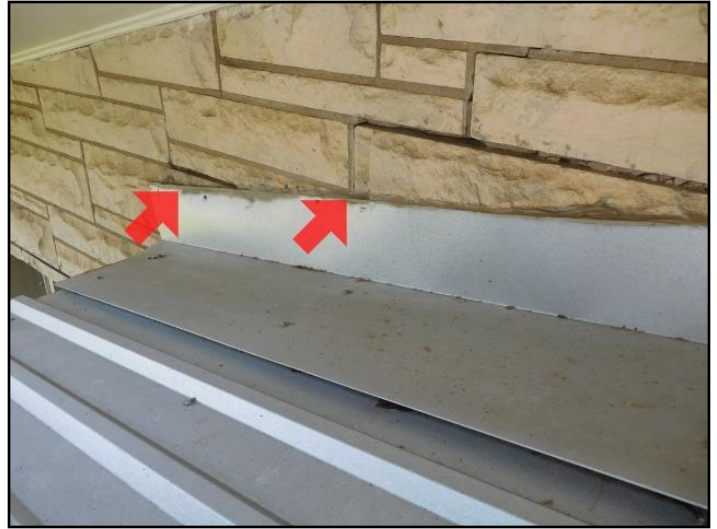
41. deteriorated caulking around flashing

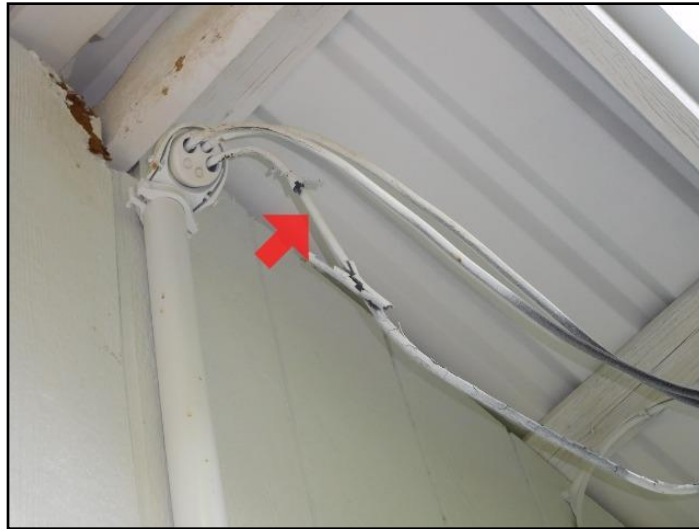
**48.** *Insulation missing or damaged*

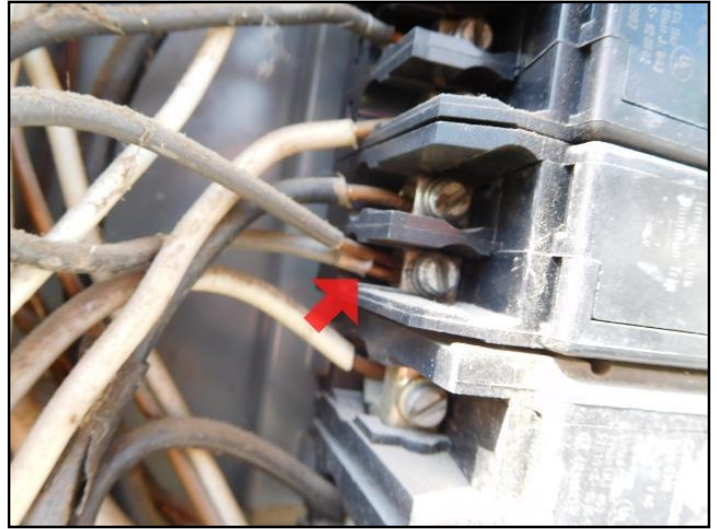
50. Double taps

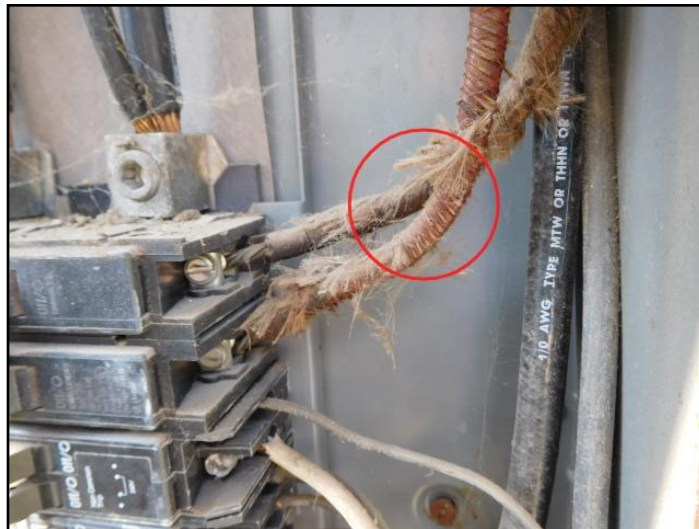
51. cloth aluminum wiring

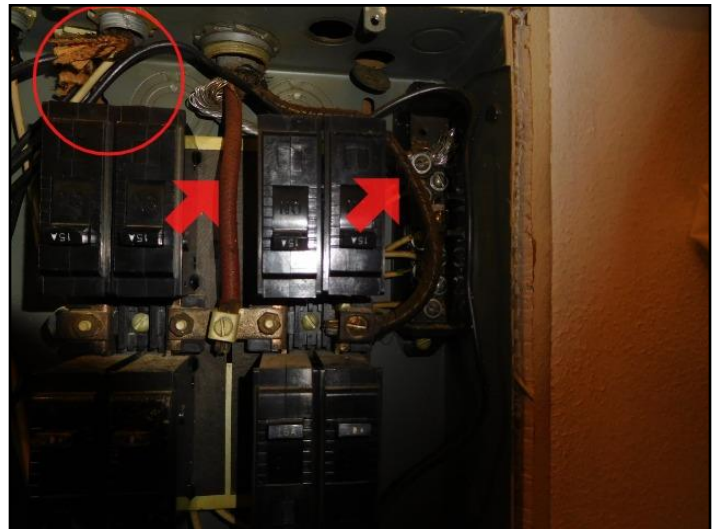
55. cloth wiring

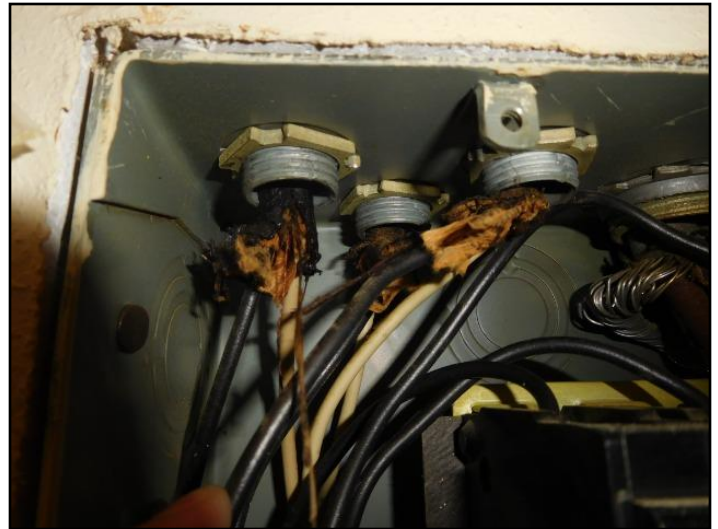
57. cloth wiring

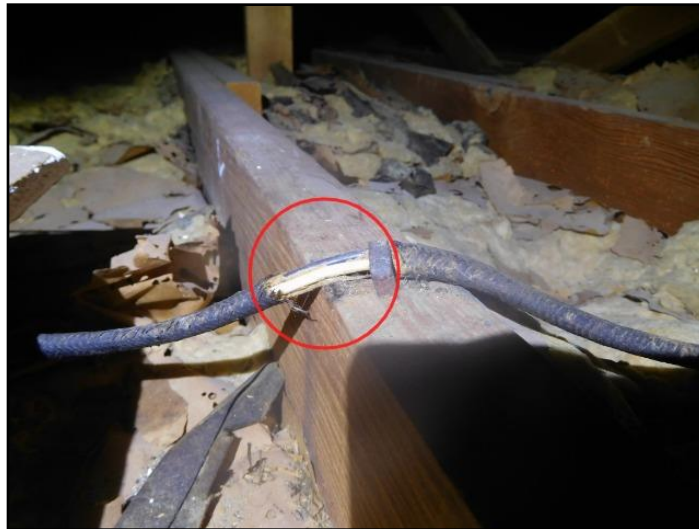
**Location:** Front House Attic

**Implication(s):** Electric shock | Fire hazard

58. Damage

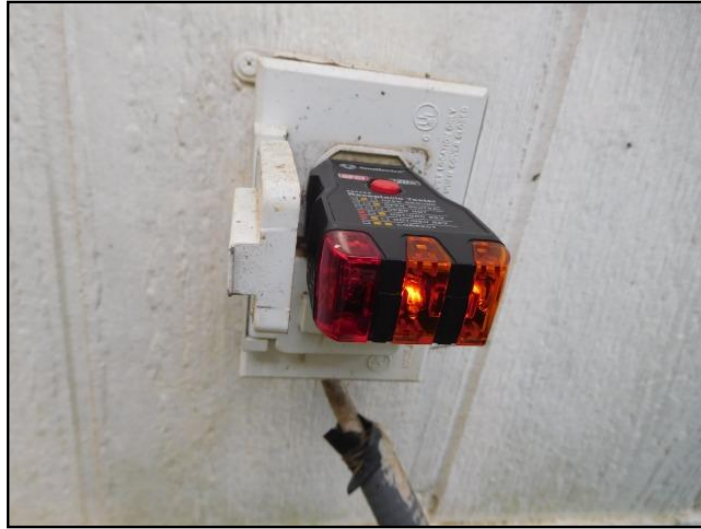
60. No GFCI/GFI (Ground Fault Circuit...

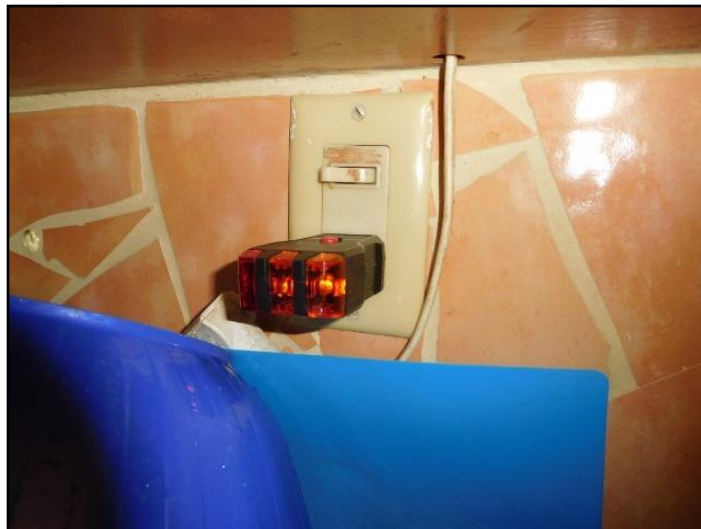
**12. Condition:** • No GFCI/GFI (Ground Fault Circuit Interrupter)

61. No GFCI/GFI (Ground Fault Circuit...

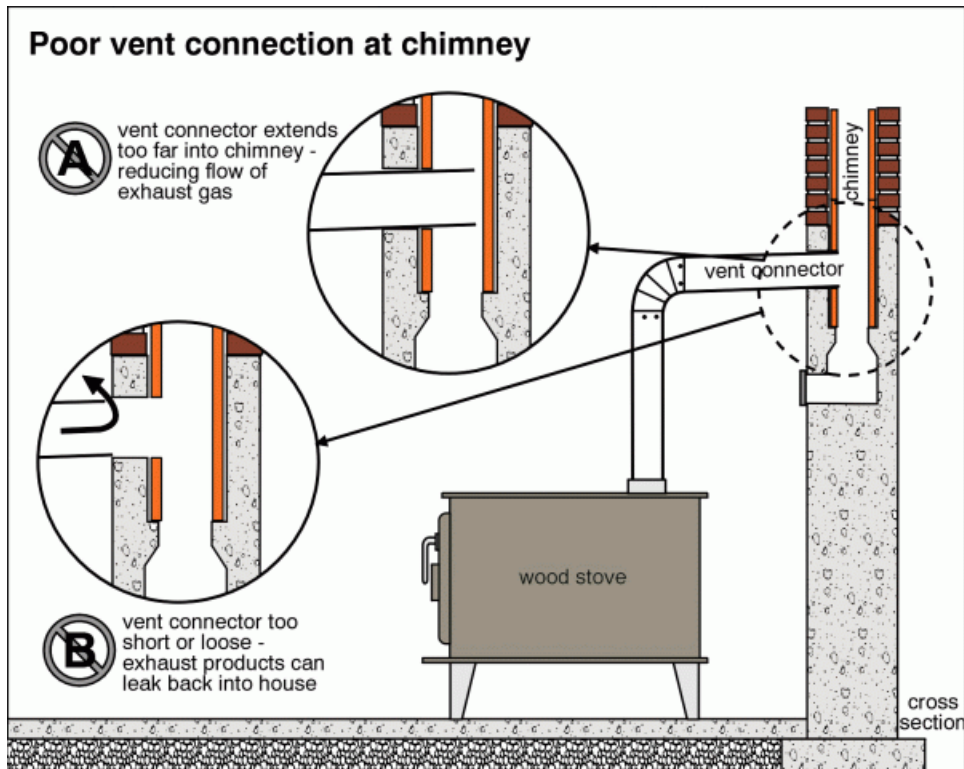
63. Poor connection to chimney

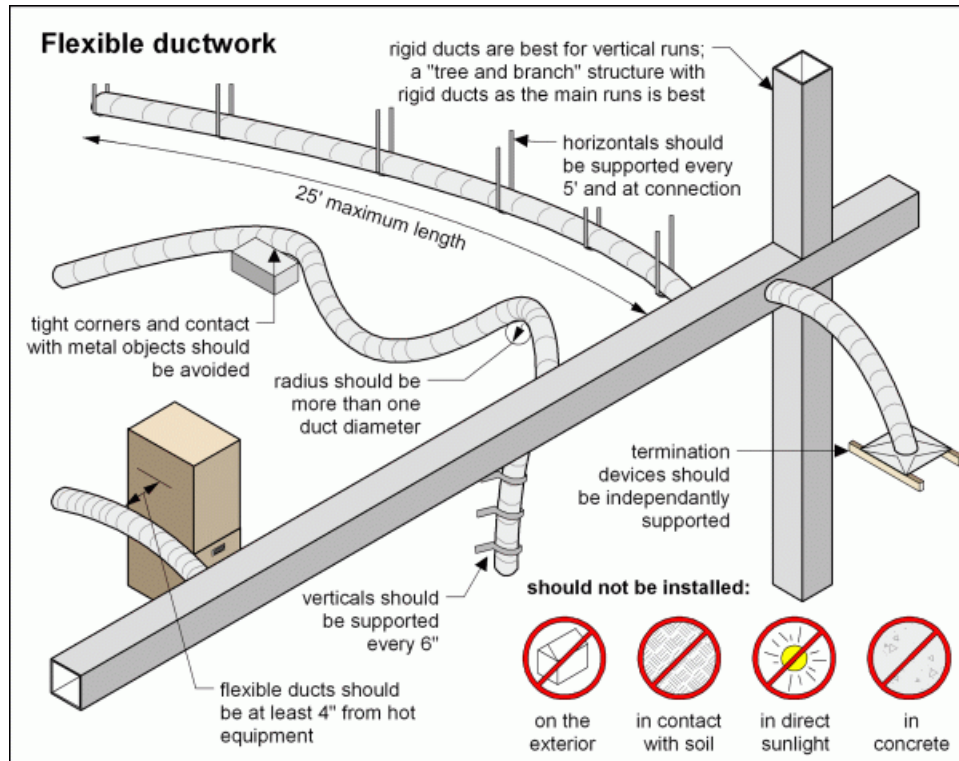
**18. Condition:** • Poor support

68. ductwork laying on the ground

**Task:** Correct

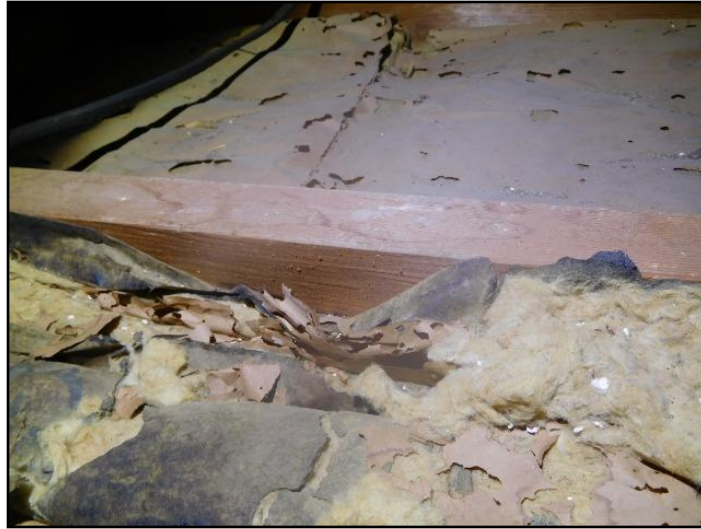
69. *Compressed*

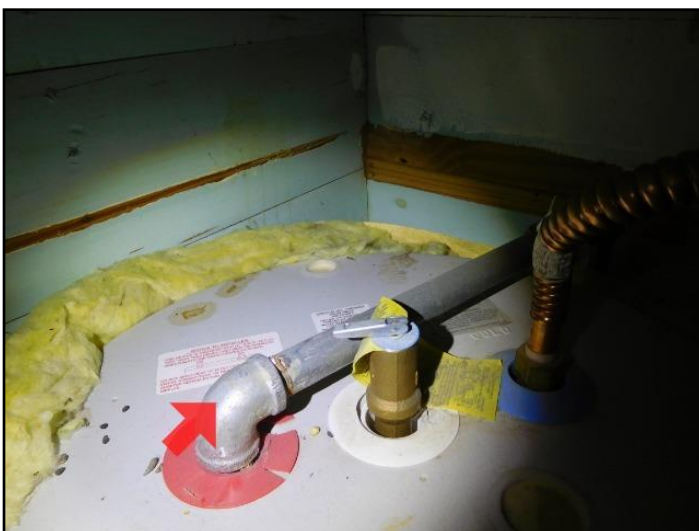
76. Galvanized steel

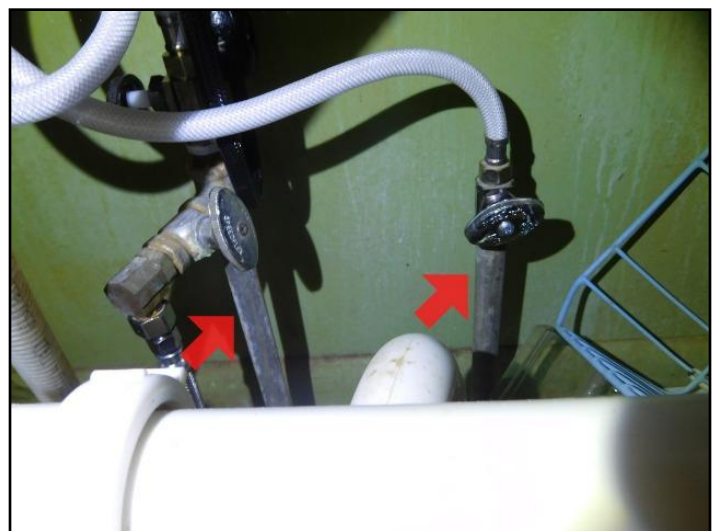
77. Galvanized steel

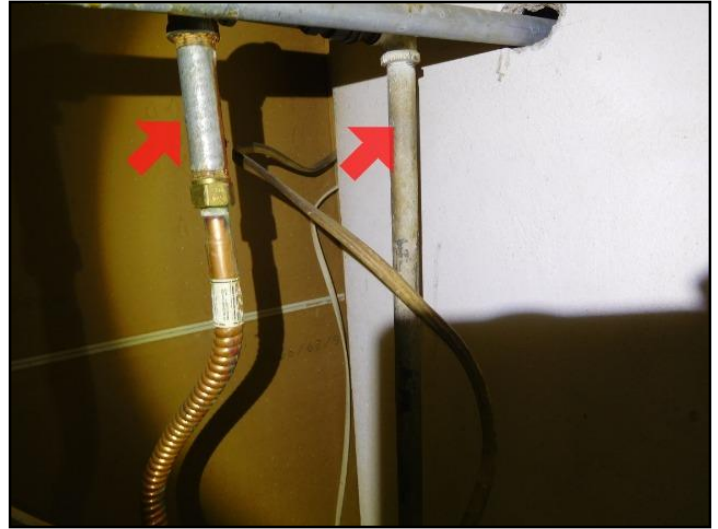
79. Galvanized steel

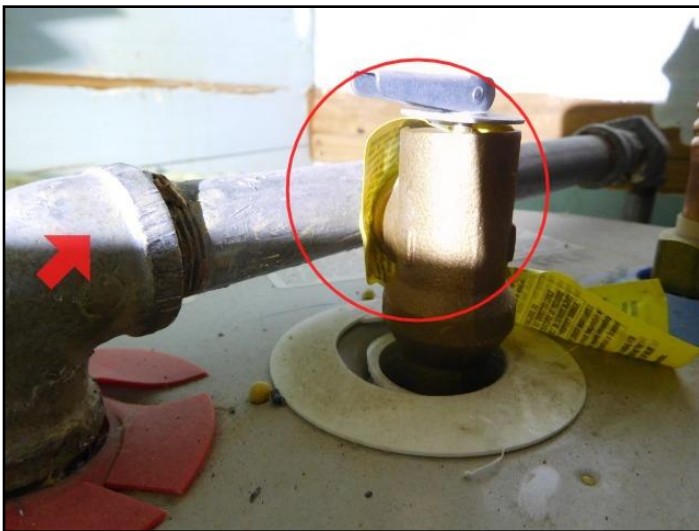
80. Discharge tube missing

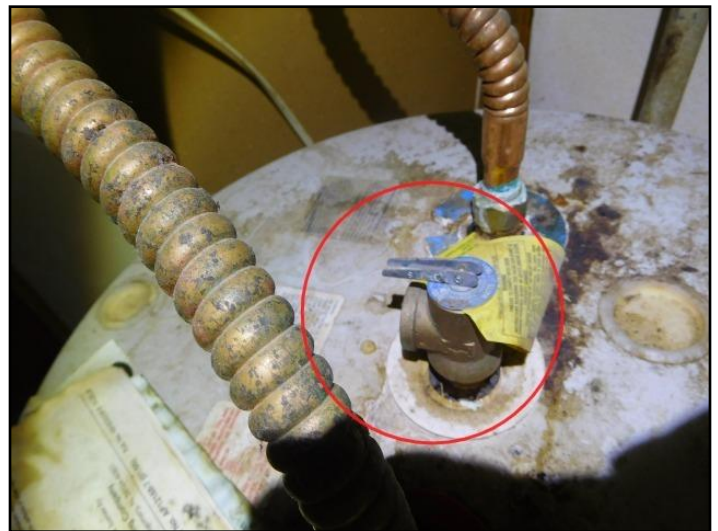
81. Discharge tube missing

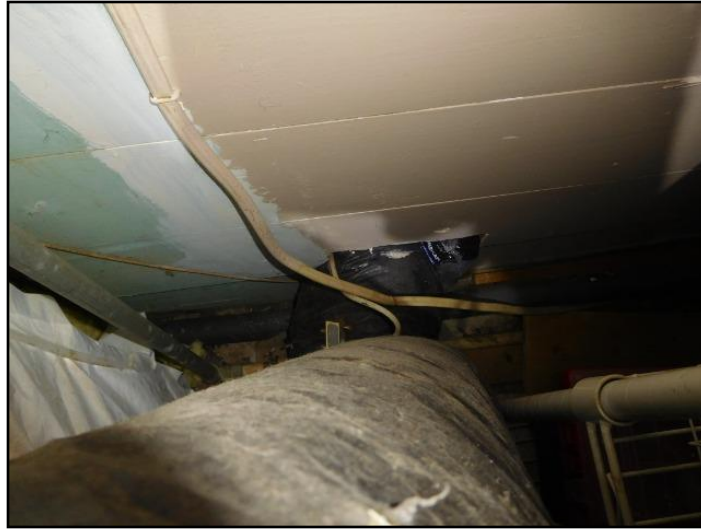
82. missing on/off switch

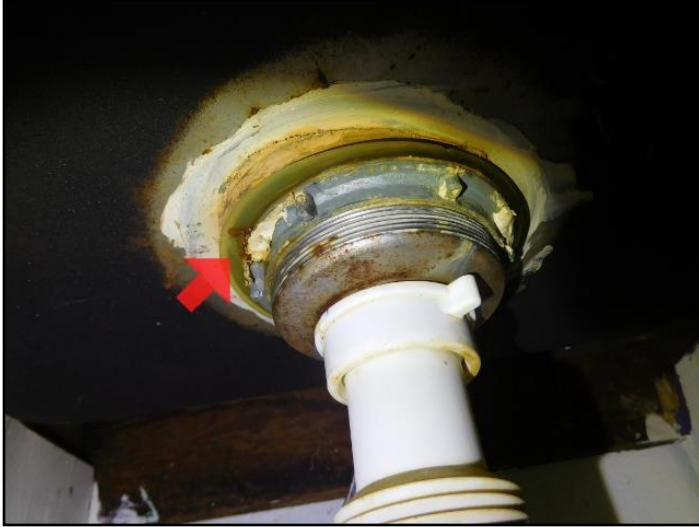
84. Leak

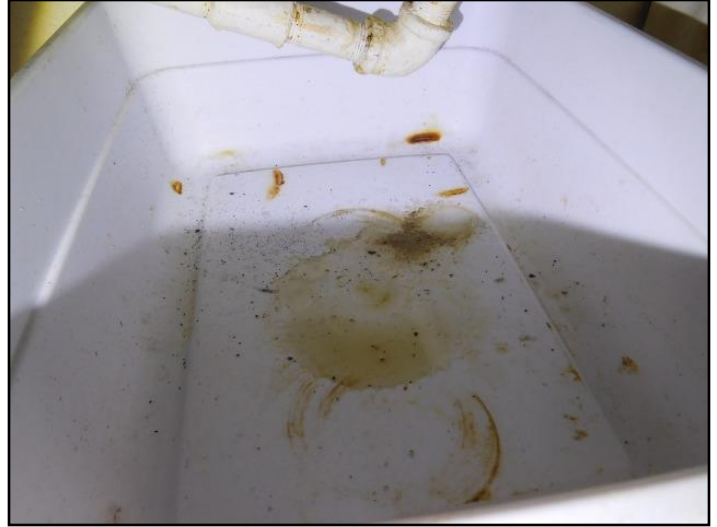
85. Leak
