# Inspection Report

**Natalie Cross**  
**6320 Vineyard Drive (Main House)**  
**Paso Robles, CA 93446**

Report Date: 8/20/2021

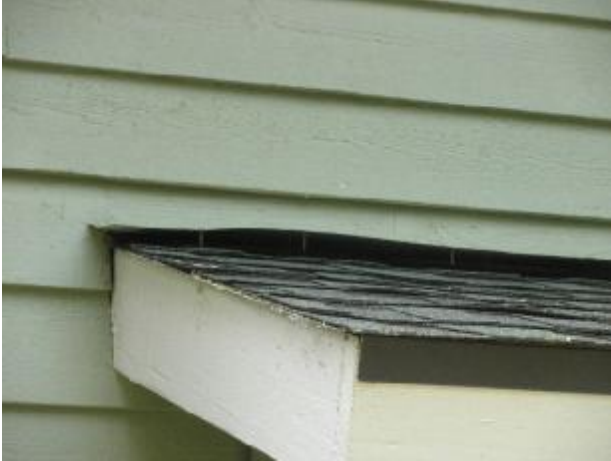
**Repair Note:** The roof-to-wall flashing above the master bedroom is uplifted. This needs to be secured down and sealed to prevent leaks during wind driven rains.

The roof-to-wall flashing above the master bedroom is uplifted.

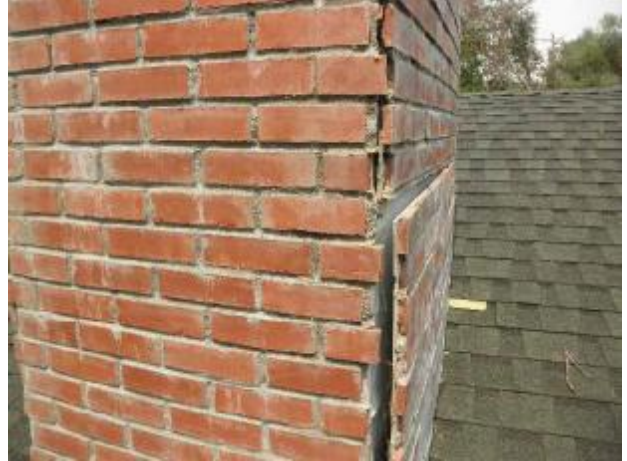
- 1.) The faux brick veneers around both of the chimney enclosures are loose/separated.

The faux brick veneers around both of the chimney enclosures are loose/separated.

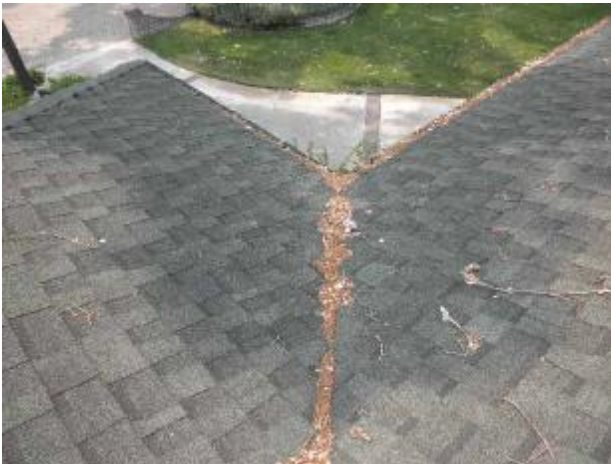
**Maintenance Note:** The leaves and foliage debris needs to be cleared from the roof to promote positive drainage. This is particularly important at the valleys and low slope areas where water damming can cause leakage and premature deterioration of the roof materials.

Clean the debris off the roof.

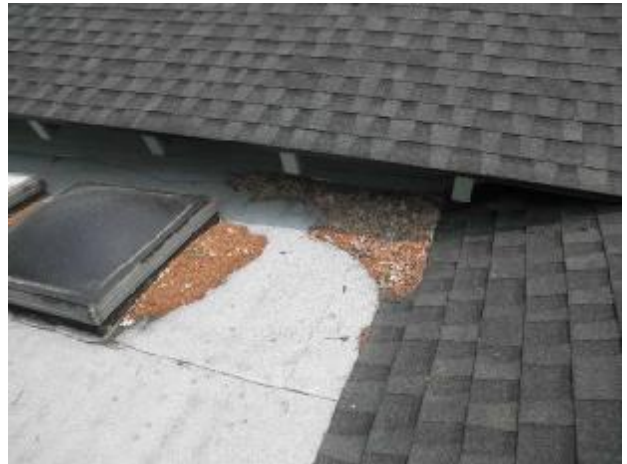
Clean the debris off the roof.

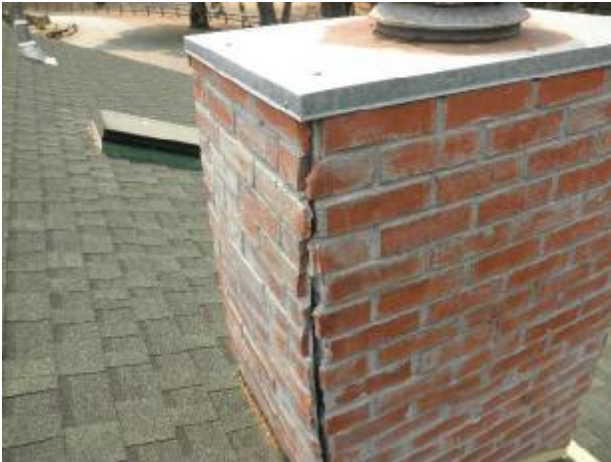
The faux brick veneers around both of the chimney enclosures are loose/separated.

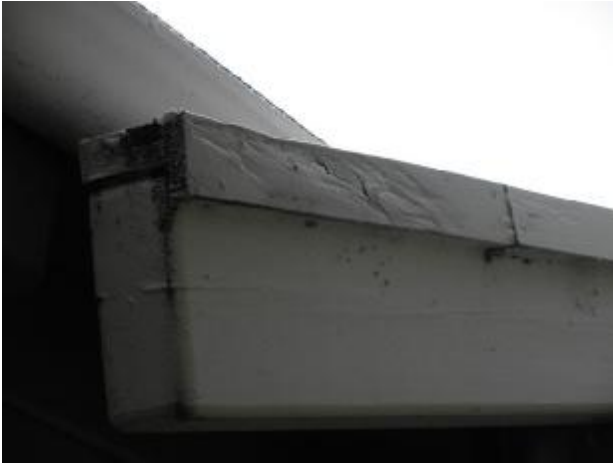
Moisture damage at the wood siding and trim at the half bathroom.

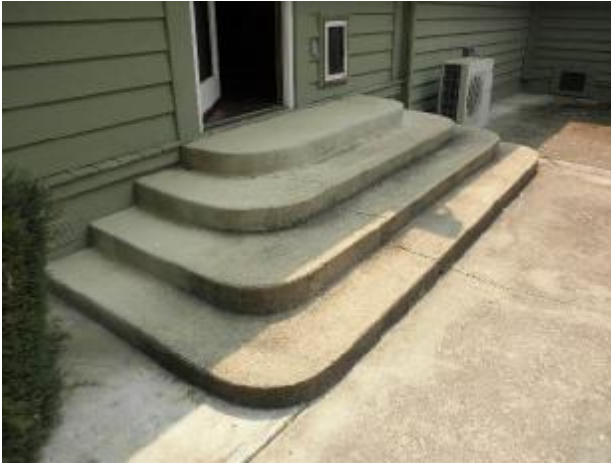
**Safety Hazard Note:** There is no railing installed at the concrete stairs on the west side of the sun room. This can be a falling hazard.

There is no railing installed at the concrete stairs on the west side of the sun room.

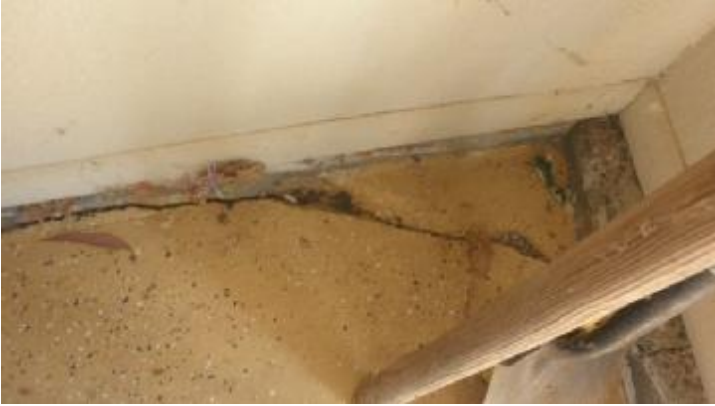
1.) The garage slab has pulled away along the stem wall and there are differential settlement cracks at the SW corner of the garage slab.

Settlement crack at the SW corner of the garage.

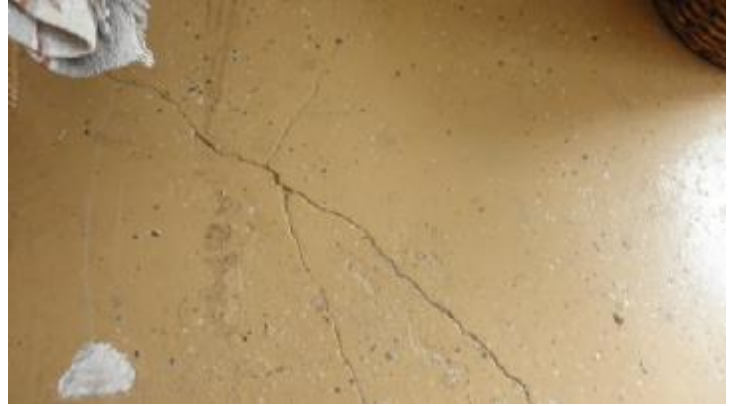
Settlement crack at the SW corner of the garage.

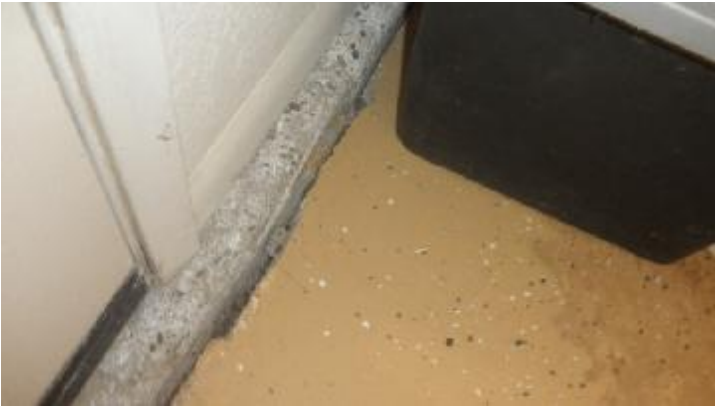
Slab pulled away from the stem wall at the west side of the garage.

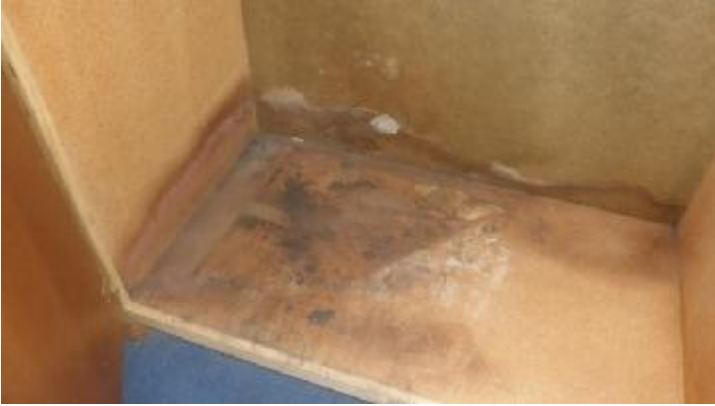
Evidence of water intrusion at the CMU block wall/cabinets in the basement

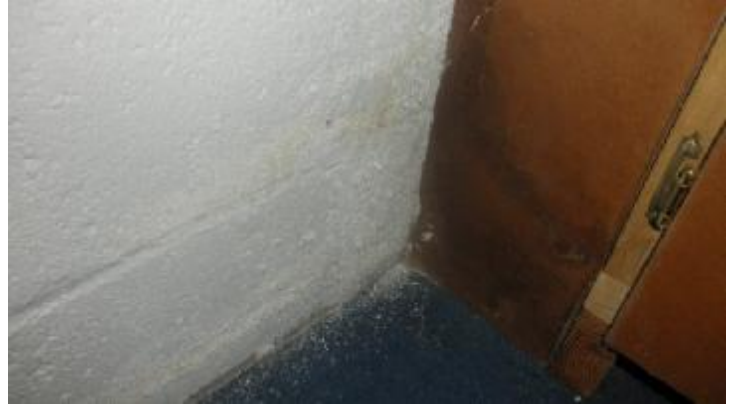
Evidence of water intrusion at the CMU block wall/cabinets in the basement
