Inspection Report

Natalie Cross
6320 Vineyard Drive (Mobile)
Paso Robles, CA 93446

Report Date: 8/20/2021

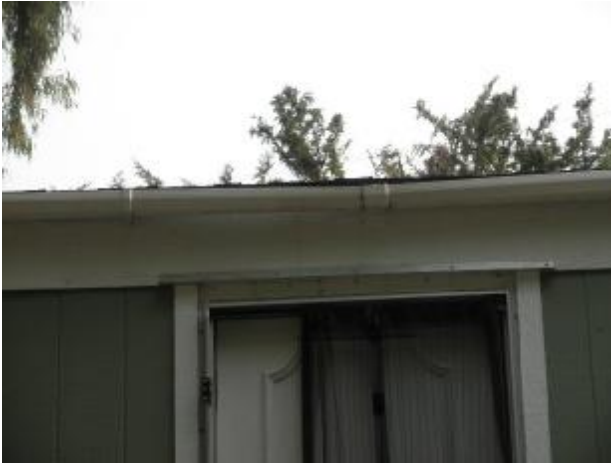
R

Maintenance Note: Part of the gutter is sagging on the west eave. The end cap is loose at the gutter on the east eave.

The front gutter is sagging.

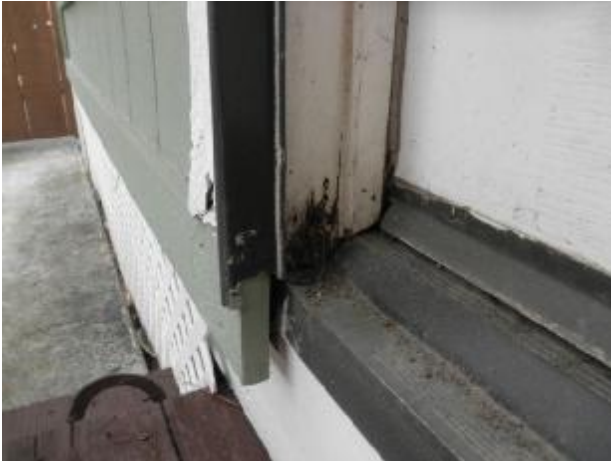
EX

- 4.) The weather stripping is partially missing and there is moisture damage to the base of the jamb at the exterior door on the west wall of the family room.

Moisture damage to the base of the jamb at the exterior door on the west wall of the family room.

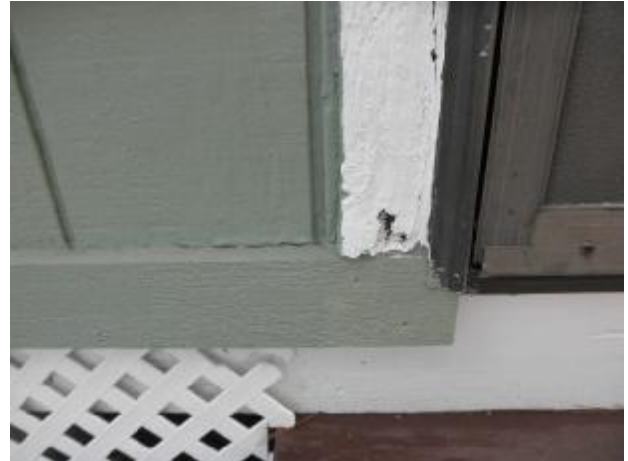
EX

- 6.) Moisture damage was observed in the following locations:
- A.) The door trim on the west wall of the family room.
 - B.) The wall trim at the SW corner of the family room.

Moisture damage to the door trim.

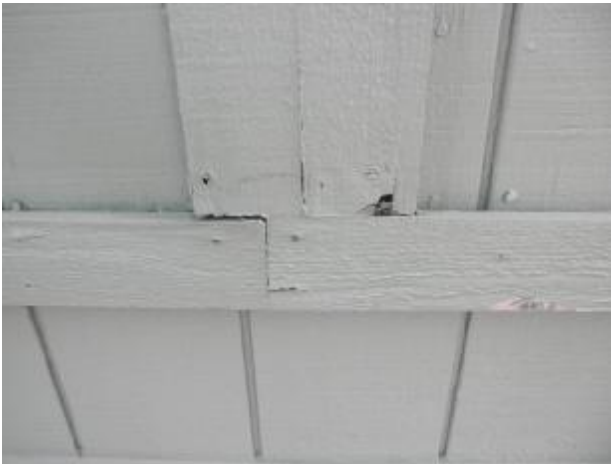
EX

Moisture damage at the wall trim.

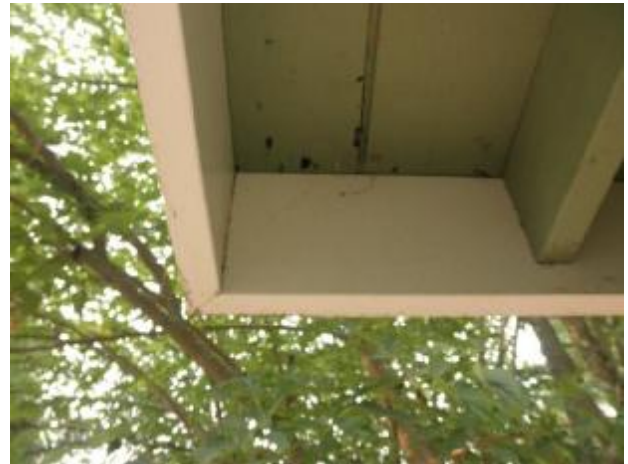
EX

Moisture damage at the eave.

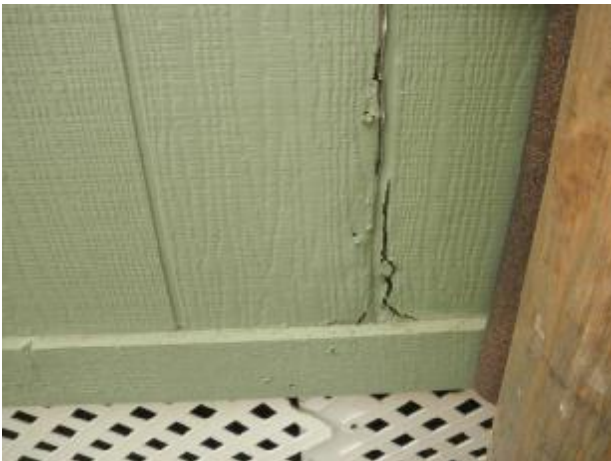
EX

Moisture damage at the wood siding.

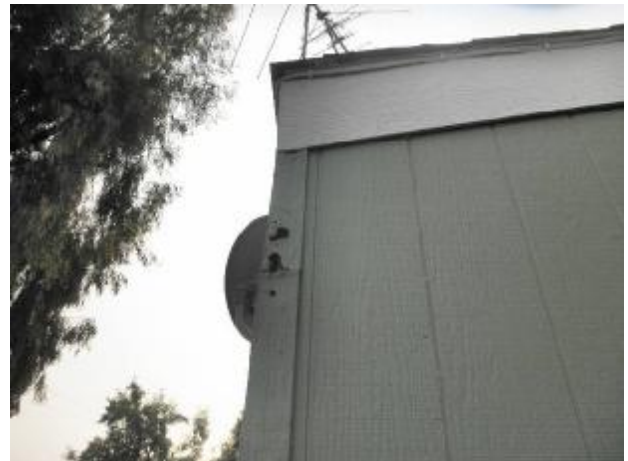
EX

Moisture damage at the corner wall trim.

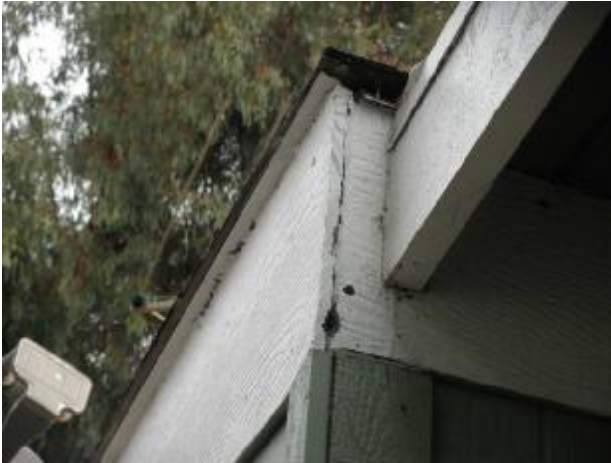
EX

Moisture damage at the fascia board.

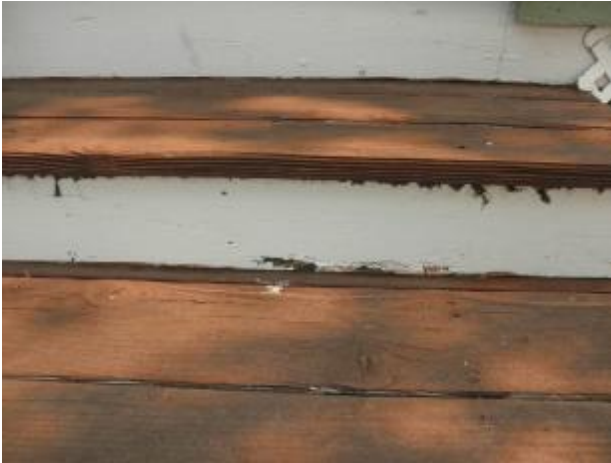
GD

2.) There is moisture damage to parts of the landing at the exterior door on the west wall of the family room. Also, the bottom riser exceeds the maximum allowable height of 7 3/4". This can be a falling hazard.

Moisture damage to parts of the exterior landing.

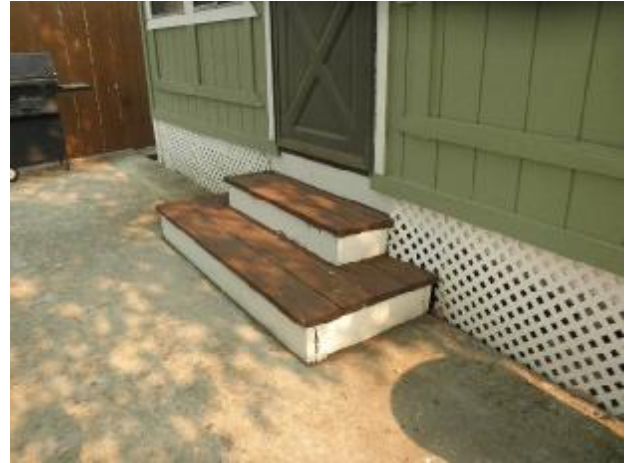
GD

Bottom step riser exceeds the max allowable height of 7 3/4"

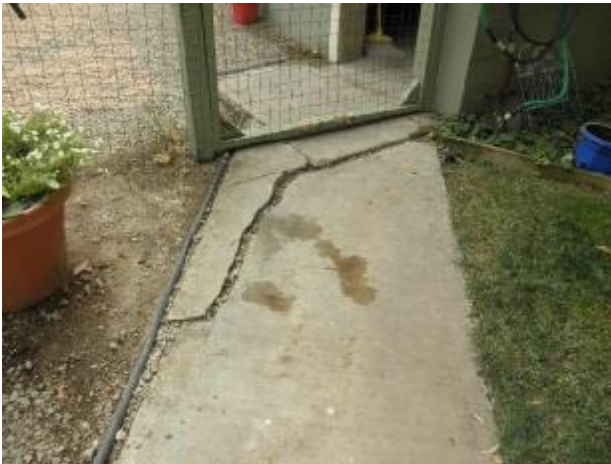
GD

1.) There is a large crack at the end of the concrete walkway in the front yard.

Large crack in the concrete walkway.

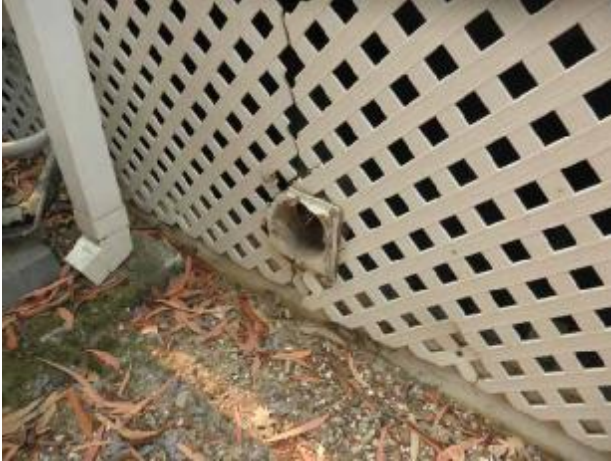
K

- 1.) The laundry lint exhaust vent hood is damaged and needs to be replaced.

The dryer lint exhaust vent hood is damaged.

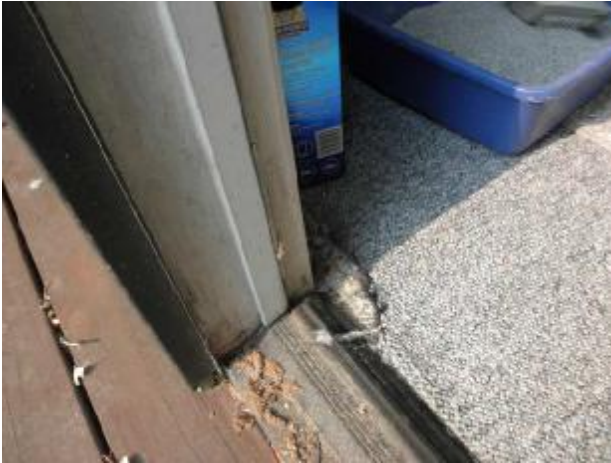
IR

1.) There is some damaged carpeting by the exterior door and at the corner of the stairs in the family room.

Damaged carpeting in the family room.

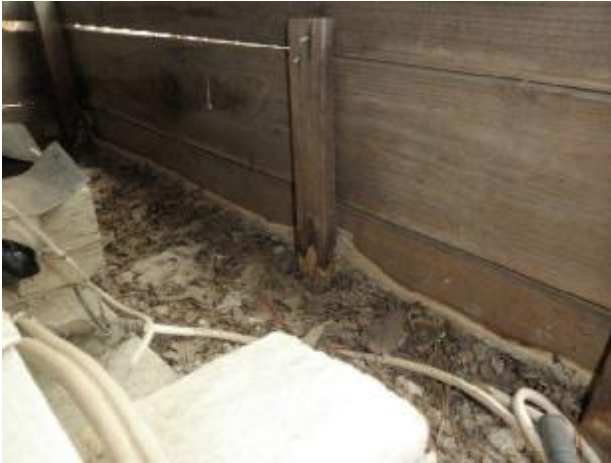
F

- 1.) There is earth-to-wood contact with fungus damage in places at the perimeter skirting.

Fungus damage to parts of the perimeter skirting.
