Inspection/Certification

Date of Inspection: **8/27/21** Property Owner: **Natalie Cross**
Inspection Address: **6520 Vineyard Drive, Paso Robles Ca 93446**
Realtor/Finance Company: **Carolyn McNairn**
Title Company: **N/A**

Existing Septic System Verification Form

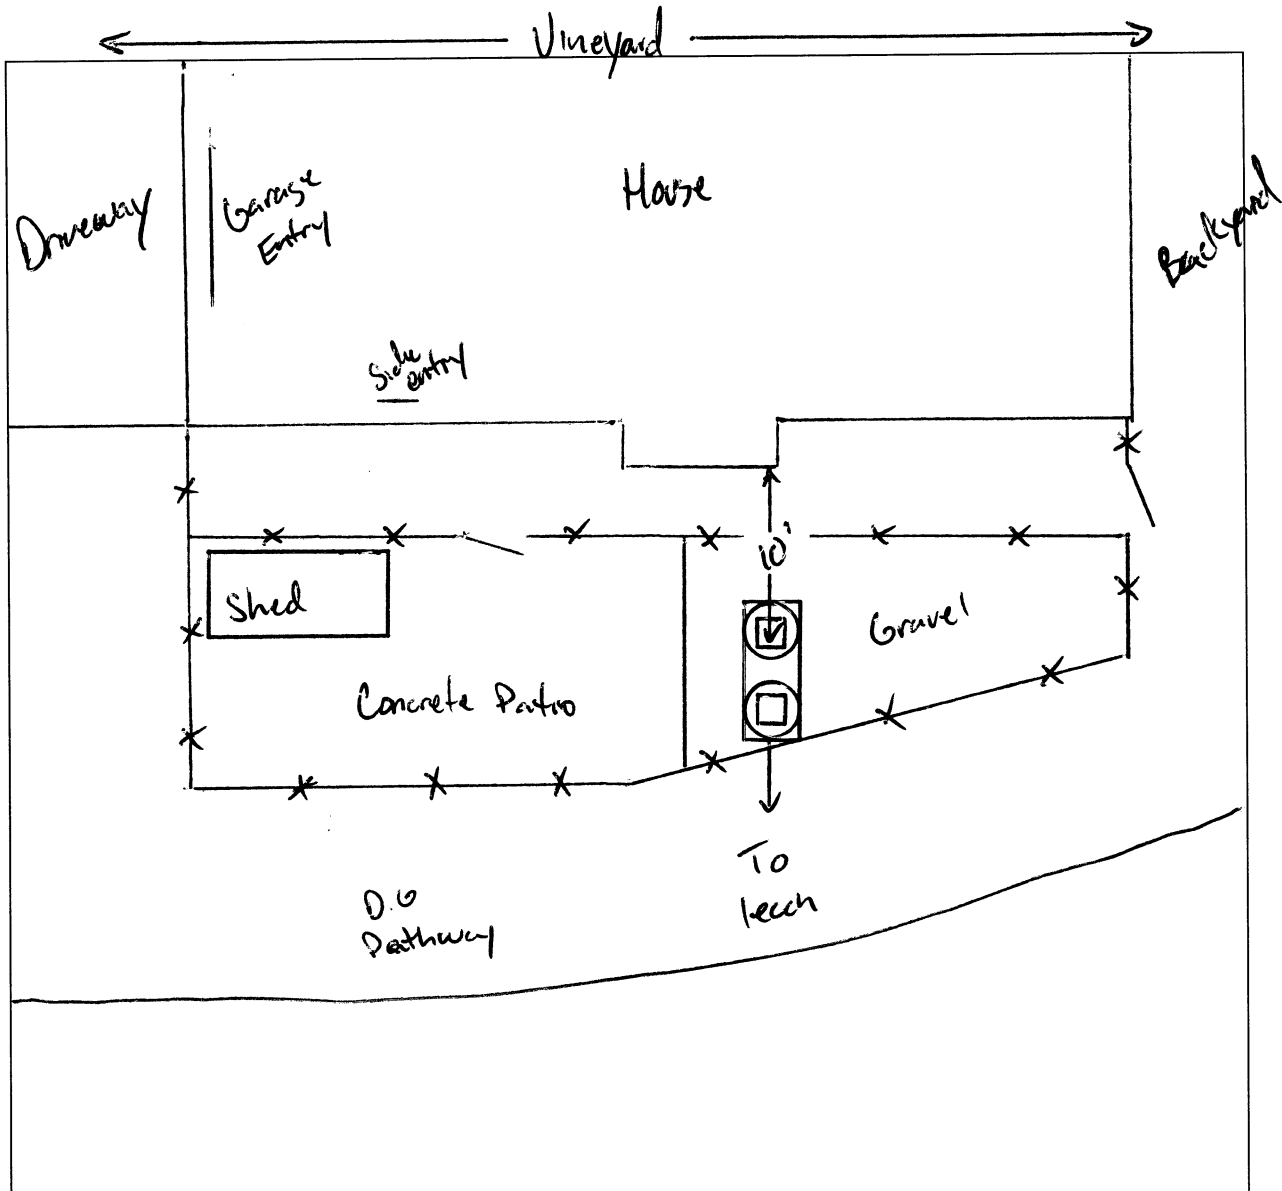
Comments: 1,200 gallon concrete tank located on side of house.

Run hose through garage to pump tank

☒ Full Diameter Access Risers to Grade Depth From Top of Tank to Grade 22"
