38939 RIVER DR

HOME INSPECTION

Inspection Report

38939 River Dr.
Lebanon OR. 97355

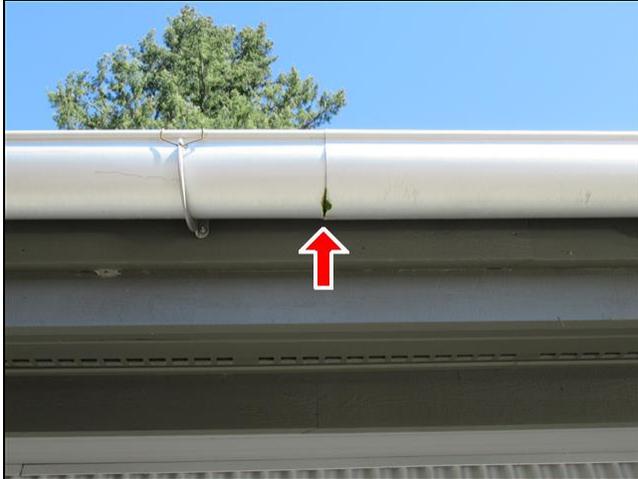
1.3 Item 1(Picture)

(1) The gutter appears to leak at the seam on the South side of the home. I recommend cleaning and apply gutter sealant or epoxy.

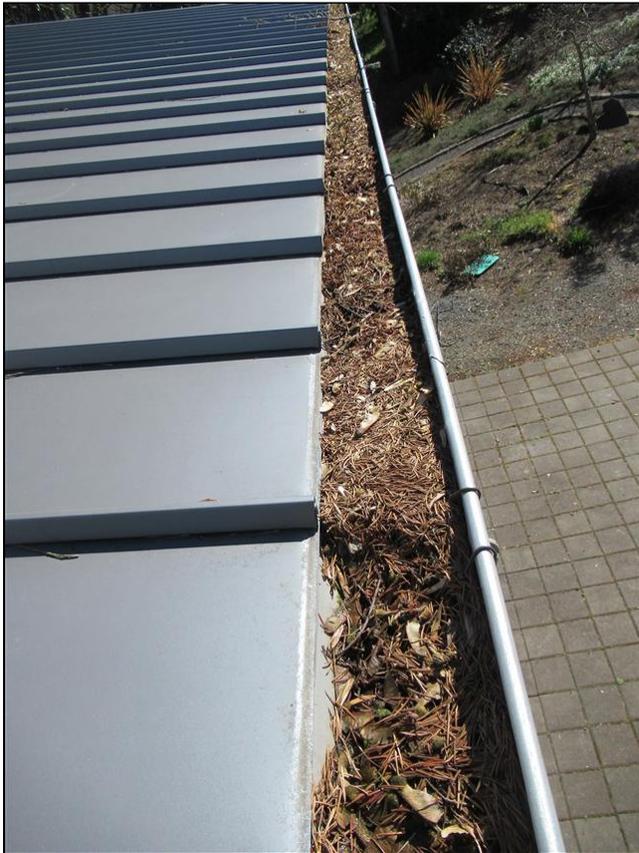
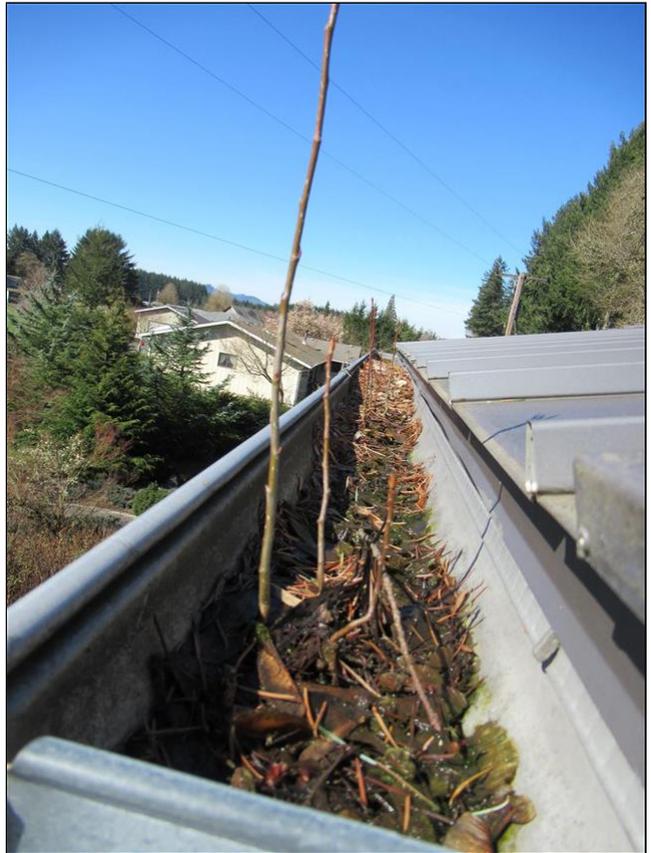
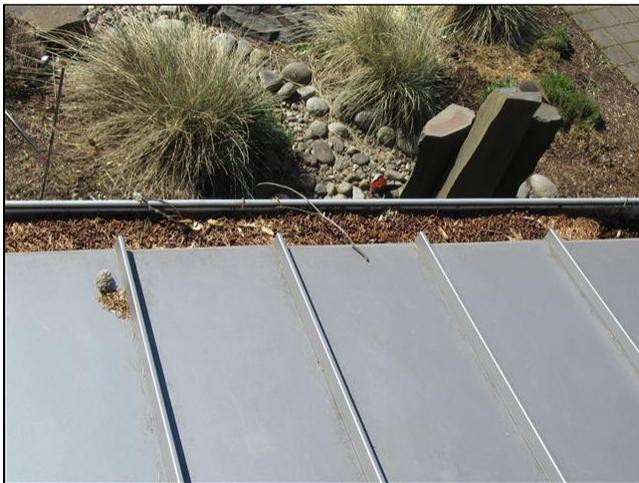
(2) The gutters are full of debris. The debris in gutters can also conceal rust, deterioration or leaks that are not visible until cleaned, and I am unable to determine if such conditions exist. Recommend cleaning gutters as part of regular maintenance.

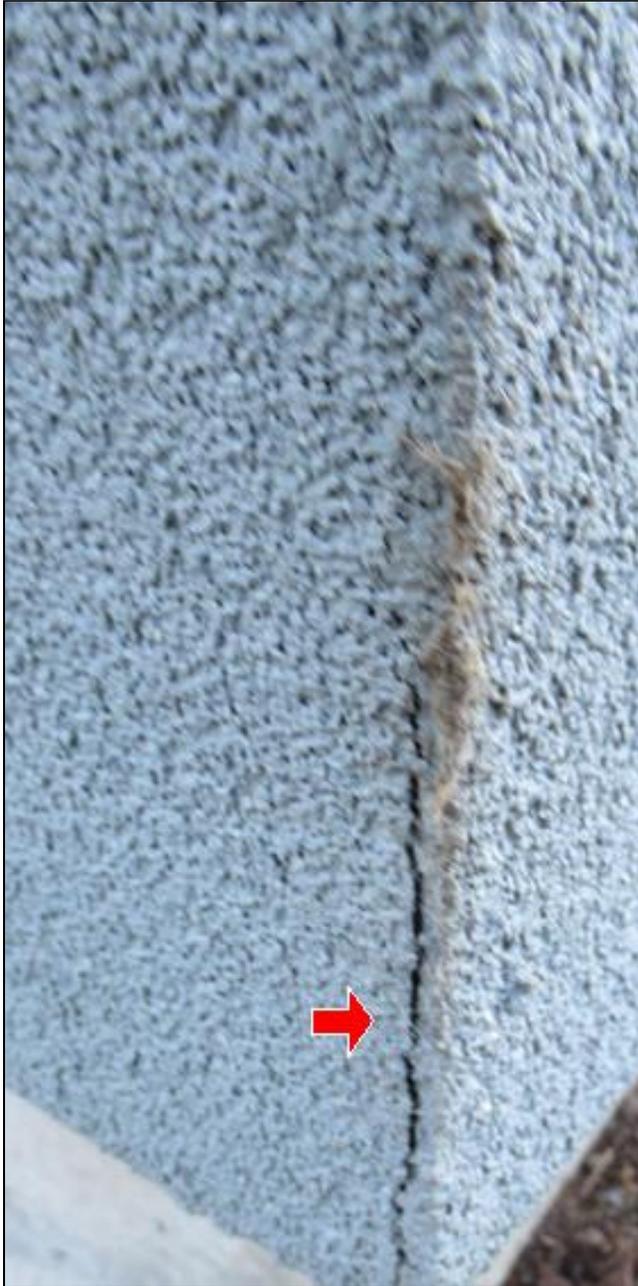
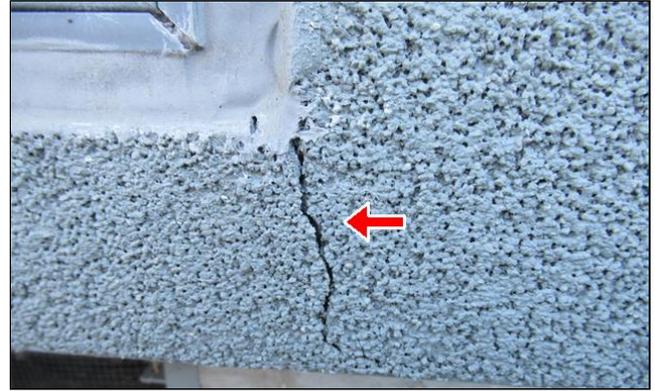
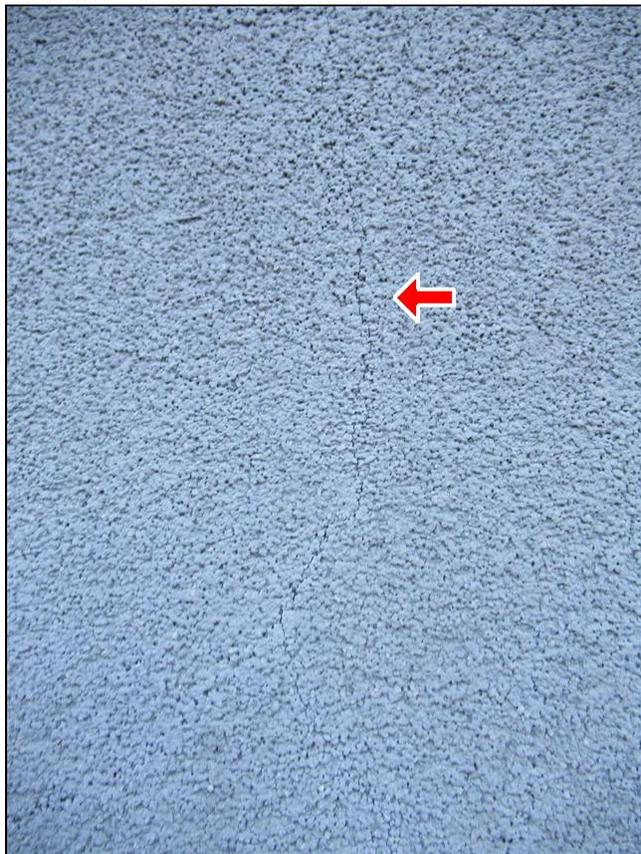
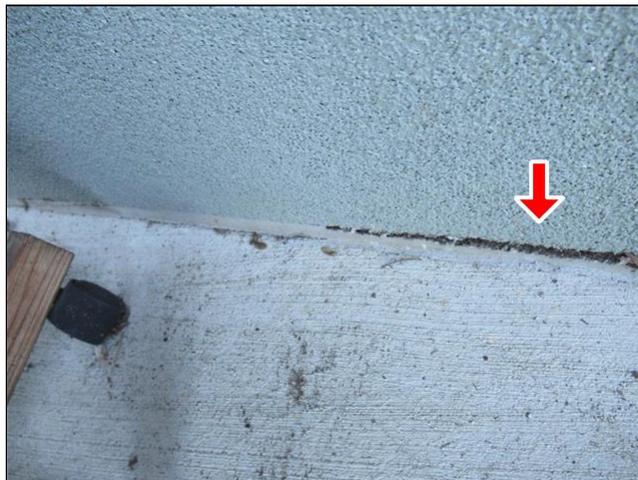
The exterior of the home appears to be made with a product known as Exterior Insulation Finish Systems, (EIFS). One of the main differences of EIFS vs standard Stucco is that EIFS will not allow water to pass back through its coating in vapor form once moisture gets behind the system. There were some hairline cracks in a few areas of the home. There is missing sealant at the bottom of the wall on the South side of the home. These areas can allow moisture penetration into the EIFS. Periodic maintenance should include thorough checking of flashing and sealing to ensure that the building envelope remains watertight. Testing of this cladding is beyond the scope of this inspection. There was no high moisture readings or evidence of moisture penetration at the time of the inspection. Recommend further evaluation by a qualified contractor.

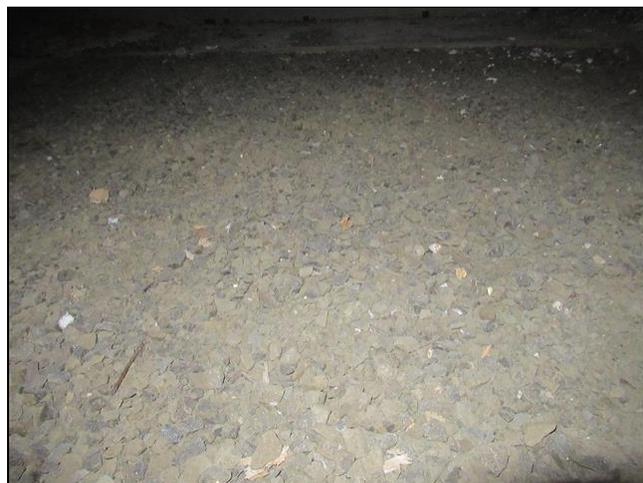
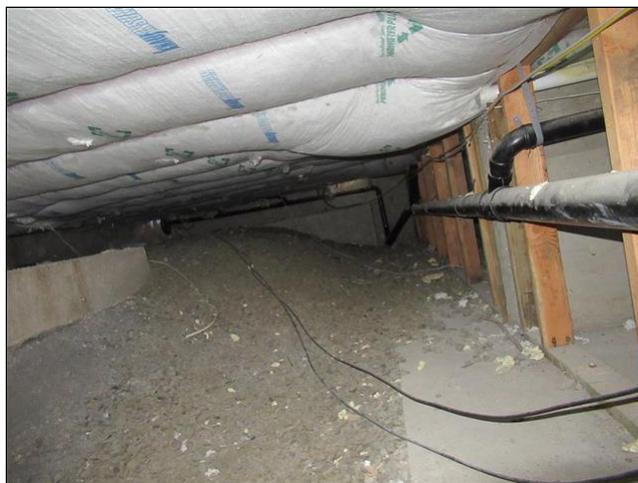
There should be a vapor barrier (plastic) on the ground in the areas where there is no concrete in the crawlspace. A vapor barrier provides added protection to the floor system from moisture or dampness that can enter from ground. I recommend adding a vapor barrier in these areas.

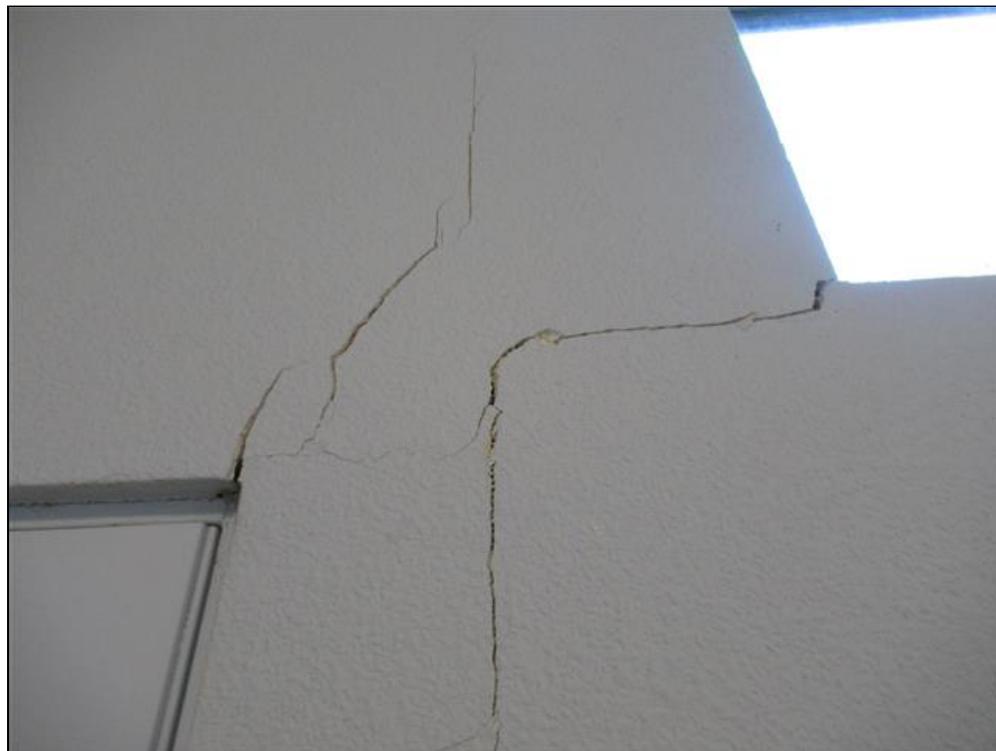
4.1 Item 1(Picture)

There is a settlement crack in the drywall at the corner of the door and window on the NW corner of the garage. It can not be determined is this is recent or from previous settlement. Recommend further evaluation by a licensed contractor.

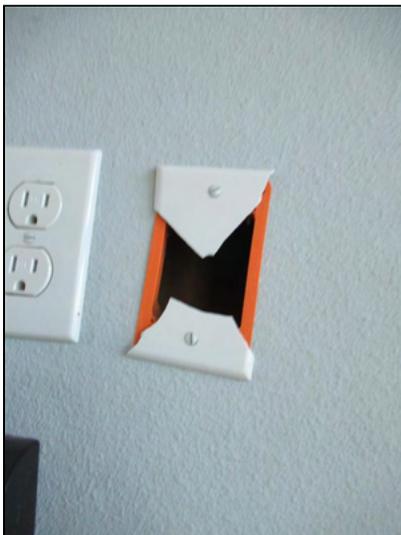
6.3 Item 1(Picture)

There is a damaged cover plate in the upstairs bedroom. Recommend repair if desired.

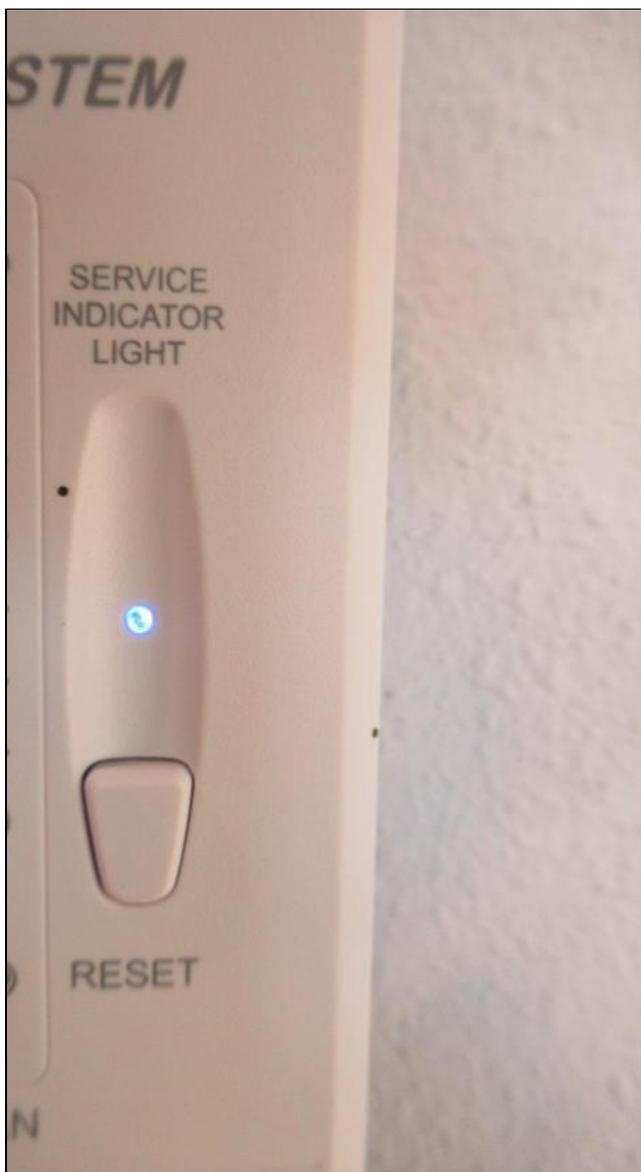
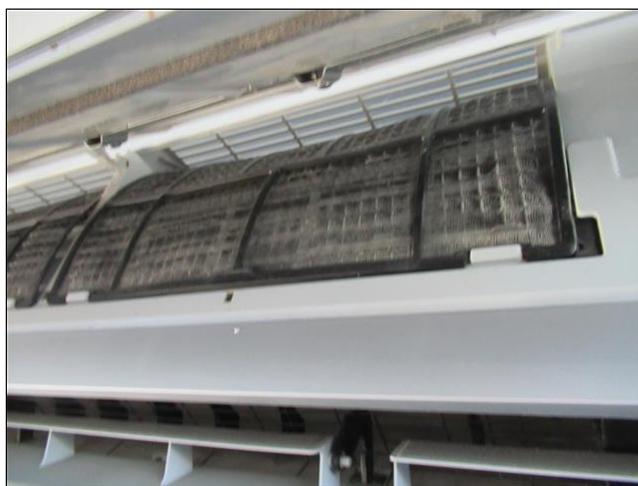
(1) The service indicator light came on when operating the HRV system (Which means it is time to preform maintenance). The filters need to be cleaned on all three of the mini splits as part of regular maintenance.

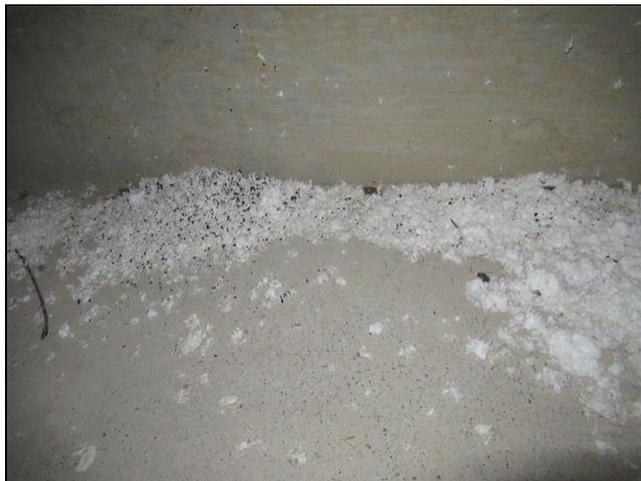
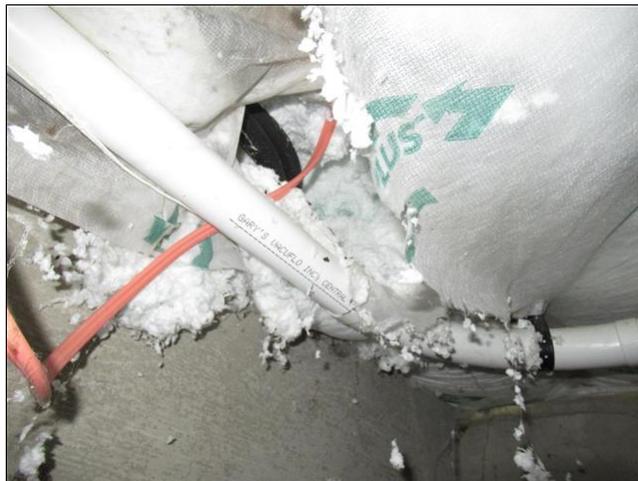
There are a couple areas under the home where the material being used to support the insulation has ripped and has caused some of the insulation to fall down. There was no signs of moisture in these areas at the time of the inspection. Recommend repair.

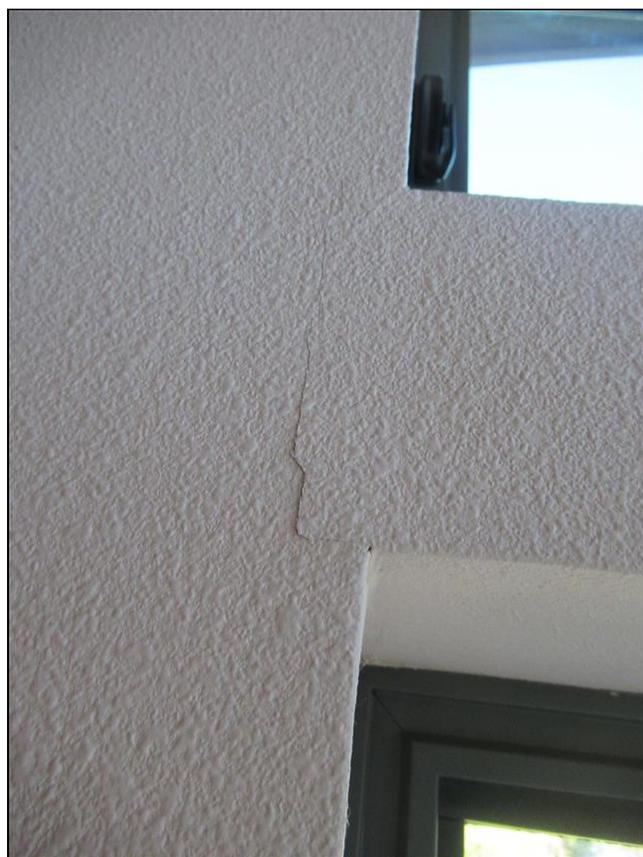
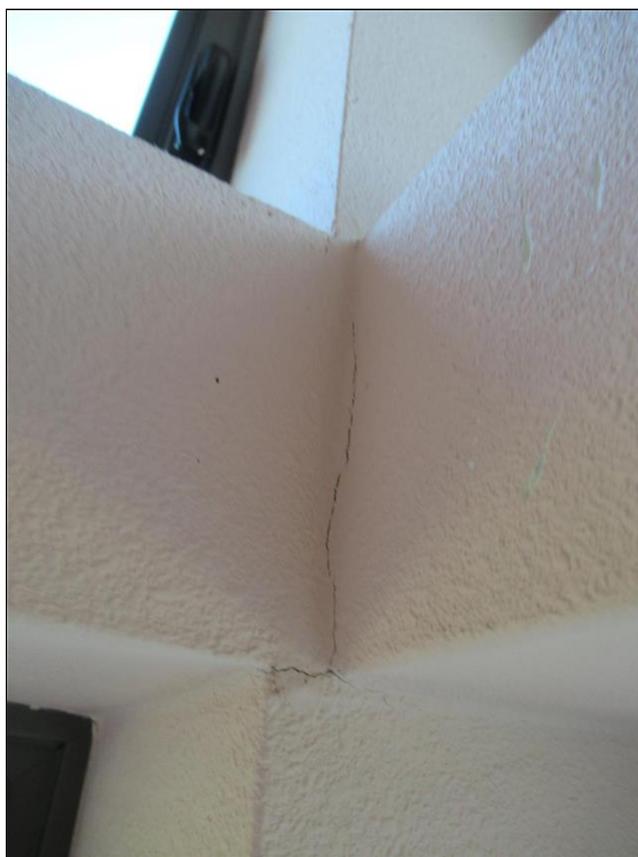
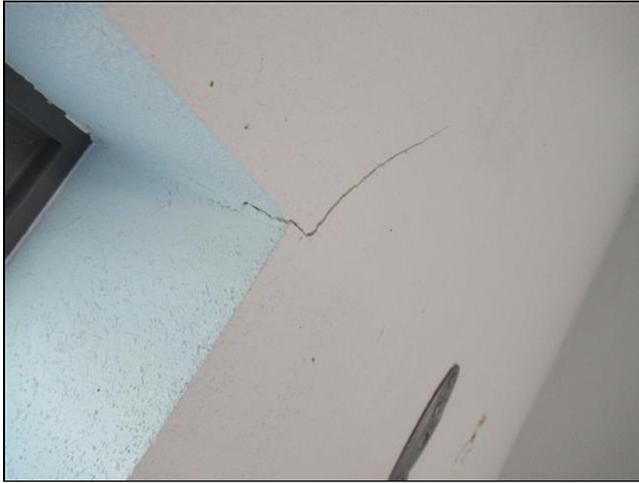
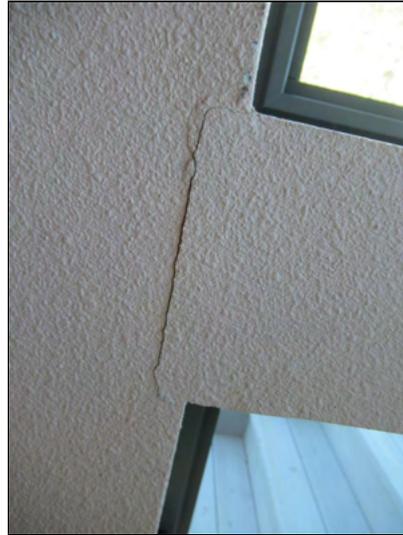
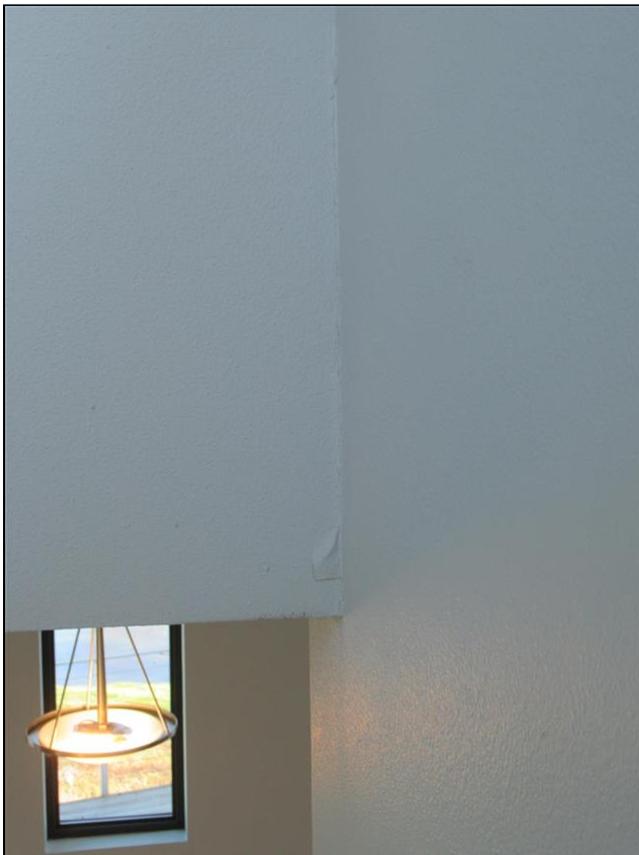
(1) There are a few small cracks in the drywall in a few areas in the home. These cracks do not appear to be structural. Recommend repairing the drywall and monitor.

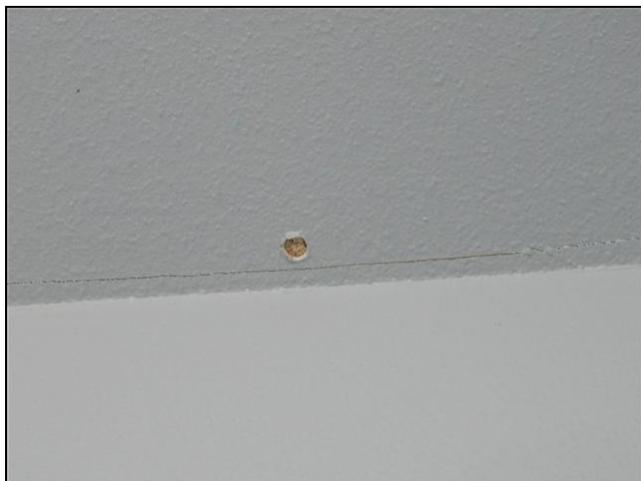
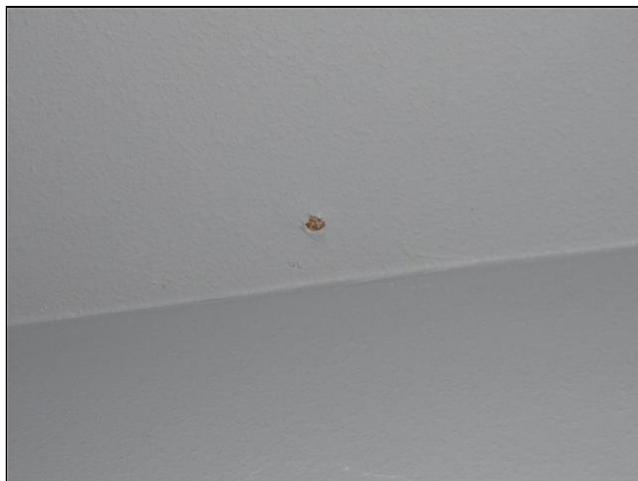
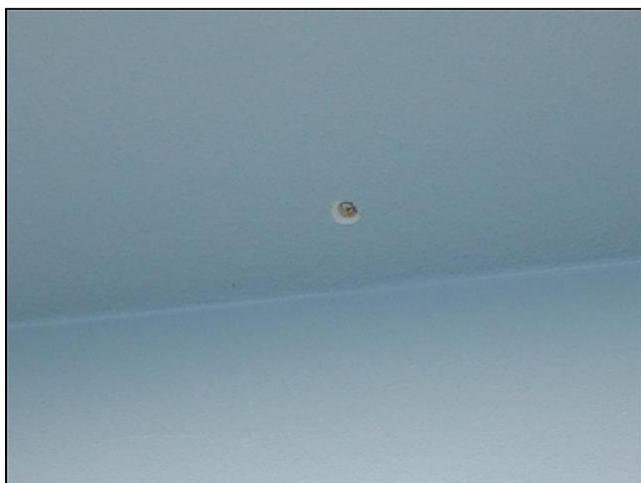
(2) Some "nail pops" (exposed nail heads in the drywall) were found in the upstairs bathroom, but can easily be repaired and do not indicate any structural issues. Seat the nails before patching and painting.

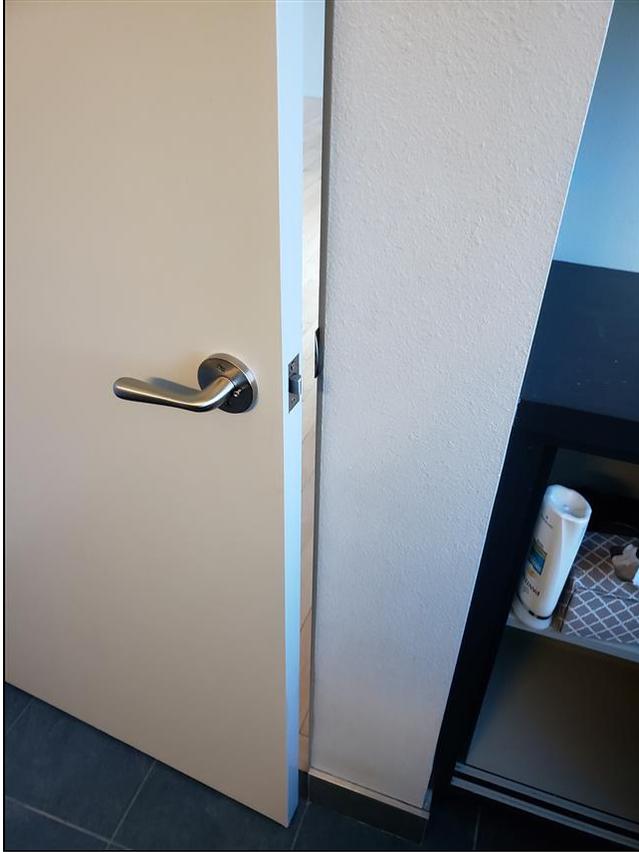
9.3 Item 1(Picture)

(1) The interior door in the downstairs bathroom needs a strike and latch adjustment to stay closed.

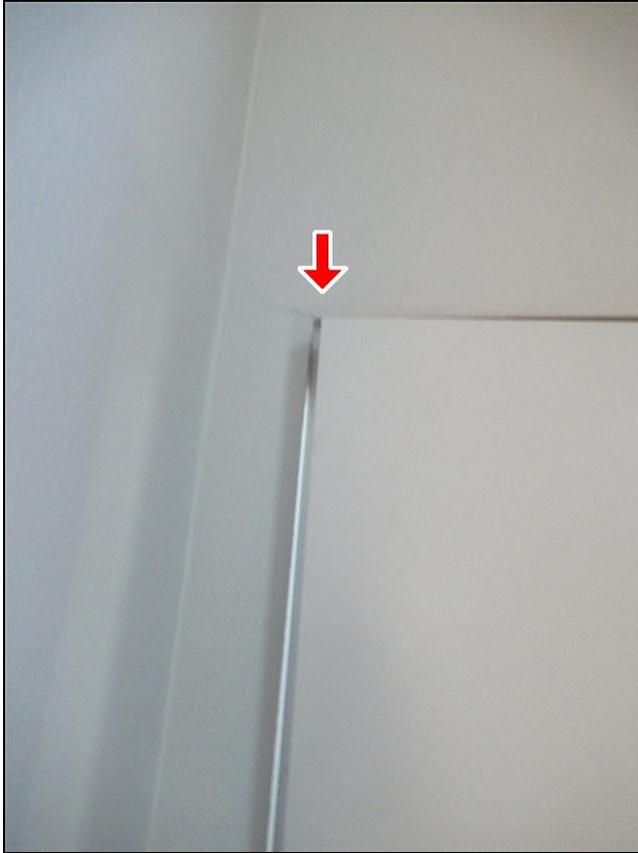
9.3 Item 2(Picture)

(2) The upstairs bathroom door rubs in the upper corner. This may involve taking the door off and shaving some of the edge of the door to allow proper clearance. Recommend repair.

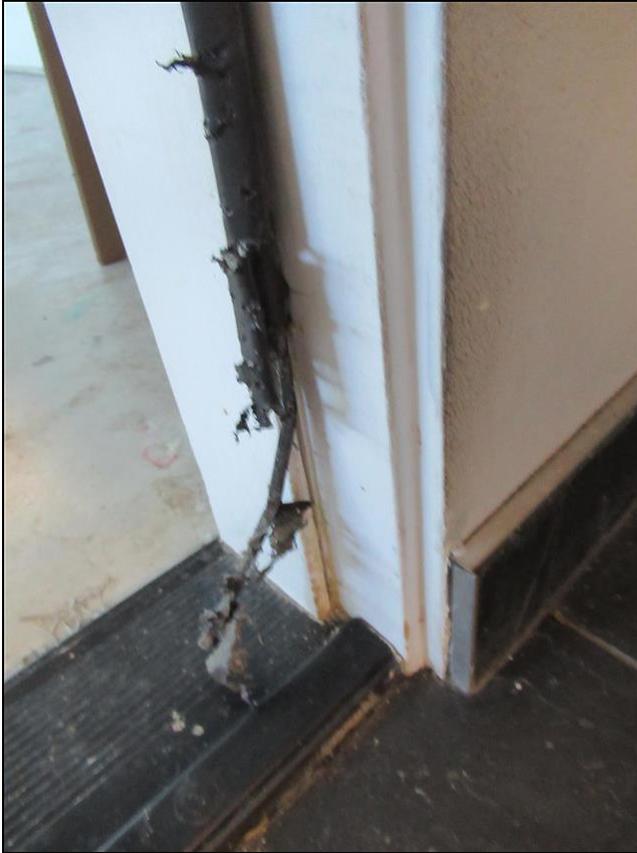
9.3 Item 3(Picture)

(3) The bottom of the weather stripping is damaged on the garage occupant door. Recommend repair as desired.

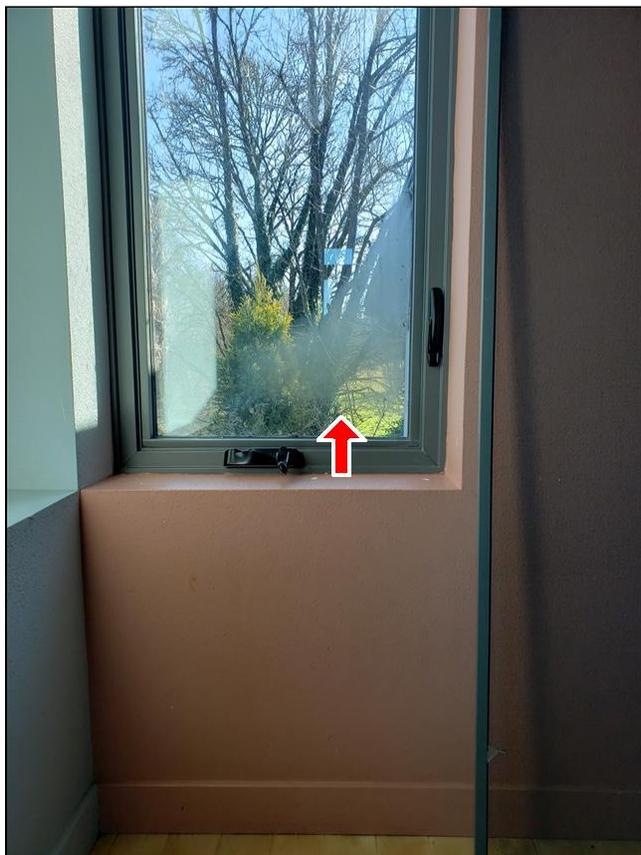
9.4 Item 1(Picture)

(1) There is a broken seal in a window on the NE corner of the upstairs bedroom. This is the argon gas seal inside the two panes of glass. When this seal is broken, it causes condensation buildup and causes the window to appear foggy. Recommend repair or replace by a licensed contractor.

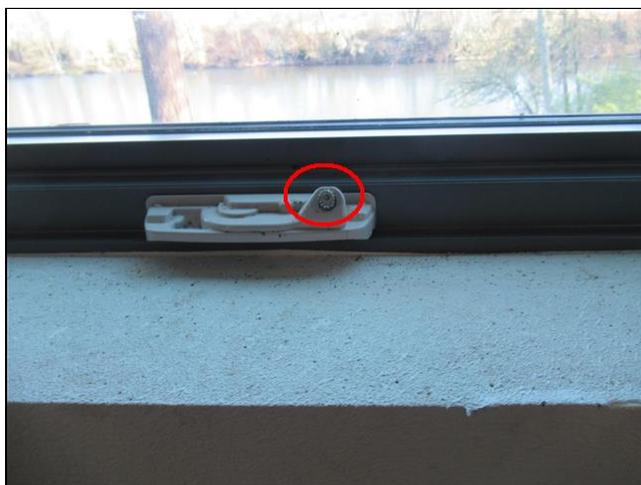
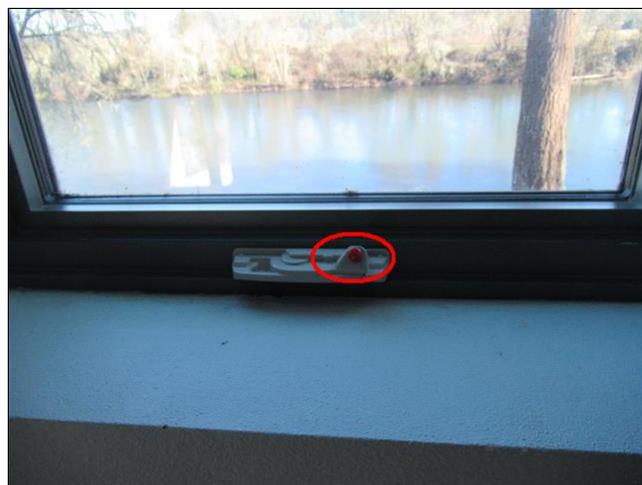
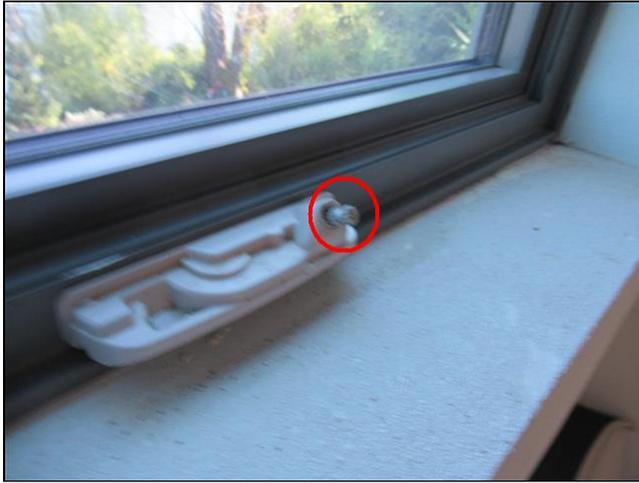
(3) There are several windows in the home that are missing crank handles. Recommend repair
