## **GREENWORKS SERVICE COMPANY**

## GW STANDARD HOME INSPECTION

1006 FM1855 Marble Falls, TX 78654

# PROPERTY INSPECTION REPORT FORM

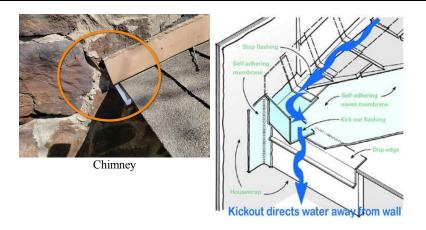
## 7: Flashing Rust

There was rust on the flashings. Rusted flashing may allow water to seep through and enter the home.

Recommendation: Contact a qualified roofing professional.

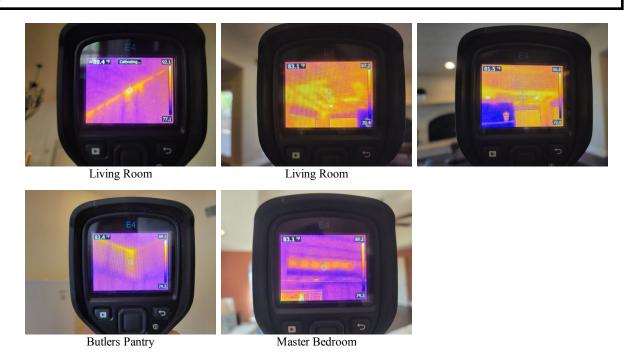
There were areas of low/missing insulation observed with the infrared camera.

Recommendation: Contact a qualified insulation contractor.

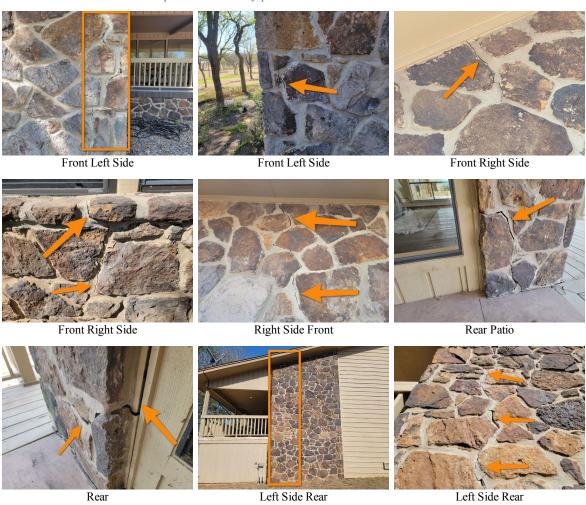
There were areas of stone and mortar separation at the exterior walls.

Recommendation: Contact a qualified masonry professional.
