15136 County Rd 220 Tyler TX 75707

PROPERTY INSPECTION REPORT

Prepared For: Jane Brockbank	
(Name of Clients)	_
ncerning: 15136 County Rd 220, Tyler TX 75707 (Address or Other Identification of Inspected Property)	
By: Zach Pruett - Trec#24380	12/20/2021 9:00 am
(Name and License Number of Inspector)	(Date)
Zechariah Pruett (Name, License Number of Sponsoring Ins	pector)

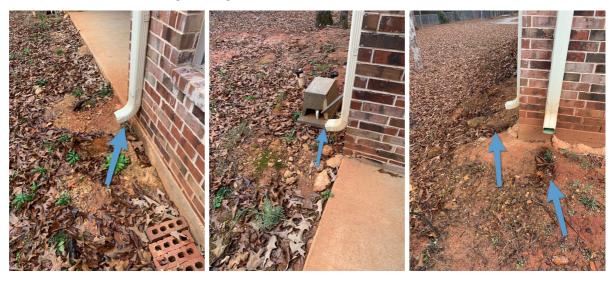
The gutters should have extensions installed to divert water away from the foundation.

Recommendation: Contact a qualified professional.

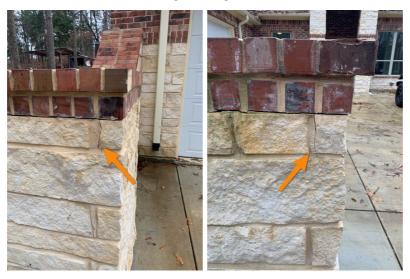
Mortar improvements are recommended for the exterior masonry veneer on the South exterior wall Locations of the structure.

Recommendation: Contact a qualified professional.

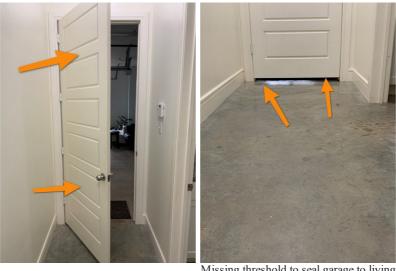
Garage access door is not fire rated. Solid core and metal clad doors can help contain a fire in the garage for roughly 20 minutes. The garage is the second most likely place for a house fire to originate in a home. The presence of a carbon monoxide sensing smoke detector is also highly recommended.

Missing threshold to seal garage to living

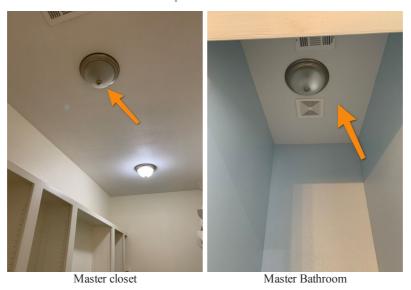
One or more lights are not operating. New light bulb possibly needed. Recommend further evaluation.

Recommendation: Contact a qualified electrical contractor.

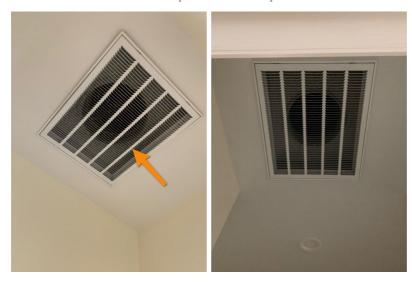
Unit is missing Air filter. The air handler does not have a port for a air filter to be installed recommend installation of air filter by qualified Professional

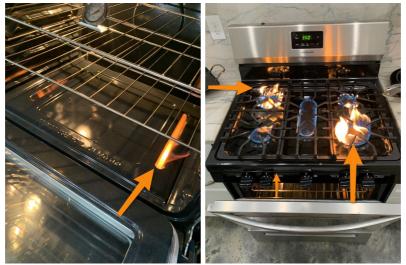
Burner orifice are in need of repair or replacement. Recommend qualified professional to evaluate

Flame roll out

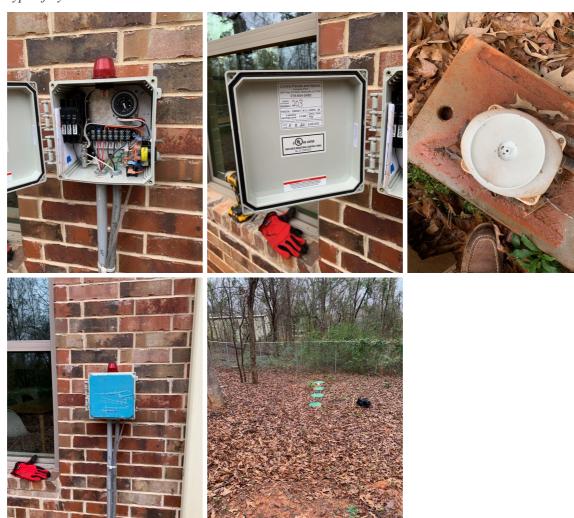
Water was added to the system at a rate of approximately 10 gallons per minute, for approximately 20minutes, applying approximately 200 gallons water into the system.

Odors present: Yes

Chlorine Dispenser: Need of Tablets

Recommend getting the septic pumped every 3-4 years for proper maintenance on system.
