# *HHI LLC*

## Property Inspection Report

20318 S McNew Rd, Pretty Prairie, KS 67570  
Inspection prepared for: Kendra Kutcha  
Real Estate Agent: Kendra Kuchta - J. P. Weigand and Son's McPherson Branch

Date of Inspection: 8/4/2022 Time: 1:30 PM  
Age of Home: 2004 / 18 Years Size: 2670 Sq Ft  
Weather: Sunny / 96

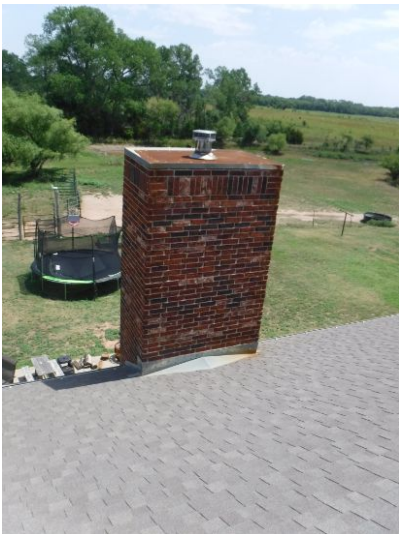
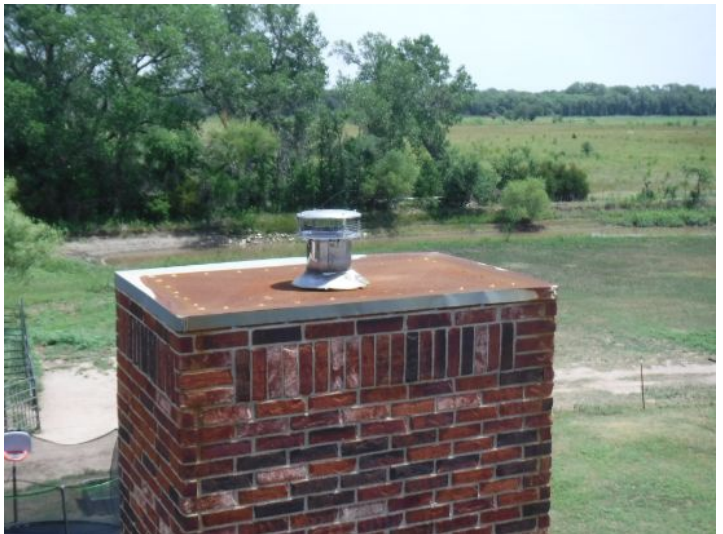
Cricket installed - A cricket was installed to protect roofing near the chimney. A cricket is a small roof built on the uphill side of and abutting a chimney. Its purpose is to keep runoff water from pooling on the uphill side of the chimney and eventually causing leakage. The cricket appeared to be correctly built and in serviceable condition.

The metal chimney chase cap is rusting and will need to be maintained.

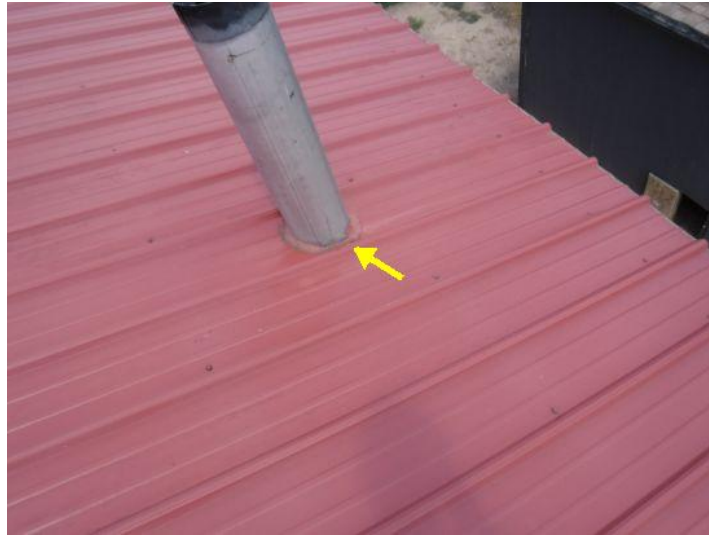
Recommend a proper roof flashing at the stove-pipe penetration of the metal roof panels.

| Page 15 Item: 5 | Flashing Status | • Recommend a proper roof flashing at the stove-pipe penetration of the metal roof panels. |

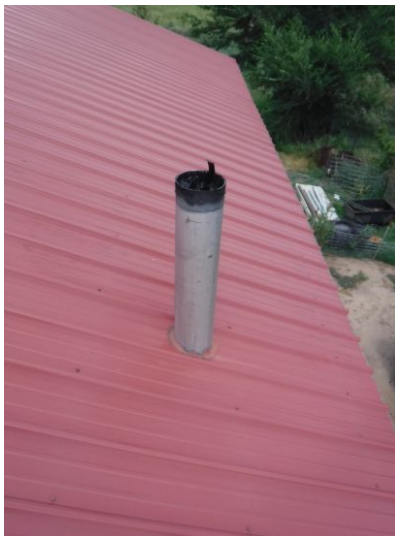
The cap is missing from the stove-pipe on the pole shed and should be replaced.

| Page 15 Item: 6 | Chimney Status | • The cap is missing from the stove-pipe on the pole shed and should be replaced. |

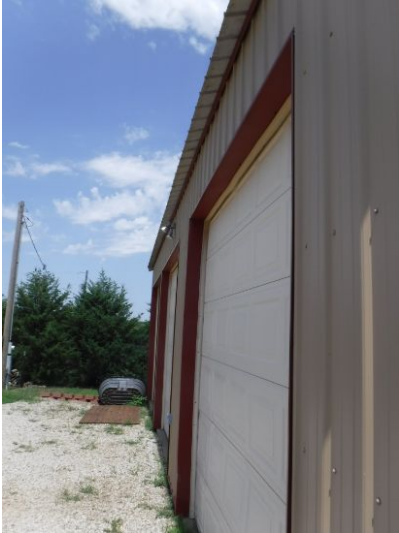
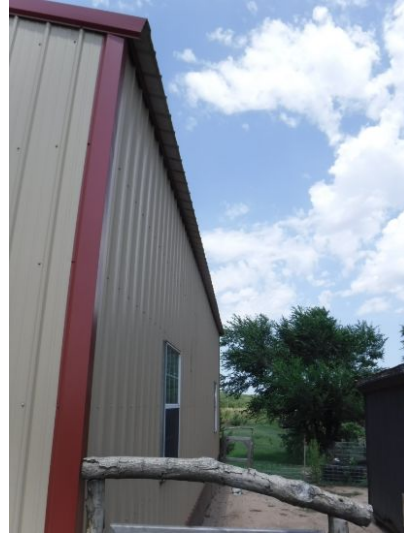
Adding guttering and downspouts would facilitate moving water away from the foundation and prevent erosion around the outside edges of the pole shed floor.

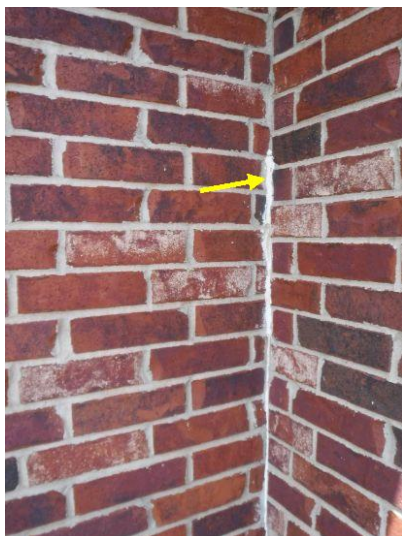
Prior to mortar repairs were noted, any mortar repair should be completed with mortar instead of caulk.

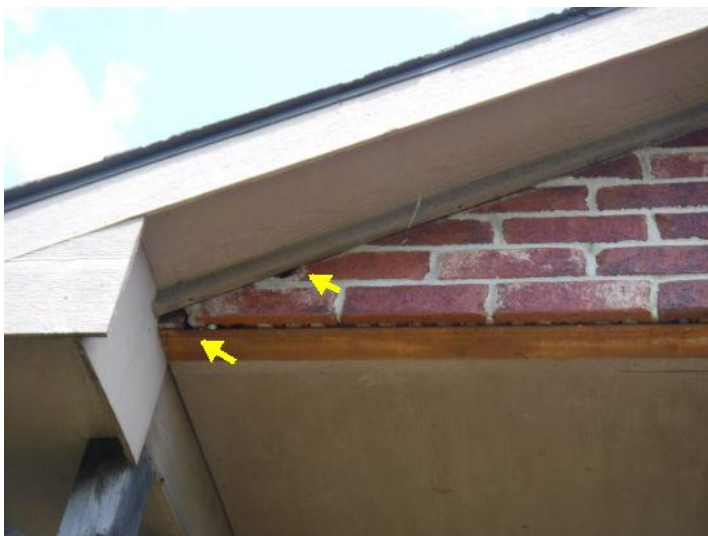
The brick at the southwest corner of the front porch need tuck pointed and sealed.

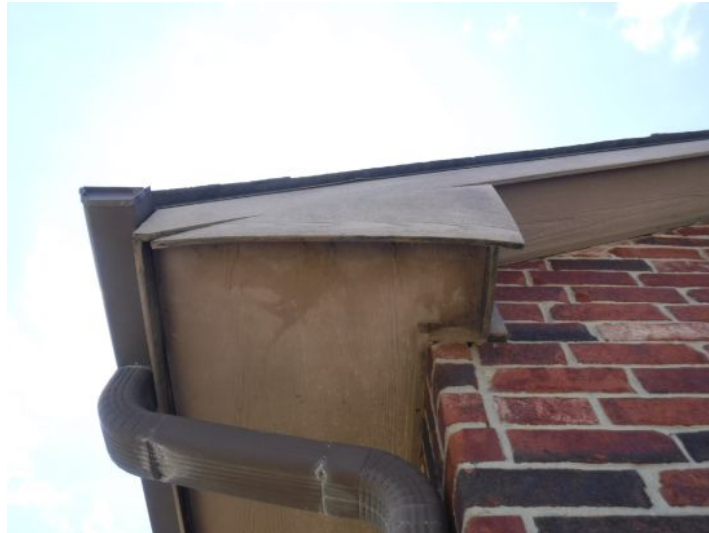
The composite fascia cornice at the northeast corner of the home is warping and will need to be repaired or replaced.

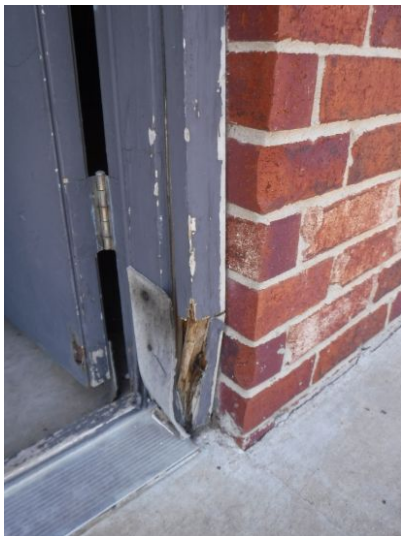
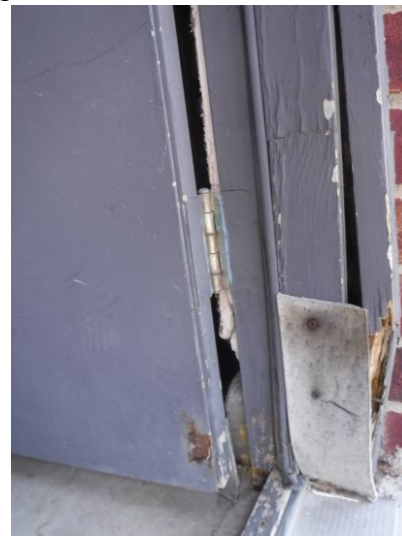
The East exterior door from the garage is rusting on the bottom and the north jamb bottom has rotted, that door will need to be repaired or replaced.

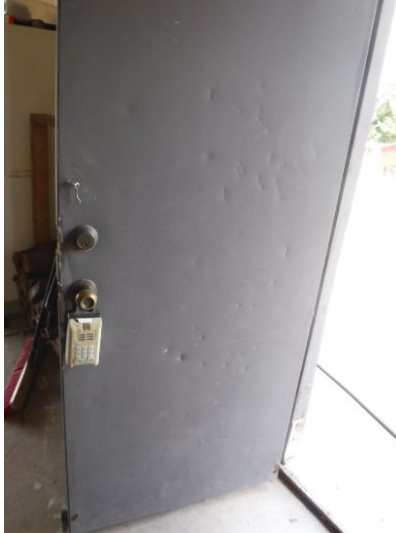
The East exterior door from the garage has some dents

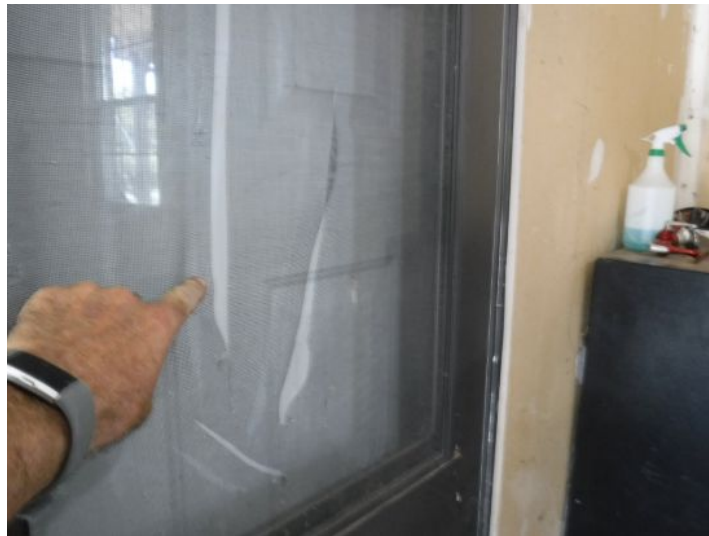
Frayed screens noted

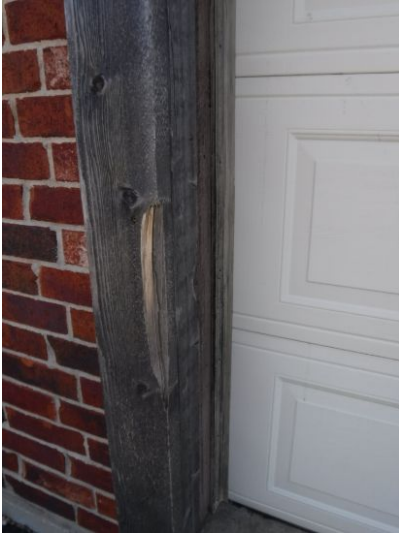
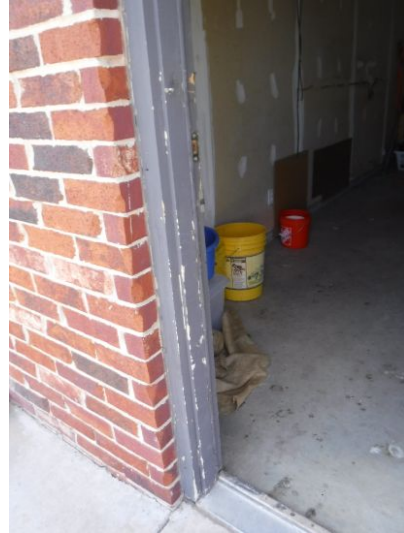
Touch Up Caulking, paint and stain is recommended

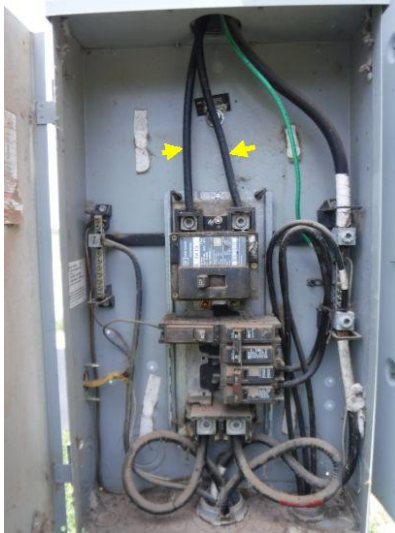
The service wires are not rated for the potential load, recommend corrections by a qualified electrician

| Page 25 Item: 4 | AMP's Service Wire Status | • The service wires are not rated for the potential load, recommend corrections by a qualified electrician |

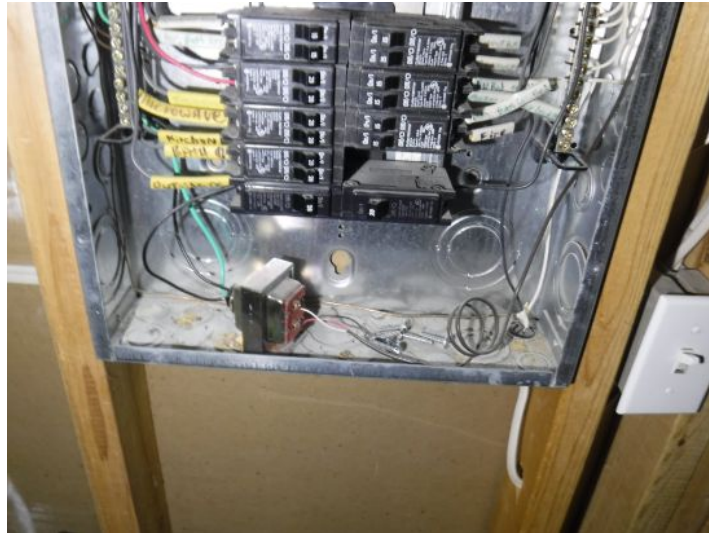
Recommend the low voltage door bell transformer be mounted on the panel exterior.

| Page 27 Item: 5 | 110 VAC Branch Circuits Status | • Recommend the low voltage door bell transformer be mounted on the panel exterior. |

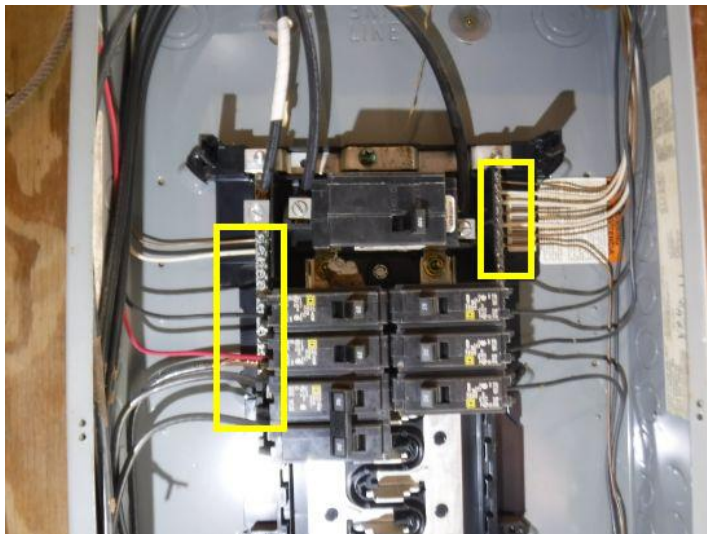
Ground and neutral on the same bus. In sub panels or a second means of disconnect the ground and neutral wires should be separated. Recommend correction by a qualified electrician.

| Page 29 Item: 5 | 110 VAC Branch Circuits Status | • Ground and neutral on the same bus. In sub panels or a second means of disconnect the ground and neutral wires should be separated. Recommend correction by a qualified electrician. |

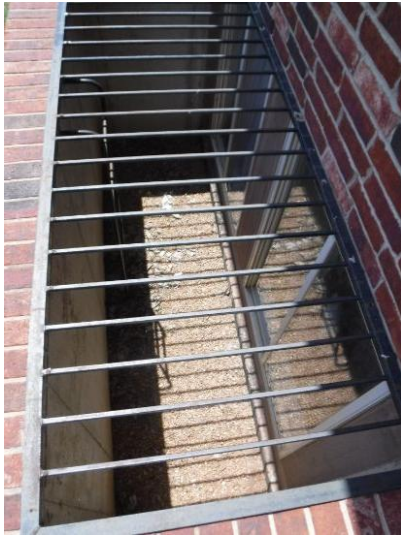
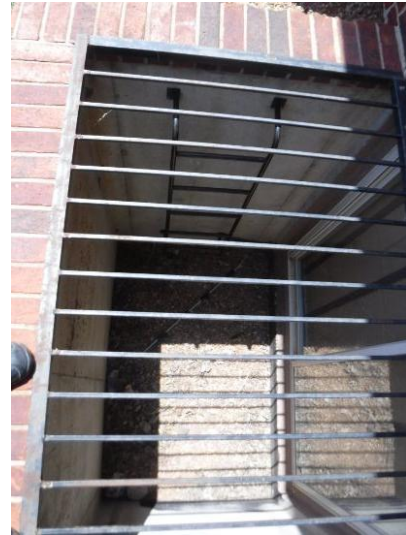
Currently, the entire metal grate needs to be removed to allow egress from the basement egress window wells, consider building the grates to allow for a small section to open making egress easier.

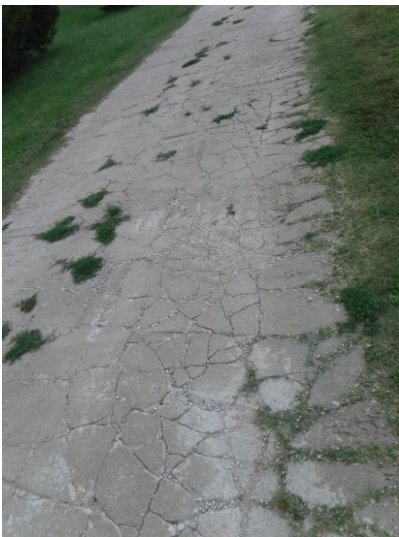
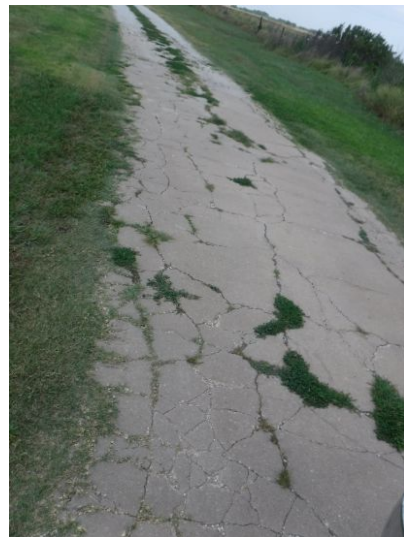
The main drive from the road has cracking and broken areas on the concrete area of the drive, seal or maintain the concrete as needed.

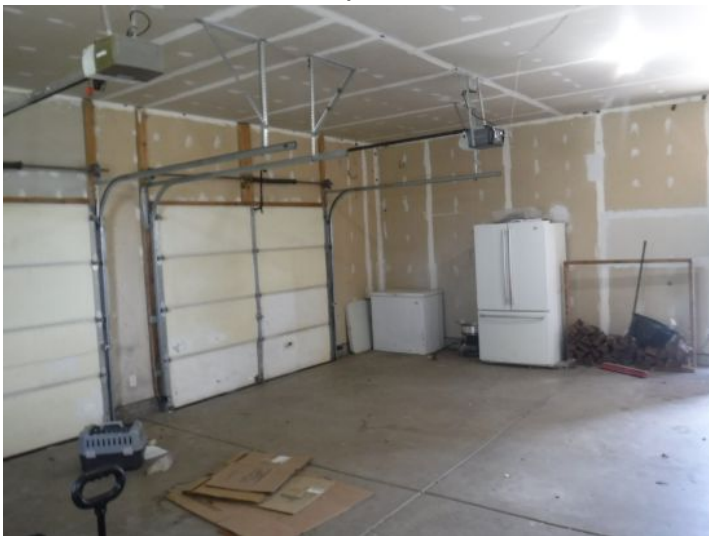
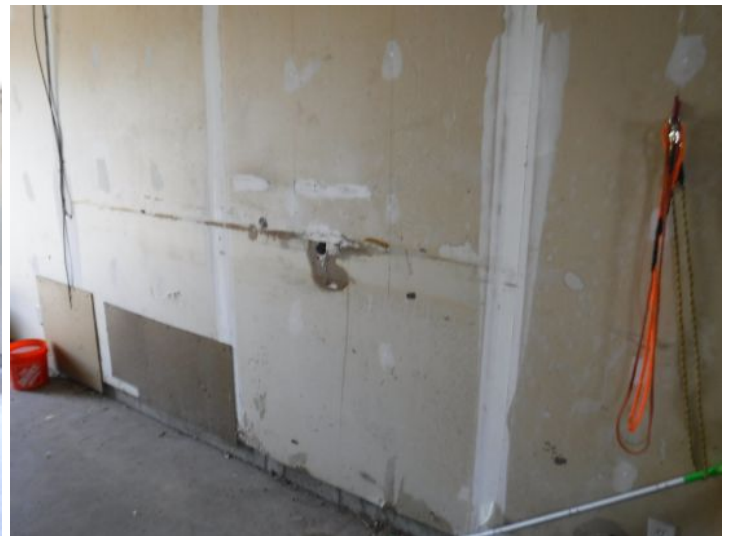
Minor damage noted

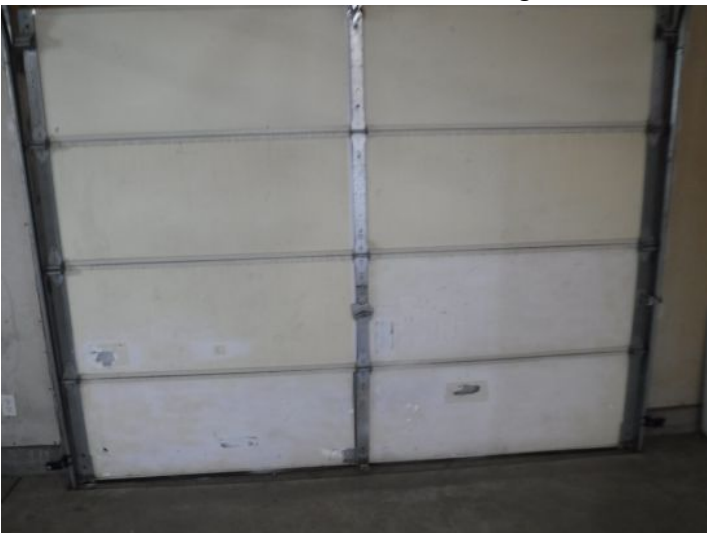
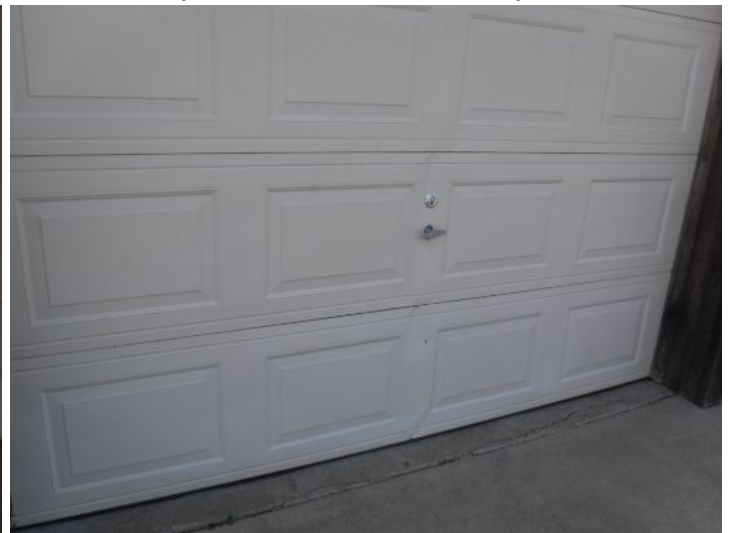
Minor damage noted on the insulation panels and the exterior panels

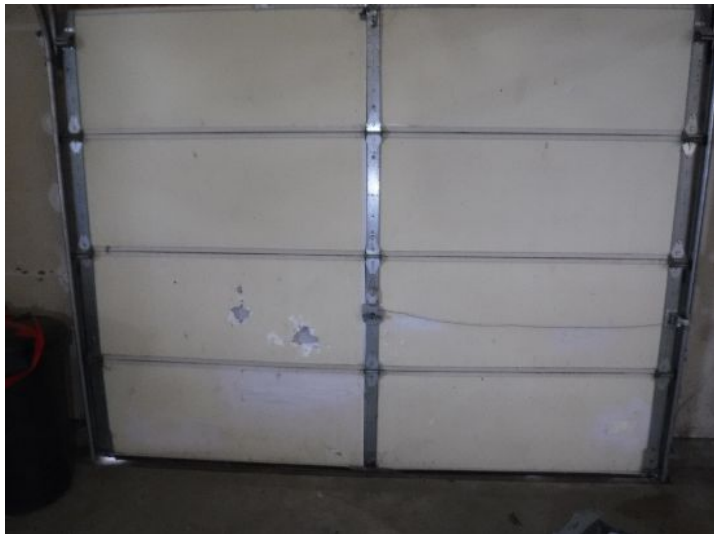
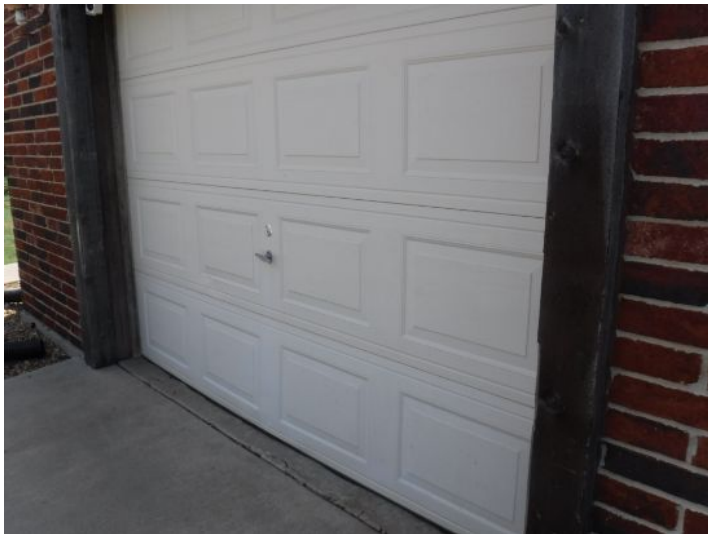
- Minor damage noted on the insulation panels and the exterior panels

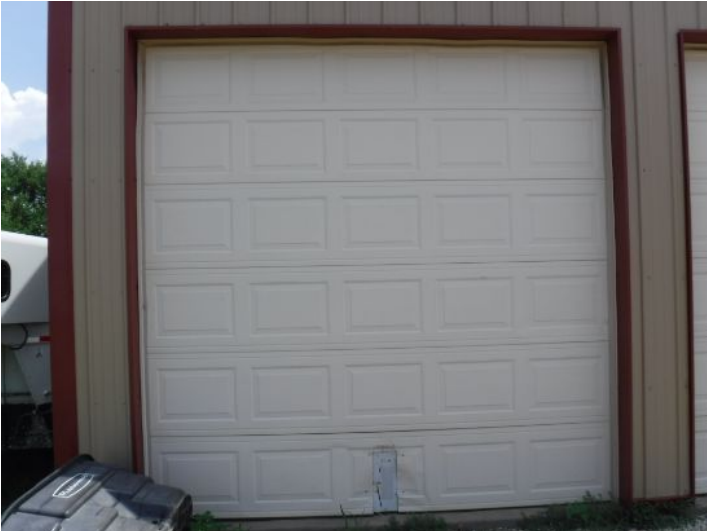
Damage noted on the lower door panels

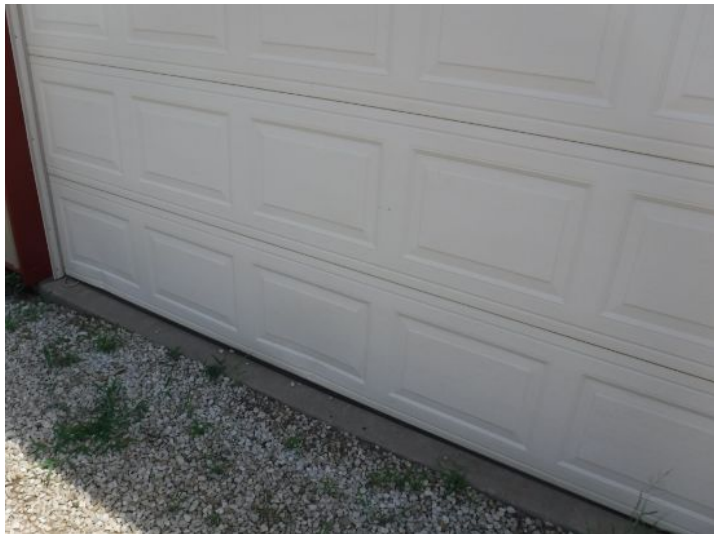
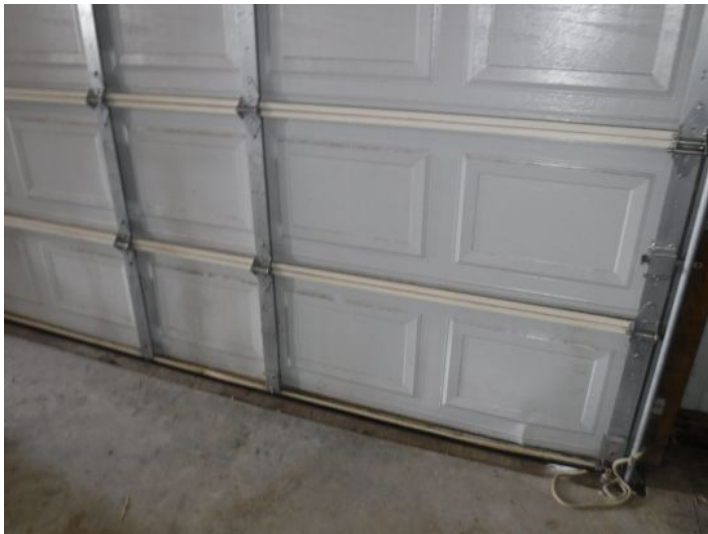
Minor damage noted on the lower door panels

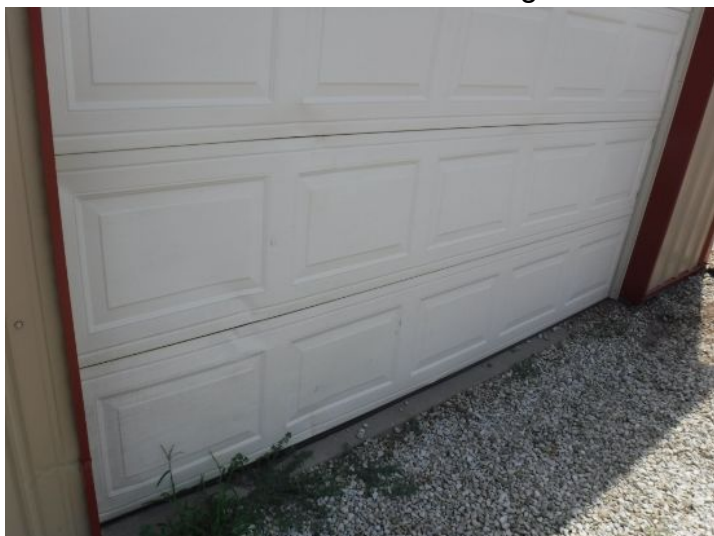
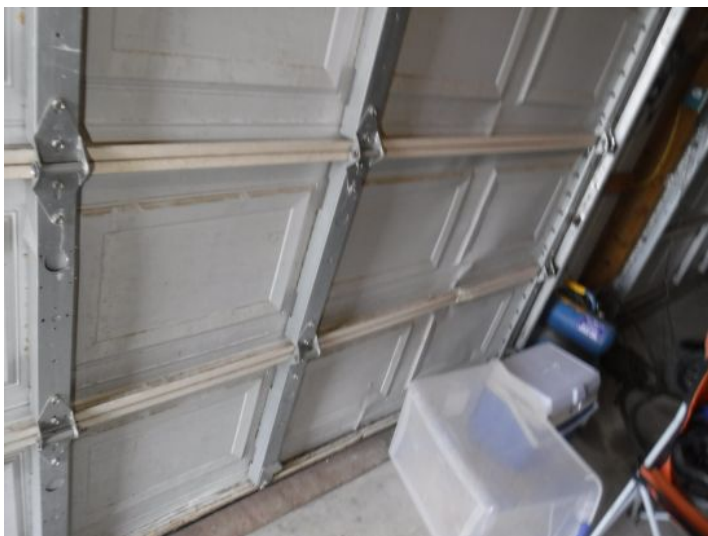
Minor damage noted

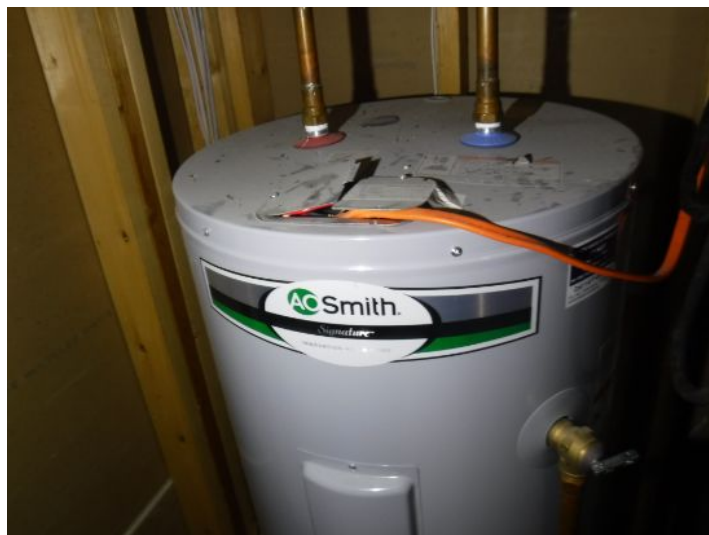
Recommend proper electrical connection to the water heater with a wire clamp at the connection.

| Page 42 Item: 4 | Tank Condition Status | • Recommend proper electrical connection to the water heater with a wire clamp at the connection. |

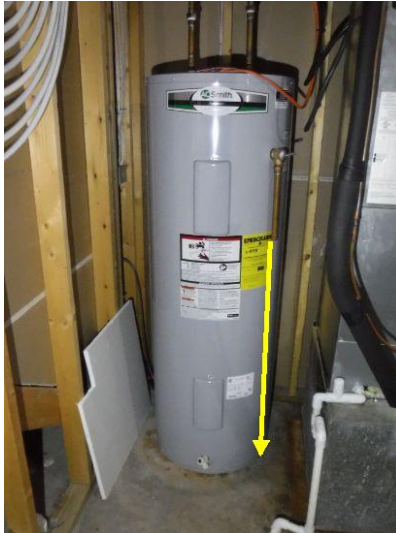
Discharge Tube terminates too high - The discharge pipe of the water heater pressure relief valve was terminated more than 6 inches above the floor. This condition could result in scalding if the pressure relief valve were activated while a person was nearby. Recommend installation of a proper discharge pipe which terminates a maximum of 4 inches above the floor.

| Page 43 Item: 6 | Relief Valve Extension Status | • Discharge Tube terminates too high - The discharge pipe of the water heater pressure relief valve was terminated more than 6 inches above the floor. This condition could result in scalding if the pressure relief valve were activated while a person was nearby. Recommend installation of a proper discharge pipe which terminates a maximum of 4 inches above the floor. |

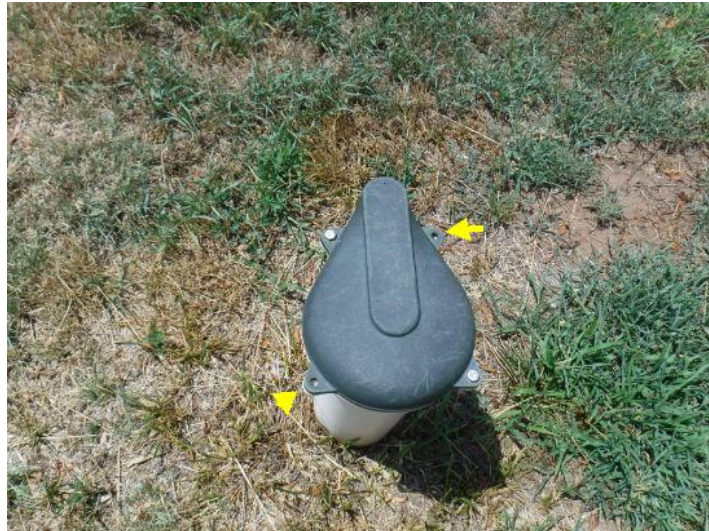
We didn't inspect the well but did want to mention two of the bolts are missing from the wellhead cap and should be installed.

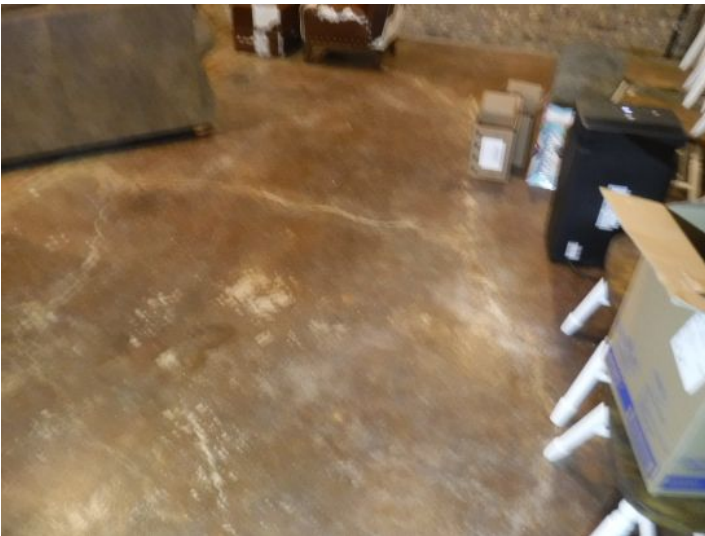
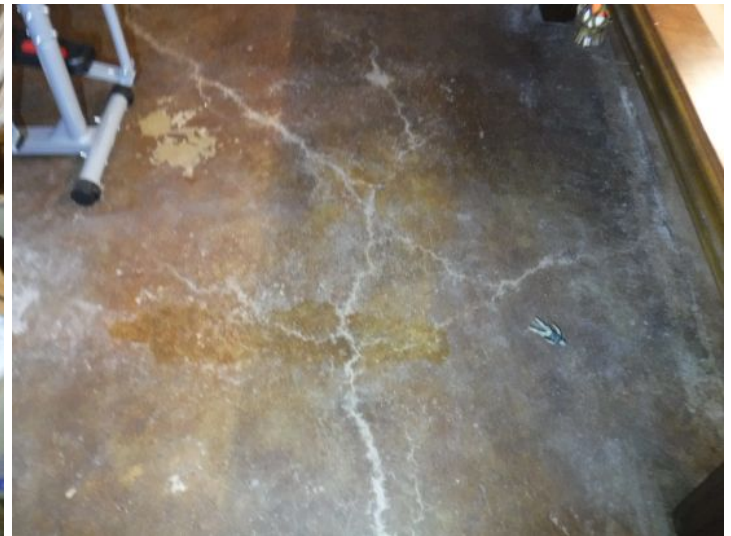
Cracking was observed in the basement floor

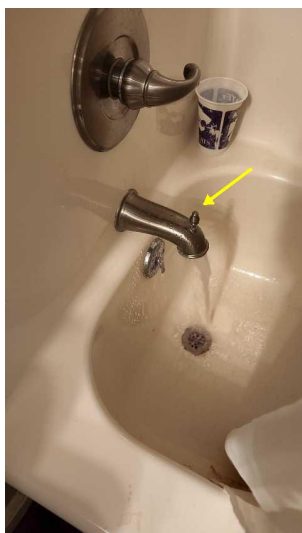
Diverter does not seal properly

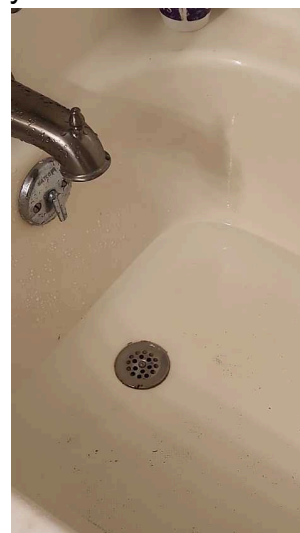
The Main floor bathroom tub drains slowly. Recommend cleaning.

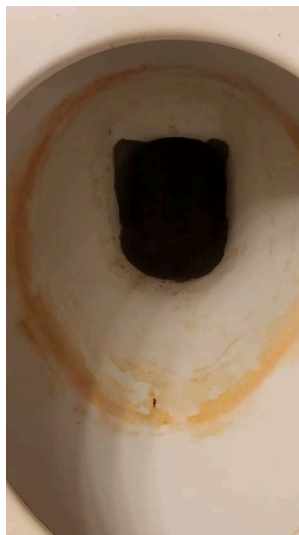
- The toilet is loose at the floor and needs properly secured.

The porcelain appears to have worn at the bottom of the toilet.

| Page 50 Item: 4 | Toilet Status | • The toilet is loose at the floor and needs properly secured. |

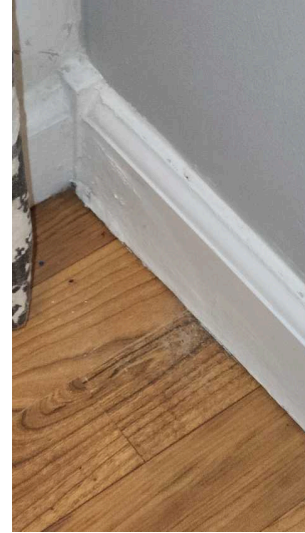
Evidence of previous moisture noted on the baseboards next to the tub. No elevated moisture detected at the time of inspection.

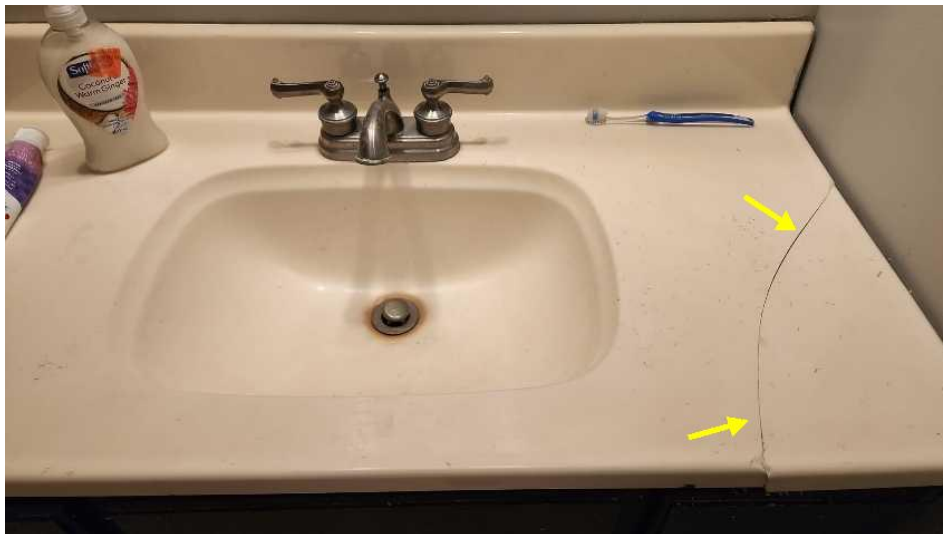
The counter top is broken.

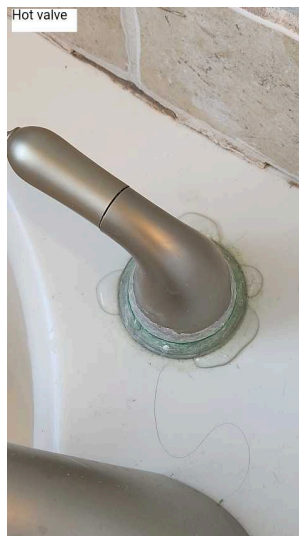
The hot water valve on the tub leaks while in use.

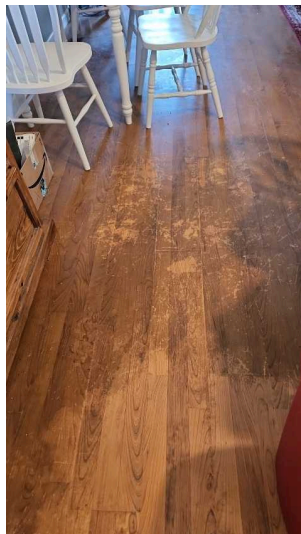
Wear and some scratches noted on the flooring in a number of areas in the home.

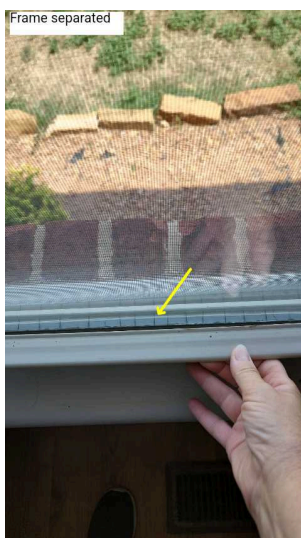
The lift flange on the bottom window sash of the north owners bedroom window is almost broken off.

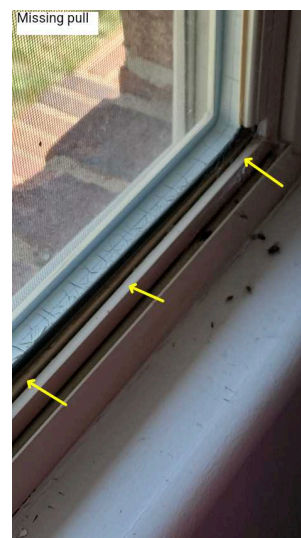
The lift flange on the bottom window sash of south bedroom window is missing making it more difficult to operate the only window in that room.

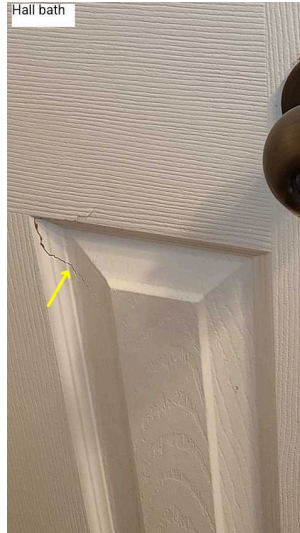
Small crack noted on the panel of the hallway bathroom door.

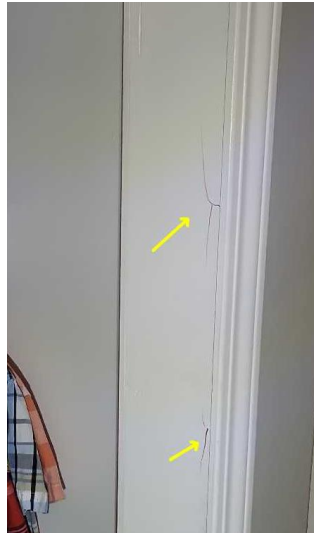
Cracking noted on the closet door frame - South Bedroom.

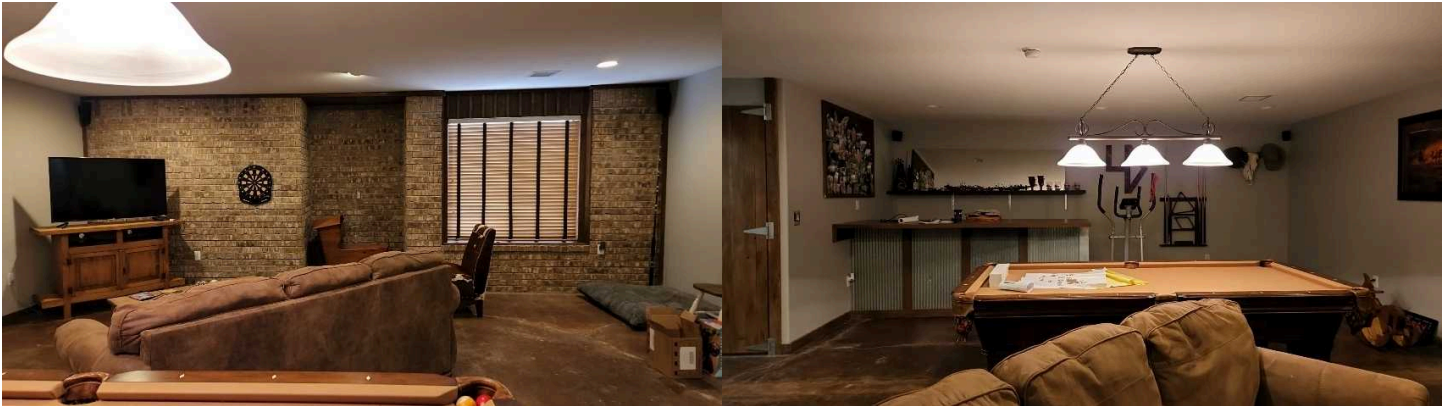
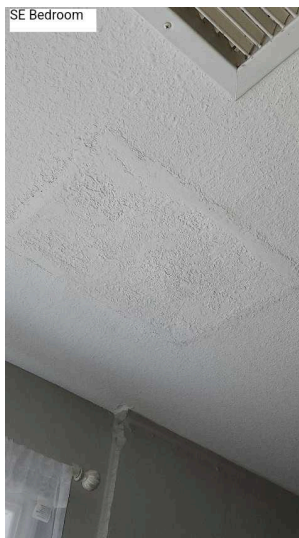
Previous repair noted on the ceiling of the south basement bedroom.

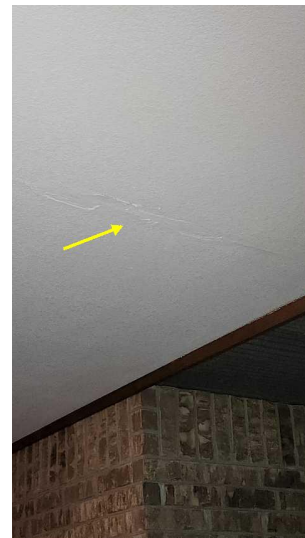
Cracking with repair noted on the basement ceiling.

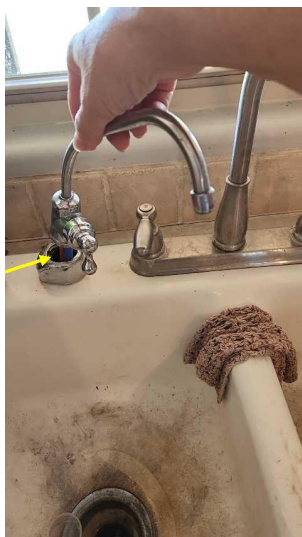
The RO faucet base is broken but operating.

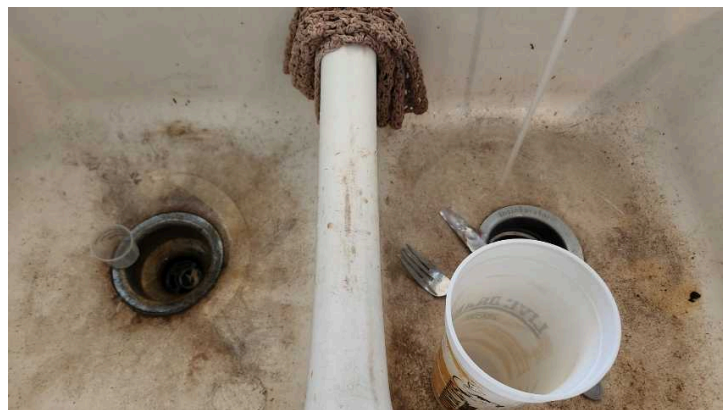
Stains noted in the Kitchen sink

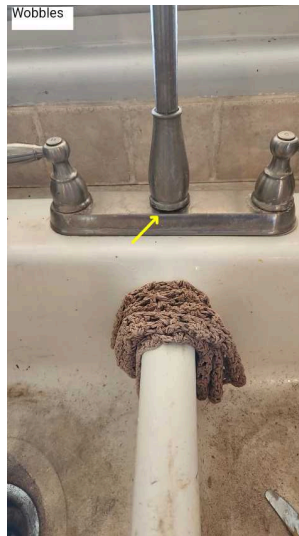
The sink faucet is loose at the base where it attaches to the sink plate.

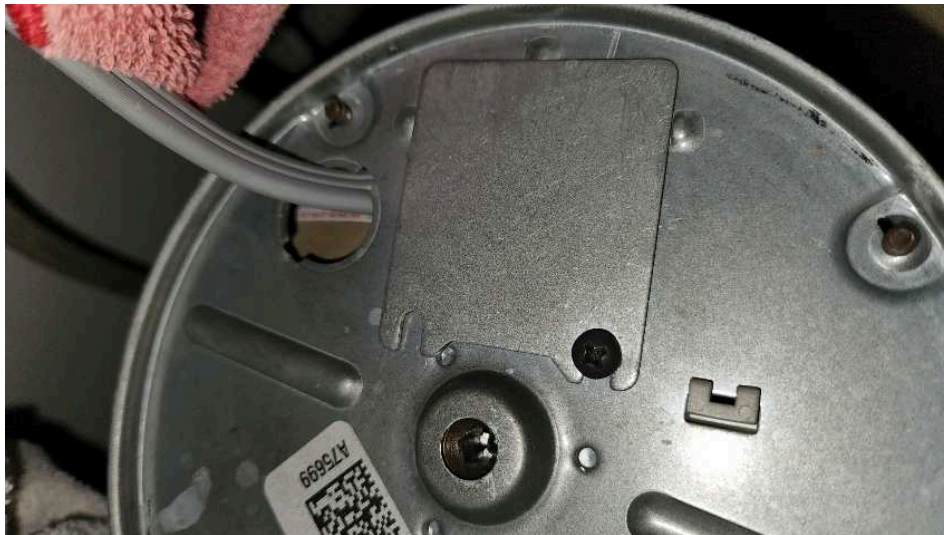
Recommend a wire clamp or plastic grommet where the electrical wire enters the disposal

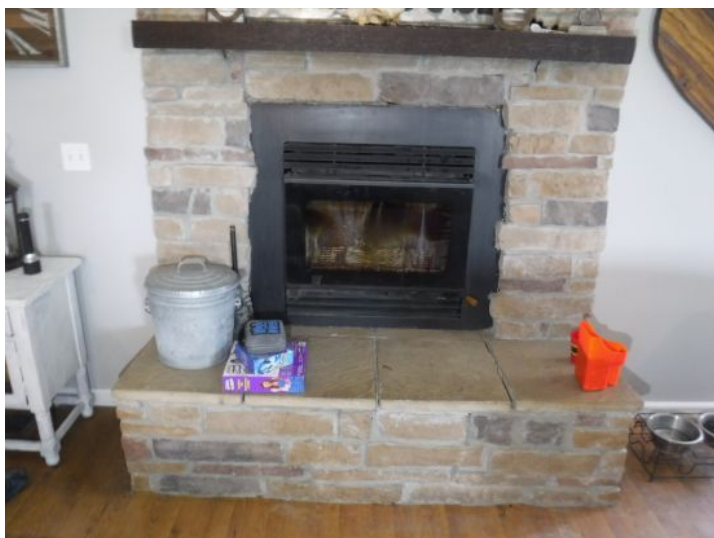
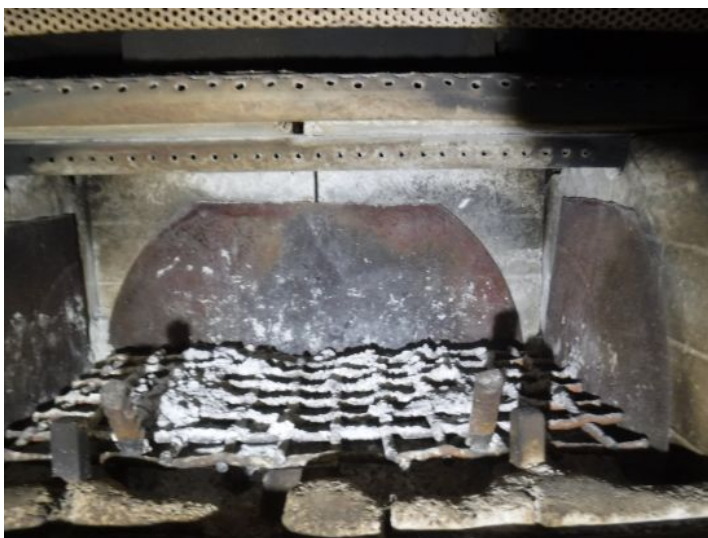
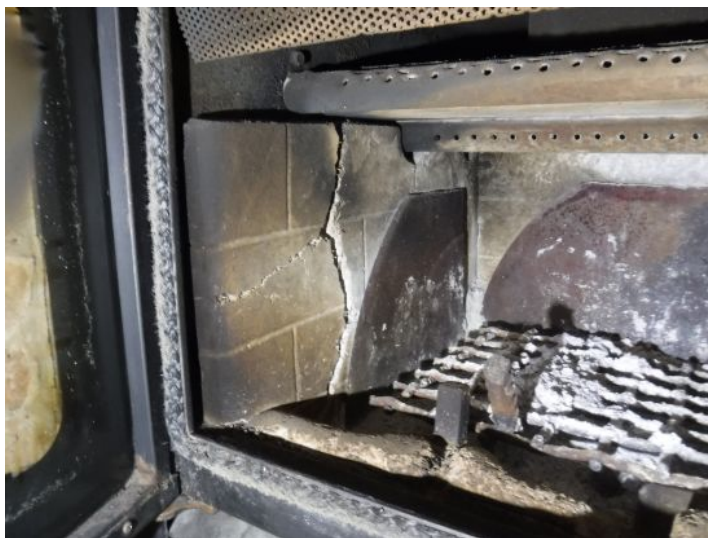
- The liner is broken in the firebox, recommend having the wood burning stove cleaned serviced and certified by a qualified chimney sweep

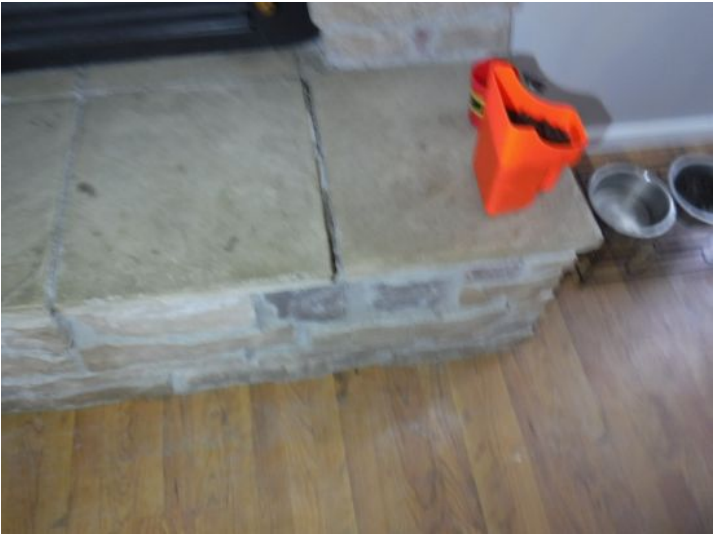
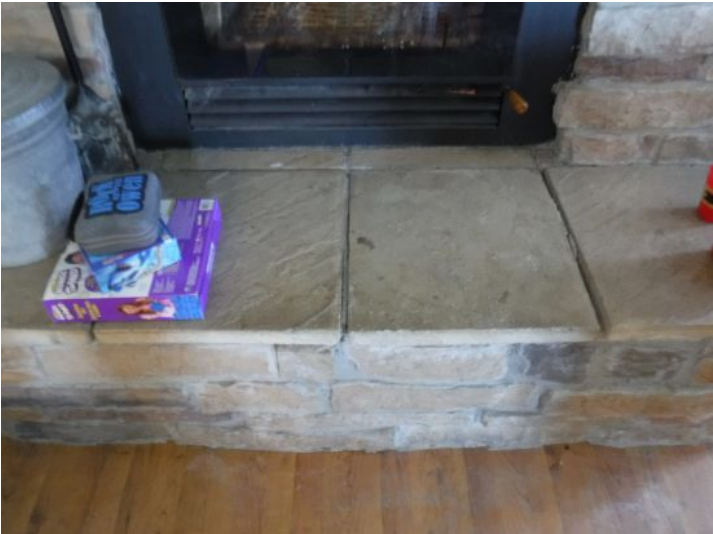
The mortar needs to be repaired on the stone hearth

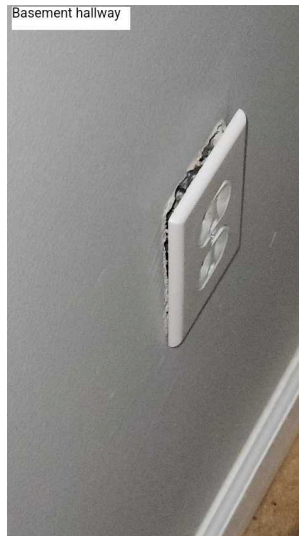
Recommend securing the receptacle in the basement hall properly.

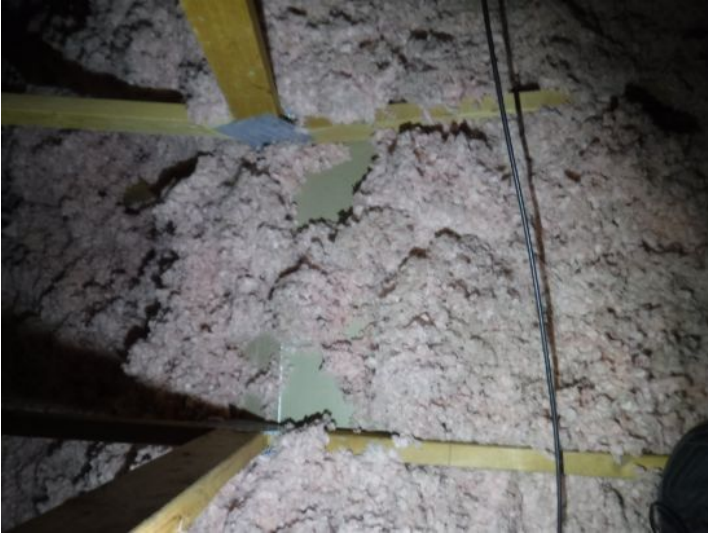
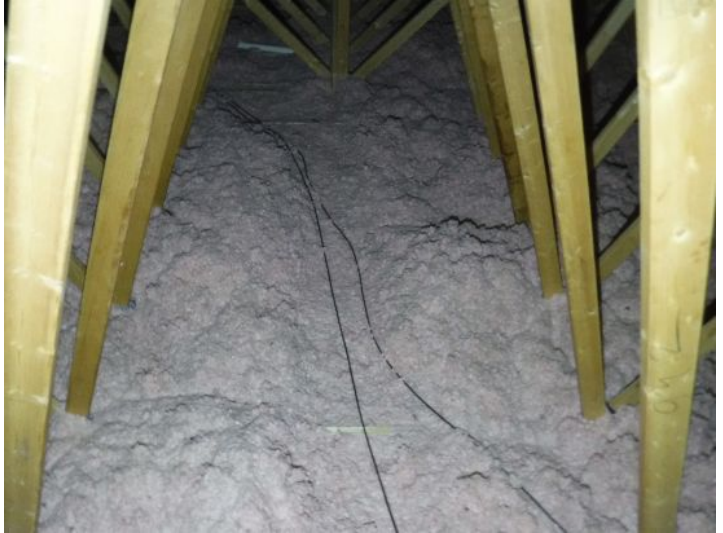
Some of the insulation is displaced or compressed, recommend even distribution of the insulation
