**Phase I Environmental Site Assessment  
Burg Tract  
131 Elberta Street  
Stonewall, Texas 78671**

**Project No. 2561**

**June 10, 2021**

William K. Duran, P.G.  
Environmental Professional

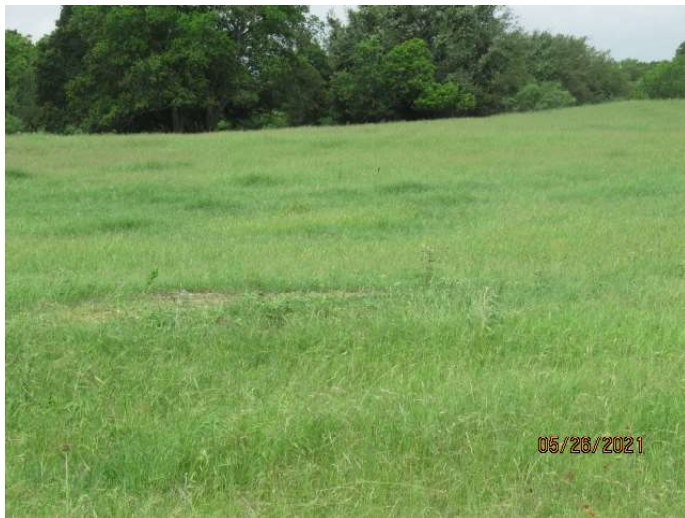
Former livestock dipping vat located north on property

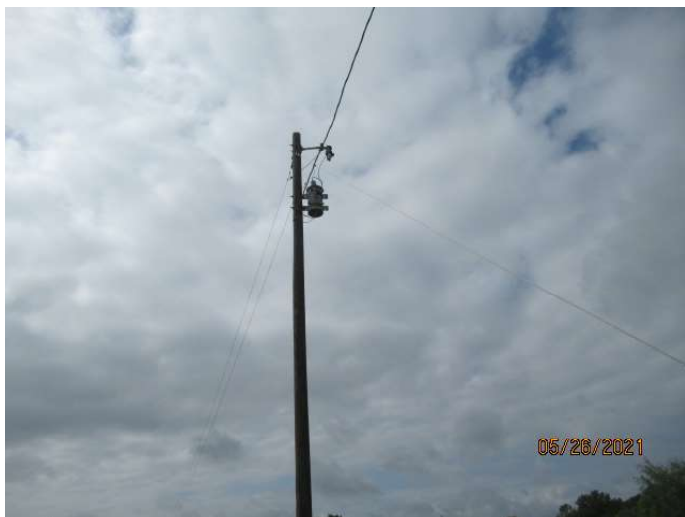
Electric transformer located on north side of property.

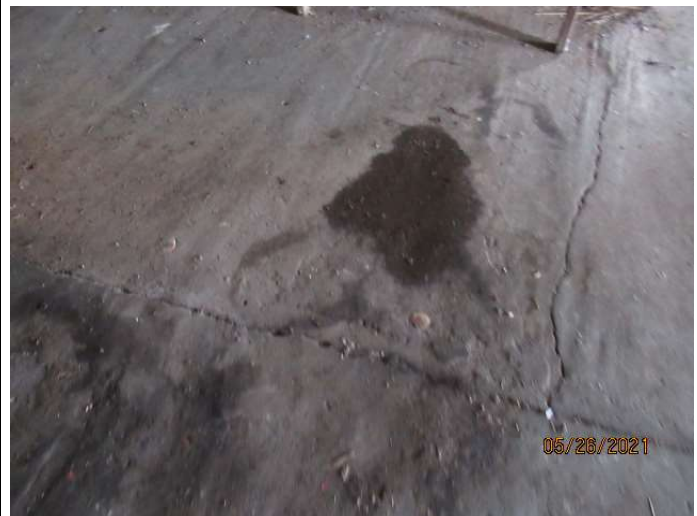
Stained concrete inside the vacant shop.

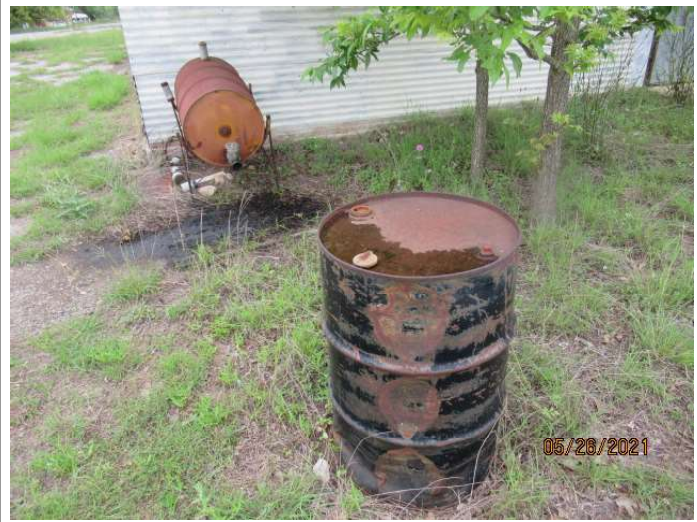
55-gallon drums observed on west side of shop.

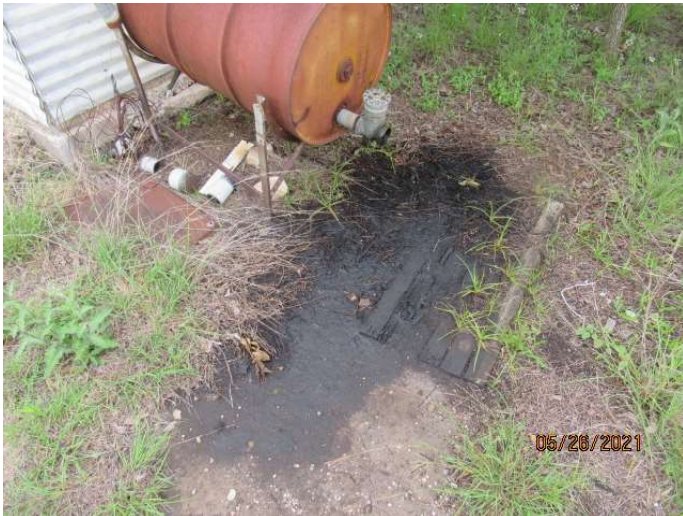
Staining beneath 55-gallon drum.

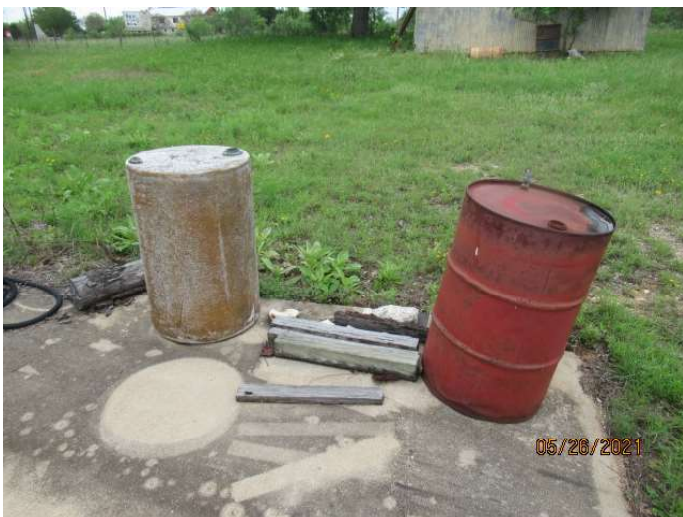
Empty drums located west of vacant shop.

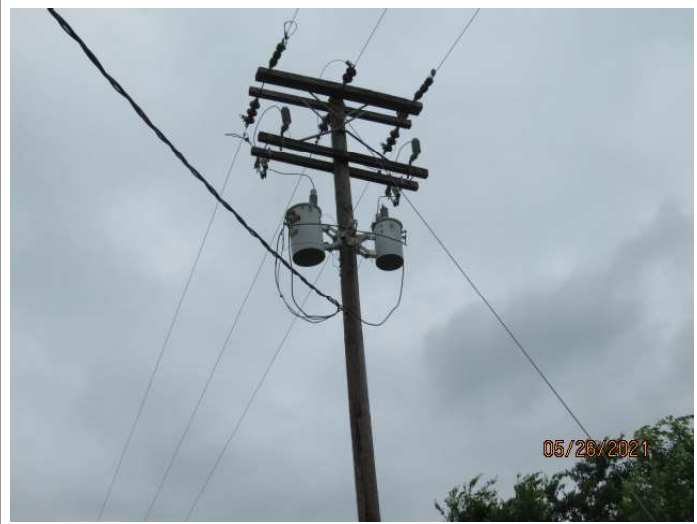
Electric transformers observed near feed lot corral.

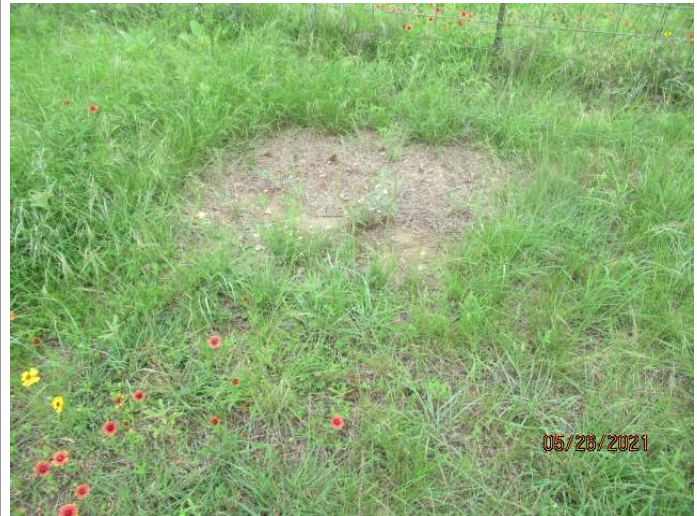
Former diesel AST site located on west side of shop.

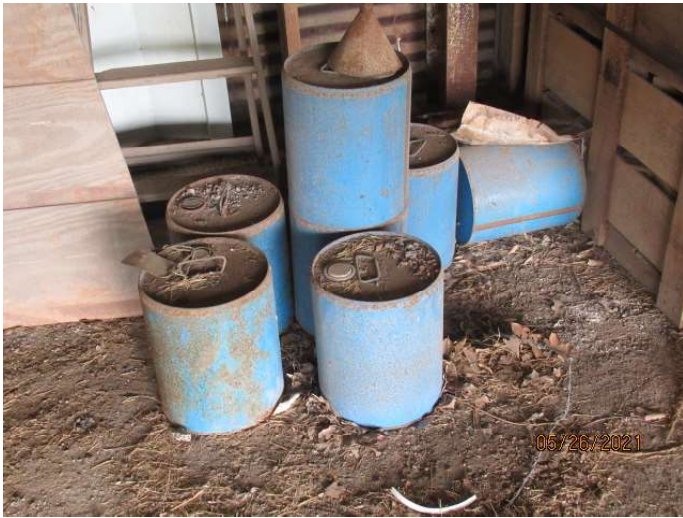
While there were no hazardous waste in connection with identified uses present on the subject property at the time the site reconnaissance, there were unidentified containers observed in the barn (possible dormant oil). Thus, these containers were considered a *recognized environmental condition* with respect to the subject property.

Dormant oil containers stored inside shed.

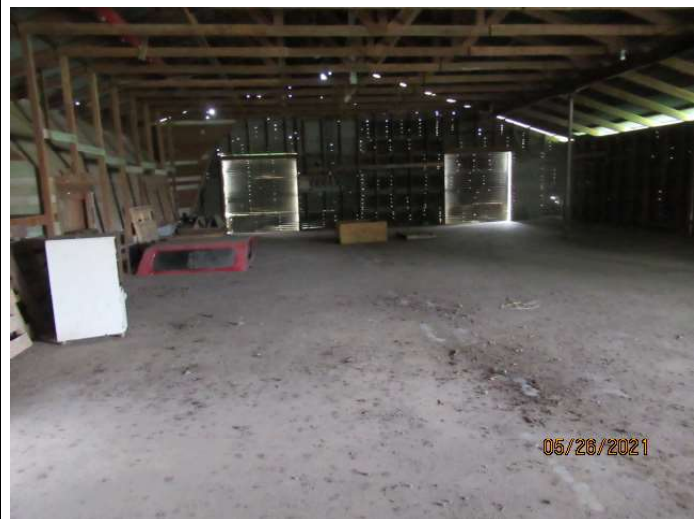
There were no hazardous substances in connection with identified uses present on the subject property at the time the site reconnaissance. There has been documentation presented to Austin EnviroSolutions that hazardous substances have been stored on the subject property when used as the sprayer repair shop and warehouse. Since bulk amounts of fertilizers, fungicides, herbicides and insecticides were stored and distributed inside the warehouse, it was considered a *recognized environmental condition* with respect to the subject property.

Interior view former chemical storage warehouse.
