## Structural Engineering

Re: Tier 1 Foundation Evaluation of a Residence at 15469 SH 135 S, Overton, Texas

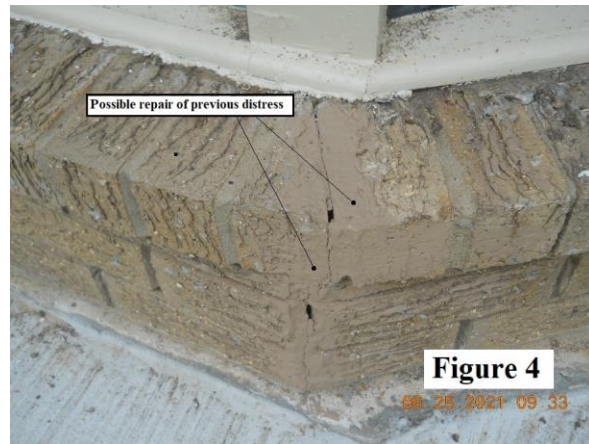
**Figure 4**

In some areas there was evidence of previous repairs (Figure 4 for example and other Figures where noted) to the masonry caused by past foundation movement. These repairs were made with such remarkable skill so as to be almost unnoticeable. It is arguable whether or not these are actual repairs or simply “touch up” by the original mason.

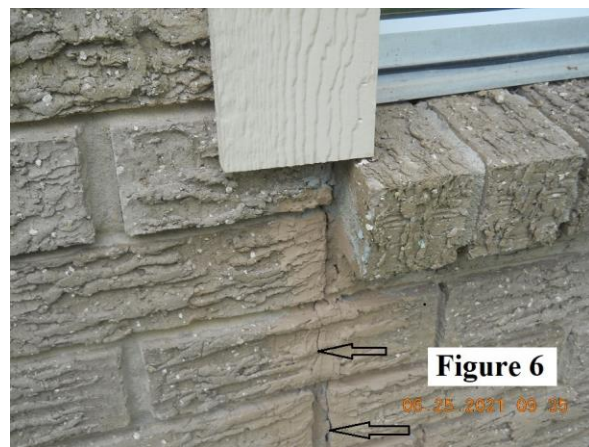
**Figure 6**

Figure 6 shows an extremely minor example of distress which could be shrinkage strain or very small foundation movement.

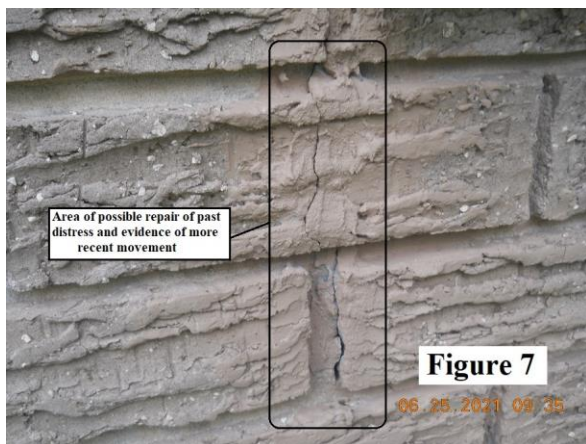
**Figure 7**

Figure 7 is an example of extremely minor additional movement after the suspected repairs were made. Figure 9 shows a possible example of a repair found along the southwest elevation in Figure 8.

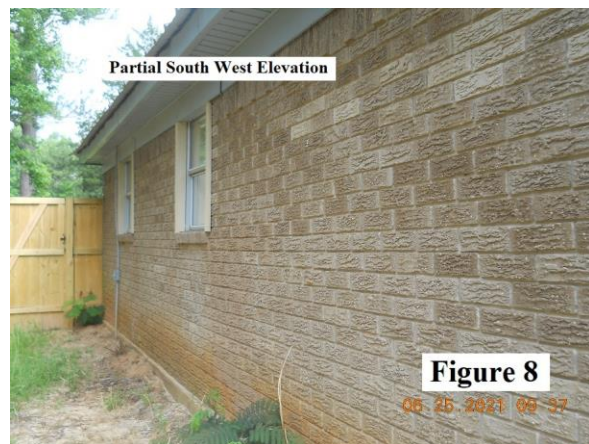
**Figure 8**

As can be seen in several photographs, the foundation perimeter dimensions were greater than the architectural masonry dimensions. Refer to Figures 8, 13, 14, 17, 18, etc. for examples of this observation. Normally the masonry and the exterior of the foundation align vertically and there is no “step” of the foundation beyond the line of masonry. This can allow rainwater to dwell on this horizontal surface and potentially invade the interior. No evidence of this was seen on the interior but keep in mind that this interior had been recently painted. Please refer to my comments on this observation in the Conclusions section below.

The possible moisture incursion due to the "step" in the masonry/foundation interface (Figures 8, 13, 14, 17, 18, etc.) can be minimized by cleaning the area during a period of dry weather with a wire brush and compressed air and applying several coats of masonry/concrete sealant according to the particular

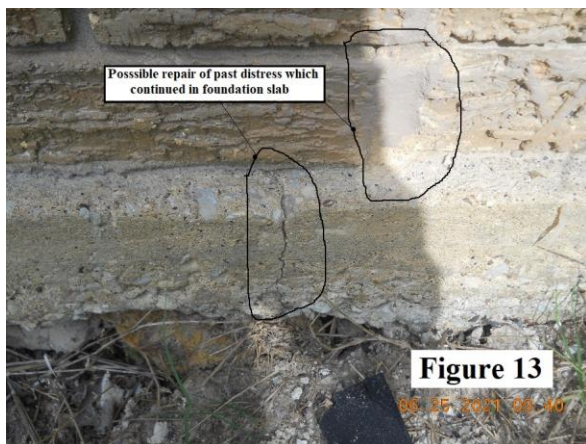
Figure 13 shows an example of the repair of the masonry which continues into the foundation concrete.

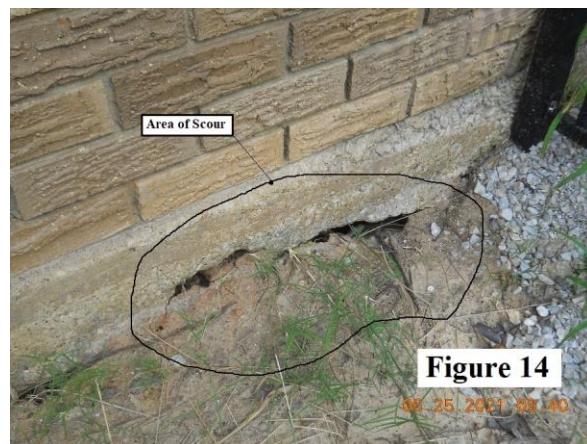
An area of scour was observed in Figure 14. Please refer to the Conclusions portion of this report for further discussion of this observation.

The areas where the perimeter soil has been scoured by runoff should be repaired as soon as possible. It is unknown how much moisture has penetrated beneath the slab or the effect this moisture has had on the unevenness of the interior floor.

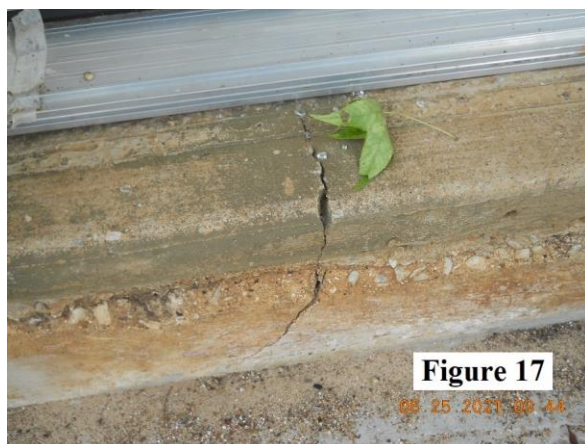
Figure 17 shows an example of distress due to very minor foundation movement.

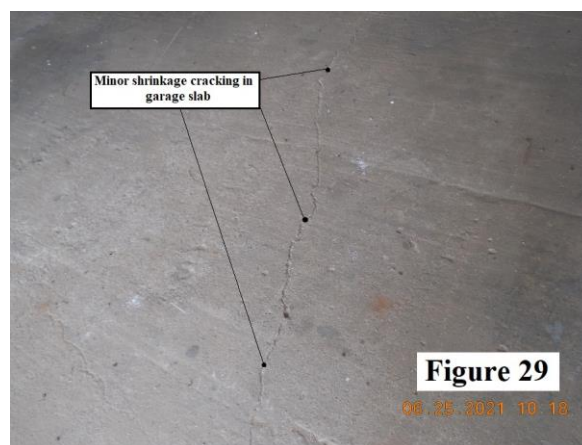
Interior masonry structures such as the fireplace in Figure 28 are notorious for displaying evidence of undesirable foundation behavior. A close examination of this element showed no evidence of this.

The lack of cracking in the lintel corner of the fireplace (Figure 28) also indicates lack of undesirable foundation movement, Likewise the very minor distress in the garage slab is a positive observation.
