# ARBORIST REPORT

306 N. Excelda

David Reilly  
Seeds to Trees, LLC  
ISA # SO-1149  
ISA Qualified Tree Risk Assessor

2/27/2023

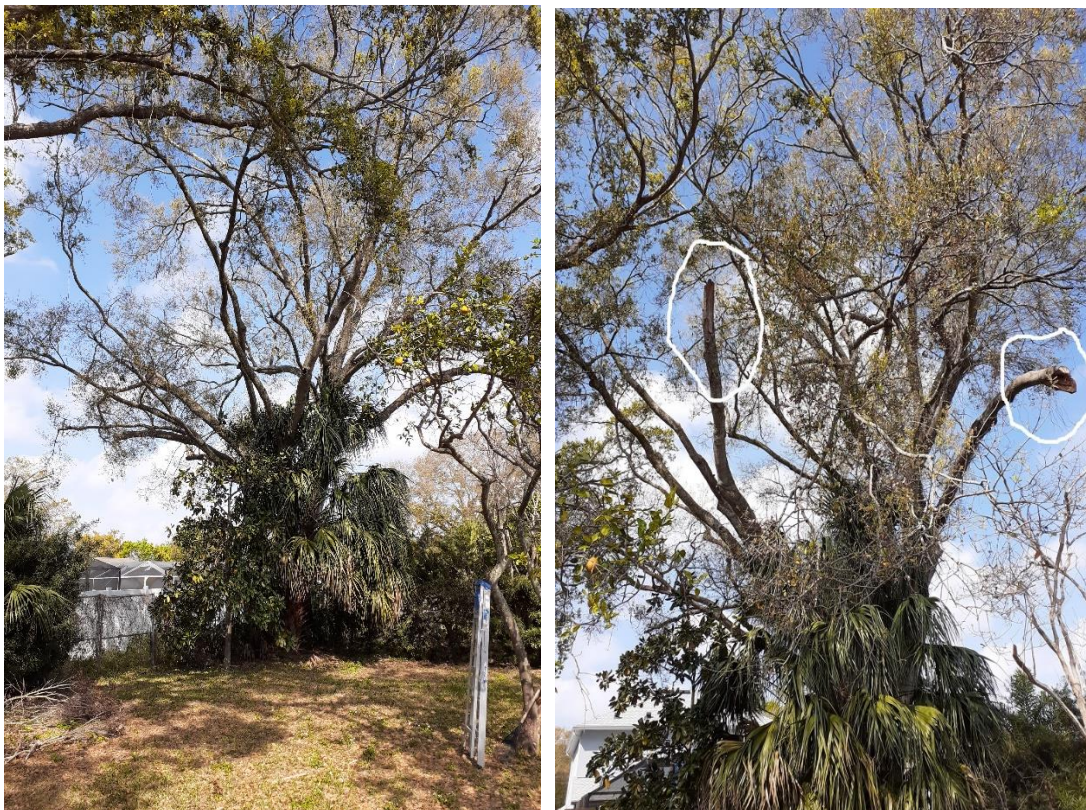
The only trees on site are across the rear fence (west side). In the northwest corner there is a 38" Laurel oak Grand Tree. The tree is in fair condition C/10 with a SCD=55' and an LCD=62'. The mitigation value is 8. The tree has multiple codominant stems with included bark and had 2-8" mid stem failures. The tree has a 20' minimum protective radius but is not preservation quality.

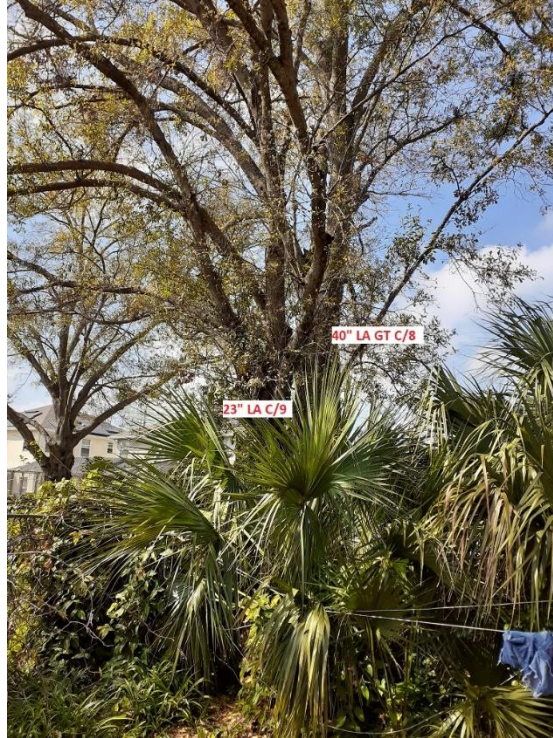
In the southwest corner there are 2 Laurel oaks. One is 23" and the other is 40" in diameter. The 23" is in poor condition C/9 and not preservation quality. It is subordinate to the 40" Grand Tree in fair condition C/8. The tree has a SCD=48' and an LCD=52' and the mitigation value is 7. The tree has a 20' minimum protective radius and removal of the tree would require a variance. For a pool, the deck could be at 15' and on grade.

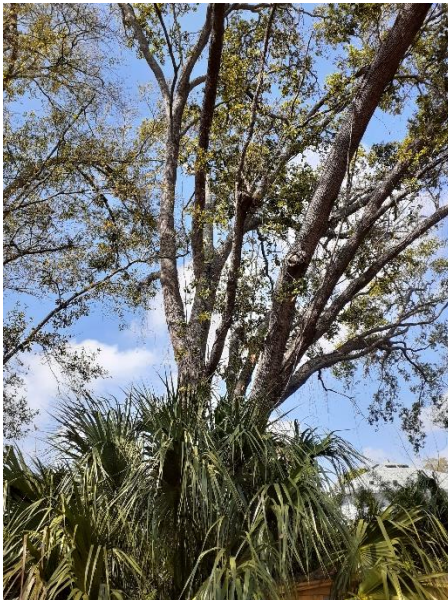
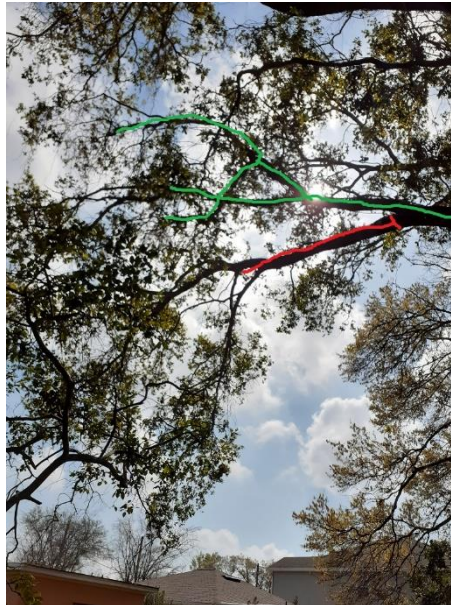
The final tree is a 38" Live oak in fair condition C/8 between the 2 Laurels. The tree has a SCD=45' and an LCD=48' and a mitigation value of 6. The tree has a 20' minimum protective radius and for a pool the deck could be at 15' on grade. Removal of the tree will require a variance. One 6" limb can be pruned to the parent stem.
