TEXAS PROFESSIONAL INSPECTIONS

## FOUNDATION EVALUATION REPORT

6388 Hurta Ln  
Bryan, TX 77808

02/11/2026

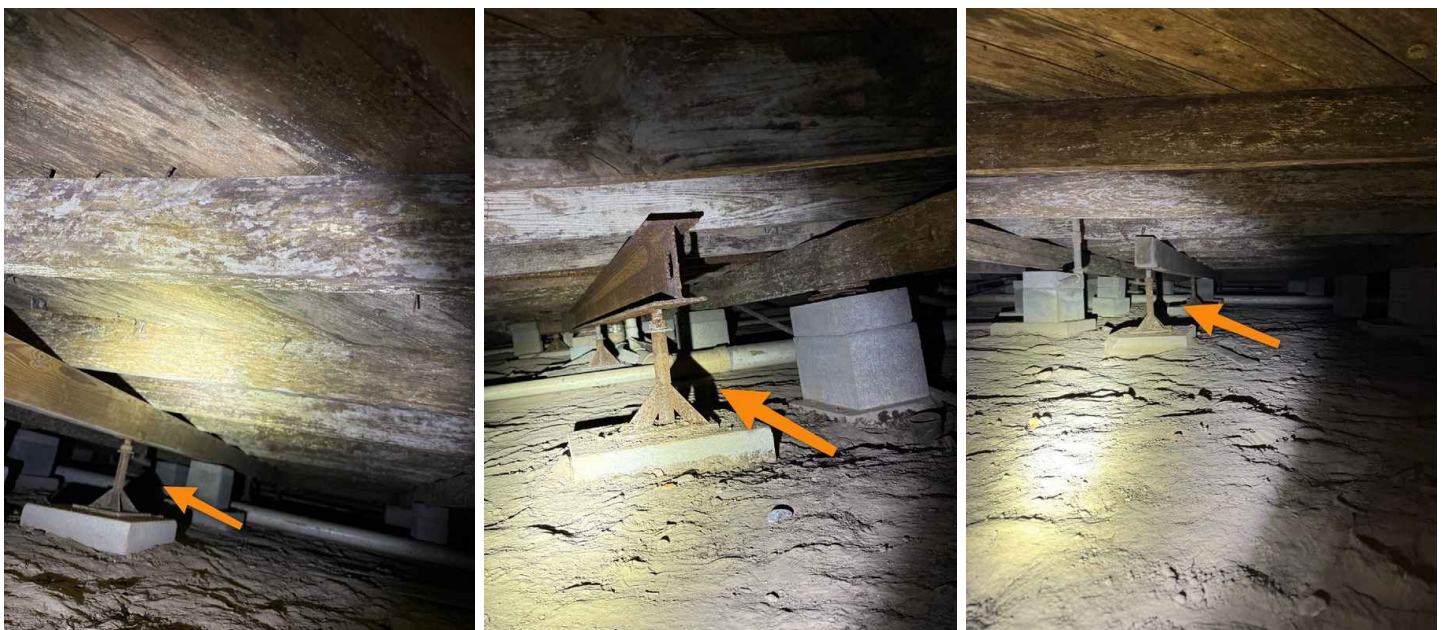
#### 3.1.1 Evaluation

#### TEMPORARY METAL SUPPORTS

Temporary metal supports in use in various areas of the foundation should be replaced with permanent concrete blocks or other pier material.

Contact a foundation contractor.

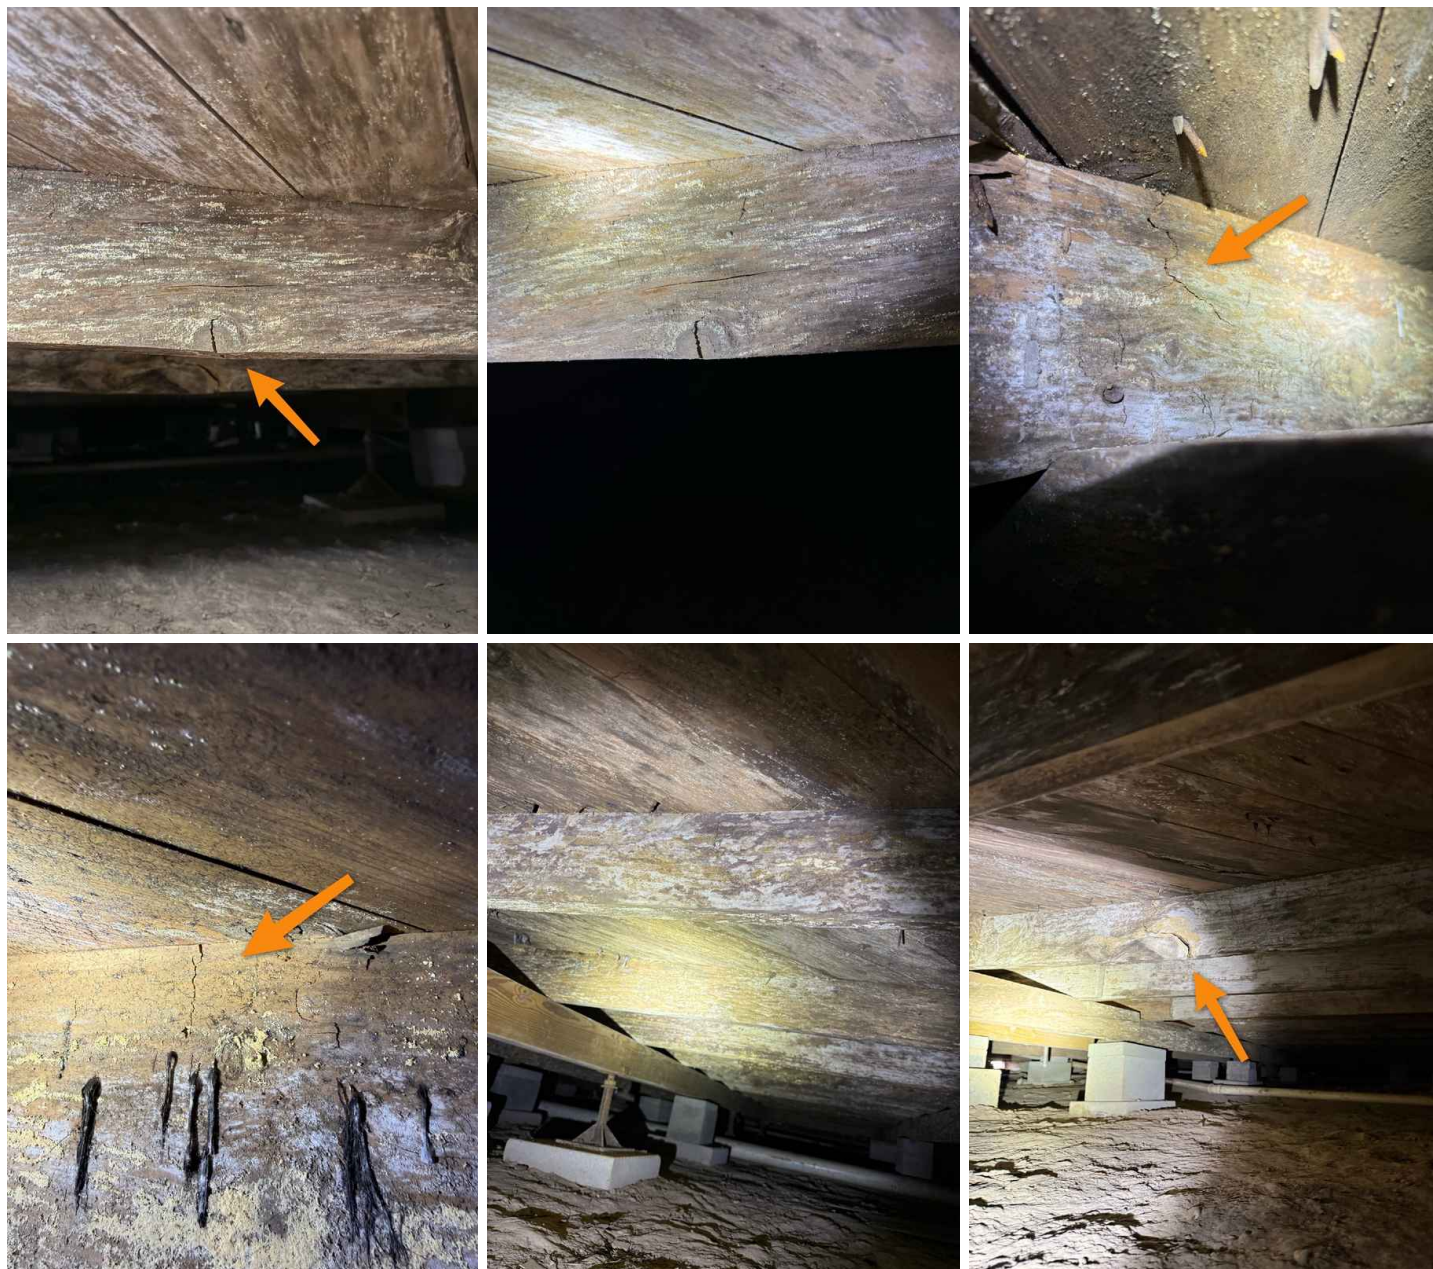
## 3.1.2 Evaluation

**CRACKED JOISTS**

## MIDDLE OF STRUCTURE

Several joists are cracked. Some of the cracking appears to be the result of excessive moisture, weakening the joists.

Contact a foundation contractor.

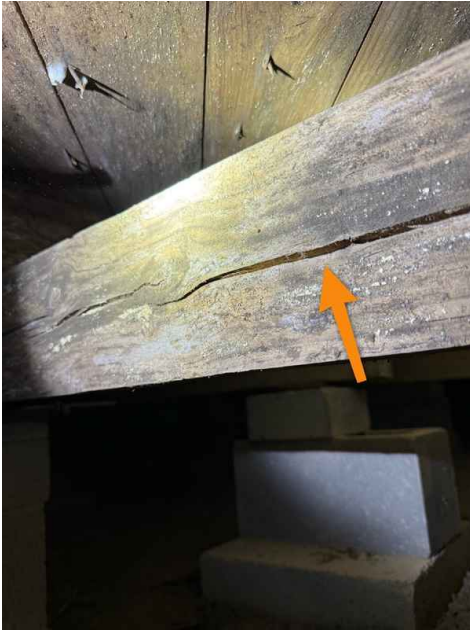
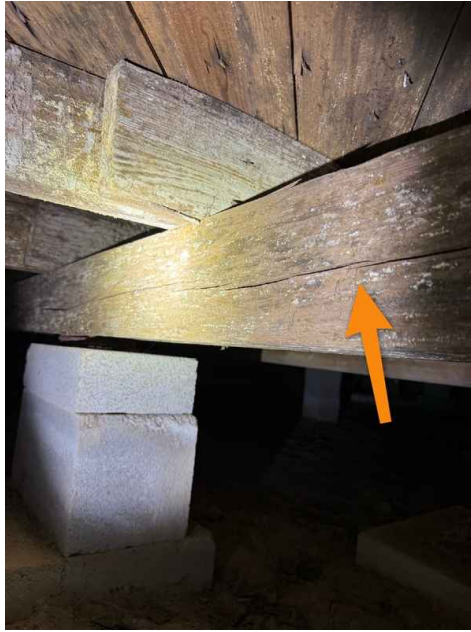
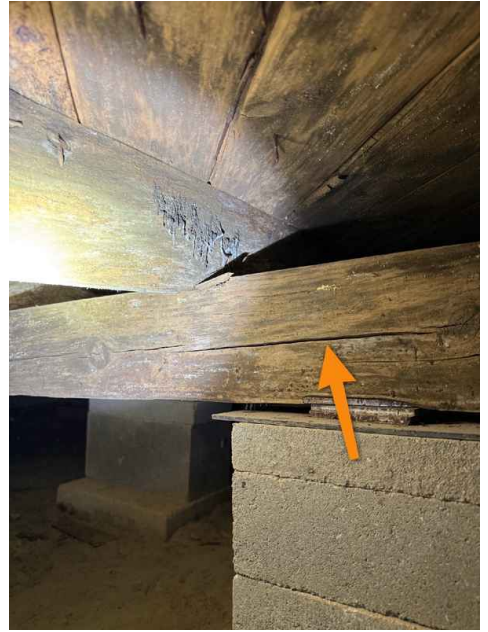
## 3.1.3 Evaluation

**CRACKED BEAMS**

Several beams have large horizontal cracks. These beams need replacement or supplemental support added adjacent.

Contact a foundation contractor.

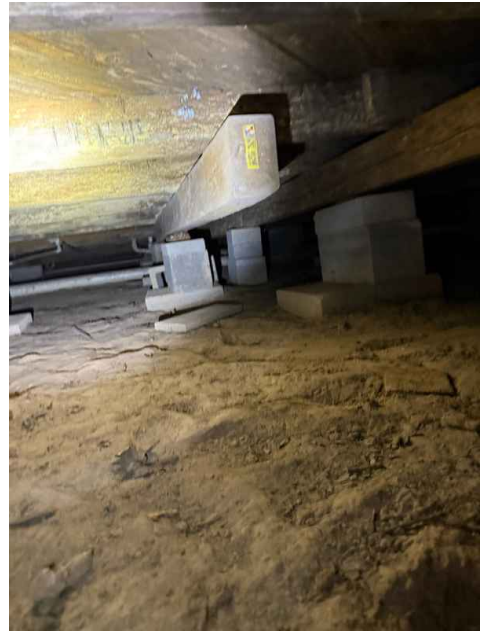
#### 3.1.4 Evaluation

### UNSUPPORTED BEAMS

#### MIDDLE OF STRUCTURE

Several beams are cantilevered excessively. Install additional support under the ends of all beams.

Contact a foundation contractor.

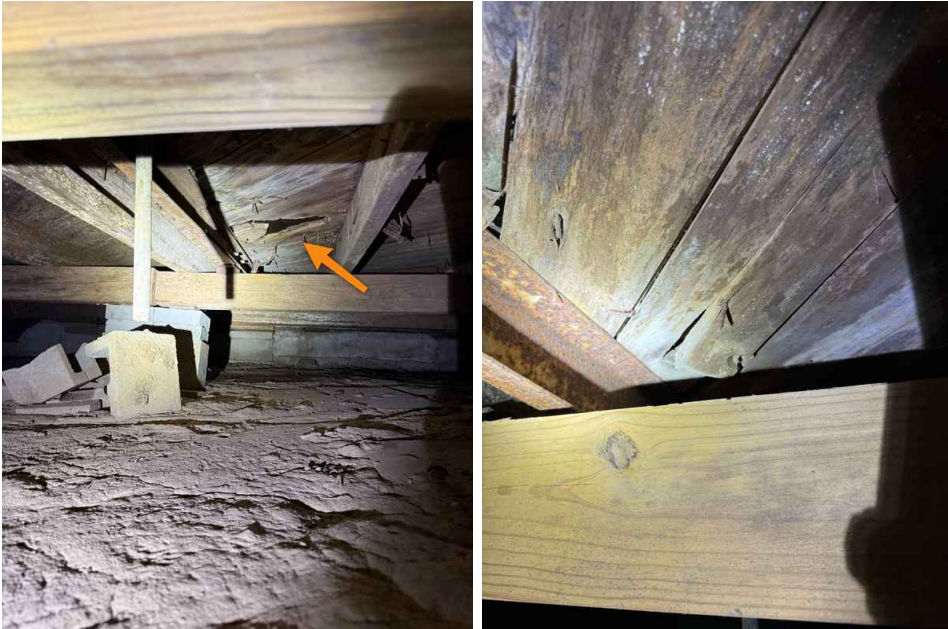
#### 3.1.5 Evaluation

### DAMAGED SUBFLOORING

Sub flooring is damaged in numerous areas from excessive moisture and will need to be replaced.

Contact a foundation contractor.

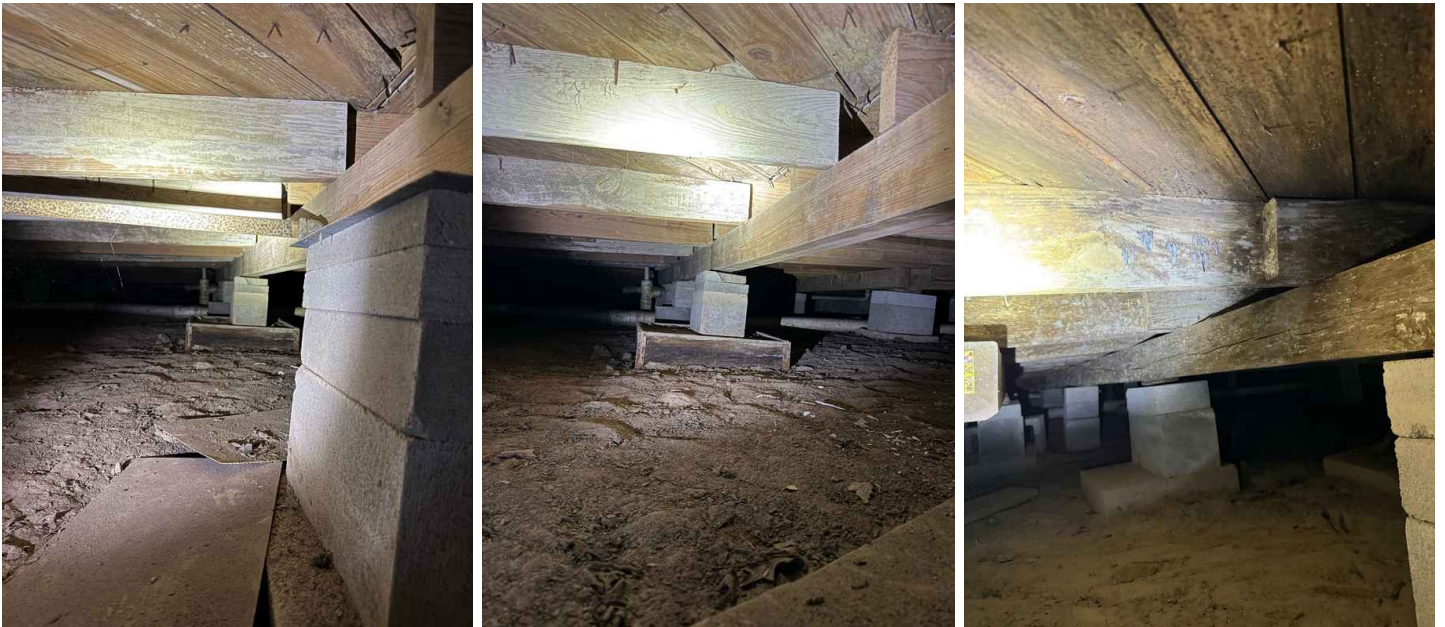
### 3.1.6 Evaluation

#### **TILTED BLOCKS**

##### UNDER MASTER BEDROOM

Several blocks are tilted. This has moved the beam, causing the ends of several joists to move off the beam.

Contact a foundation contractor.
