Re: Forensic Engineering Study

Nevels Residence 4008 FM 50

Washington County, Texas RES Project No. 0018-1-009

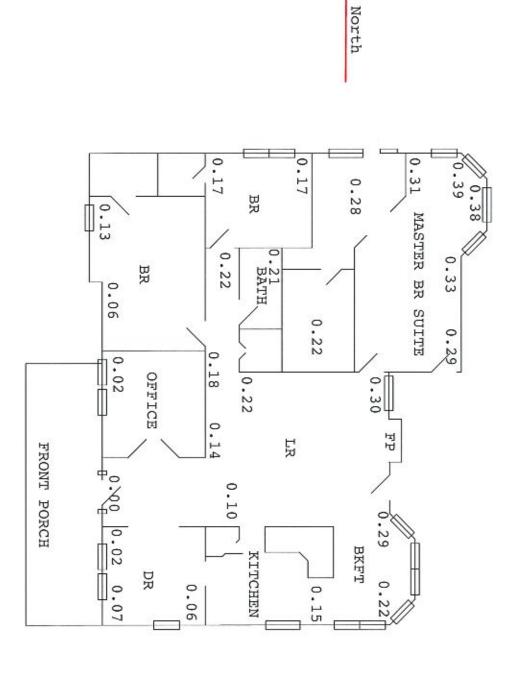
Figure 1. Nevels Residence - Washington County, TX

Elevation measurements were recorded for this residence slab and are depicted on Figure 1. It appears that the foundation slab was constructed on compacted fill when originally built in 2001. The south and east elevations of the residence were

The highest portion of the foundation slab was recorded in the master bedroom area. The maximum differential elevation measured was 0.39 feet between the most northeasterly corner of the master bedroom and the front entry of the residence. The maximum slope of the slab between these two points is less than 1.00%. The recorded slab elevation for the remainder of the residence is denoted on Figure 1.

The American Society of Civil Engineers (ASCE) *Guideline for the Evaluation and Repair of Residential Foundations* discusses deflection and tilt of the slab. Deflection is typically associated with the movement due to loss of slab support or excessive loading of the slab. Tilt is typically the slope of the slab due to construction finish or loss of slab support. The limits for deflection is typically defined in the local building codes. The term tilt with reference to the foundation slab attempts to describe the comfort or aesthetic use of the structure. A tilt greater than 1% is typically noticeable to even to the lay person. As noted, the slab slope for this residence was determined to be less than 1% for all portions of the residence.

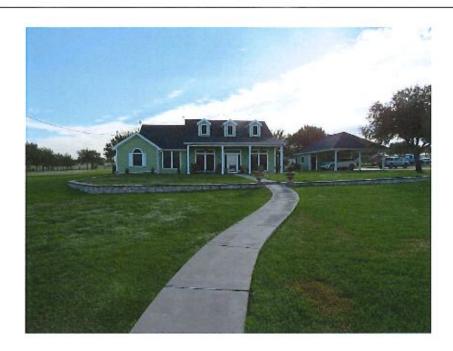
Front of the residence facing west for this report Photo #1

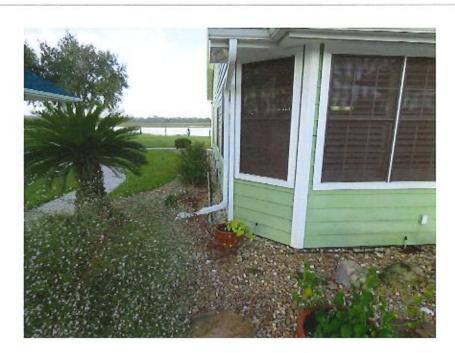
Please review Photographs 2 and 3 which depicts drainage modifications installed to convey runoff from behind the residence. These drains denoted are not French drain systems previously discussed. The slotted drain along the east side of the residence extends to the north and south away from the collection point and discharges the runoff away from the residence. This drain should be periodically inspected to assure that no blockage has accumulated in the pipe that prevents the system from functioning properly. The property owner can test the system by simply placing a hose in the drain and observe the outlet to be assured that the water is discharging.

South elevation drainage Photo #2

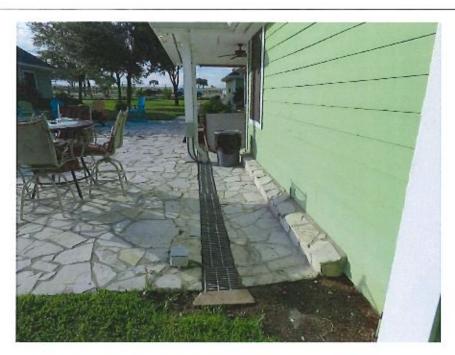
Photo #3 East elevation drainage

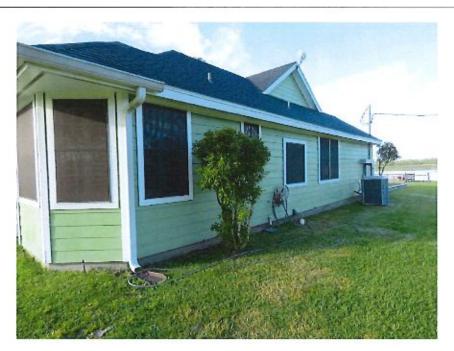
Photo #4 North elevation
