# 301 River Oaks Dr Gatesville, TX 76528

# **PROPERTY INSPECTION REPORT**

<b>Prepared For:</b>	Nichole Munday	
•	(Name of Client)	
Concerning: By:	301 River Oaks Dr, Gatesville, TX 76528	
	(Address or Other Identification of Inspected Property)	
	Brian Healy, Lic #21734	10/17/2019
	(Name and License Number of Inspector)	(Date)

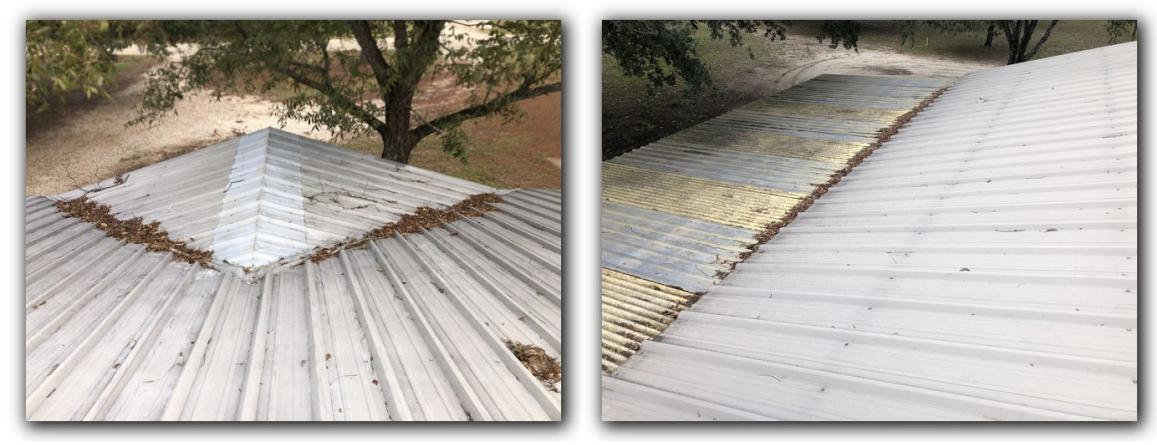
The debris should be cleaned off the roof to help prevent leaks and premature wearing of the metal.

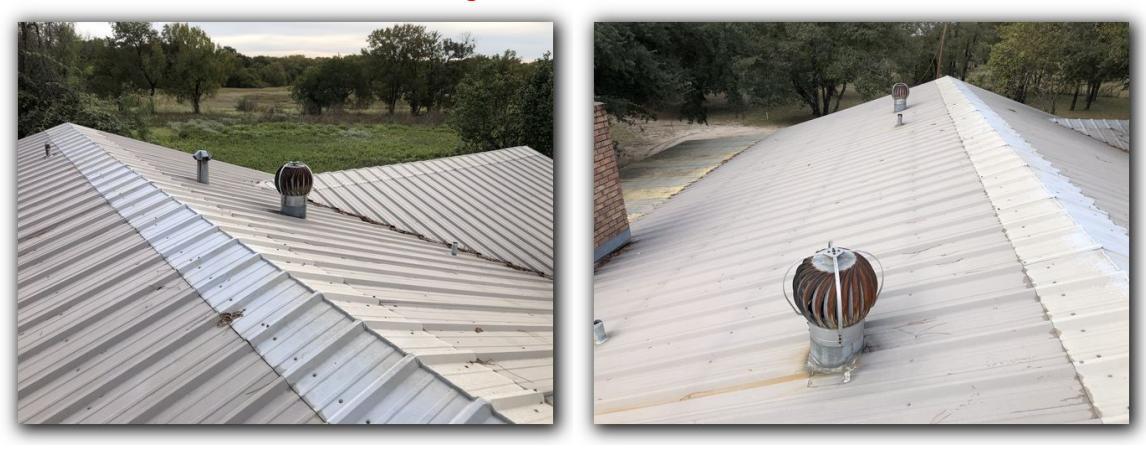
The turbine on the left side did not spin.

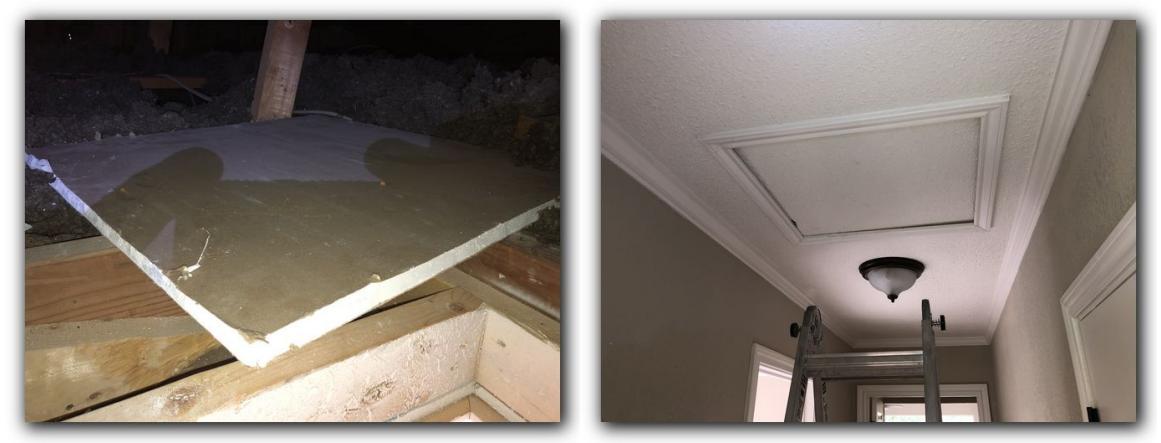
There was no insulation on the attic access panel.

Additional attic insulation should be added to improve energy performance.

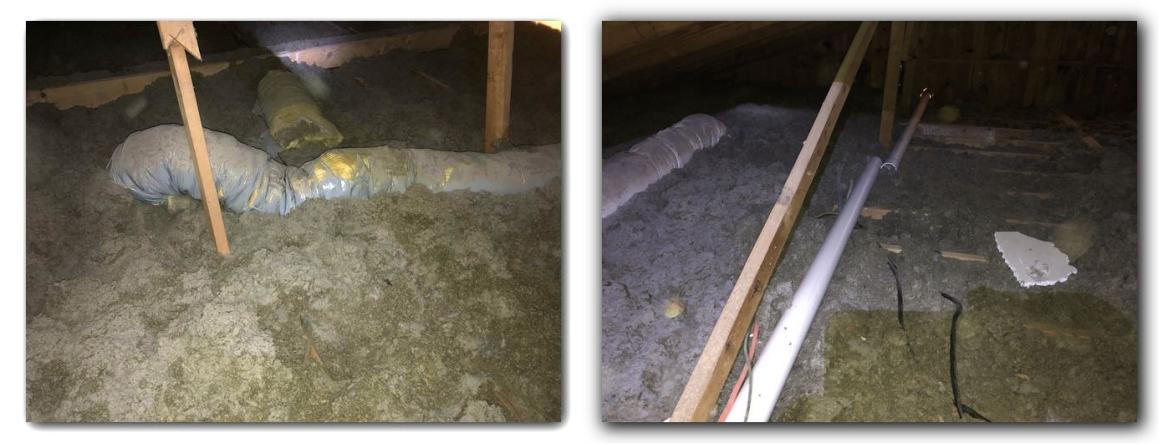
This report was prepared by Healymonster Home Inspections for Nichole Munday Page 6 of 40 There was dryer lint in the attic. The different color materiel is dryer lint.

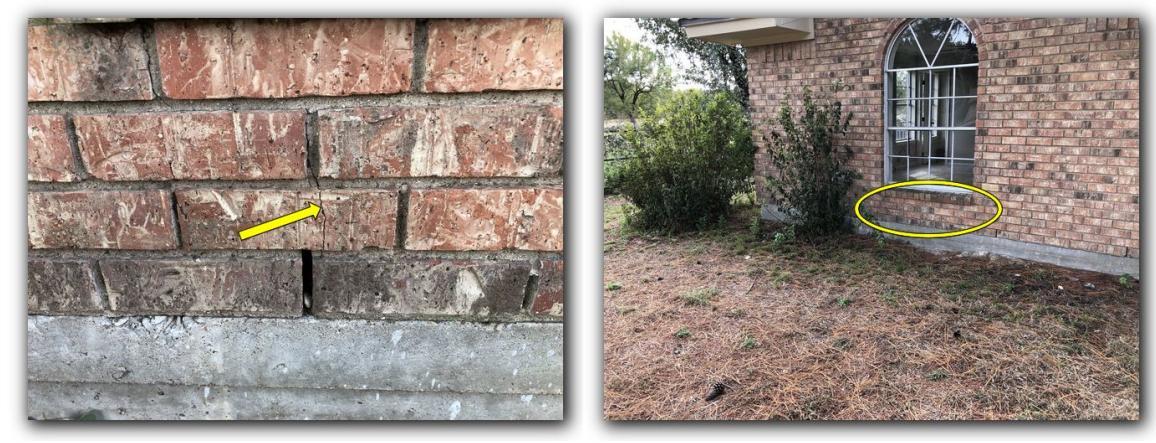
There was a hairline crack in the mortar of the brick veneer on the front of the home.

Hairline cracks are are usually caused by the mortar drying too fast and shrinking or minor settlement. They are usually not a concern, but should be sealed to prevent water penetration.

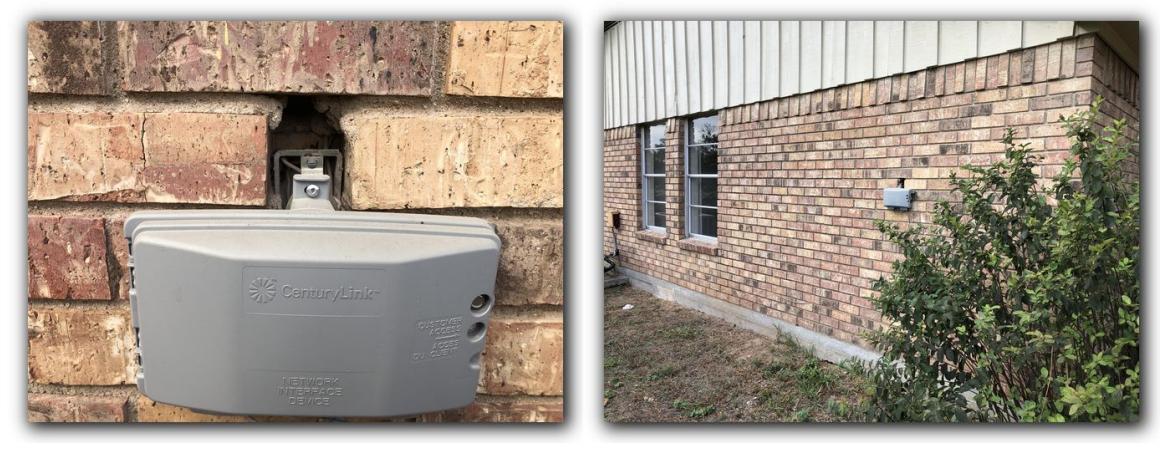
The hole behind the cable box should be sealed with expanding foam.

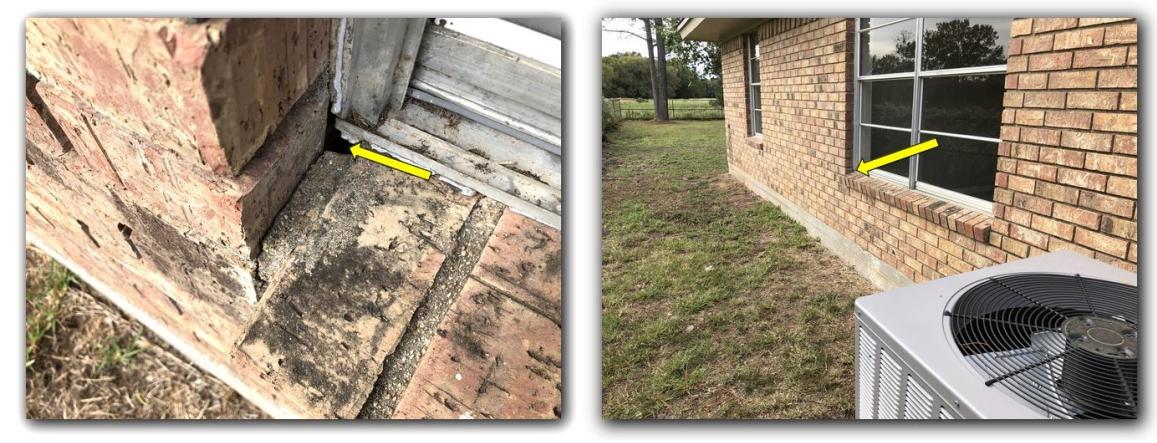
The mortar on the trim around the window of the the middle bedroom was deteriorating and should be touched up to help prevent water intrusion.

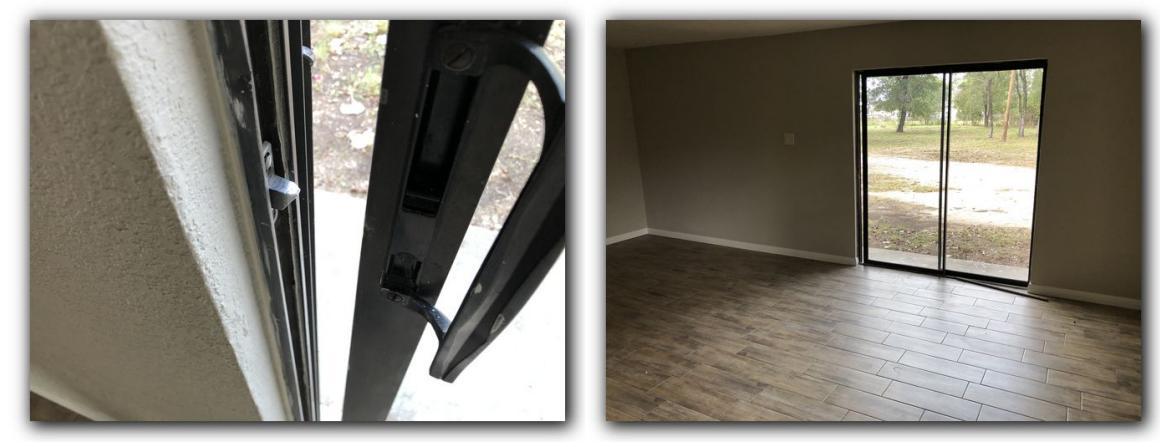
The lock is broken on the sliding glass door.

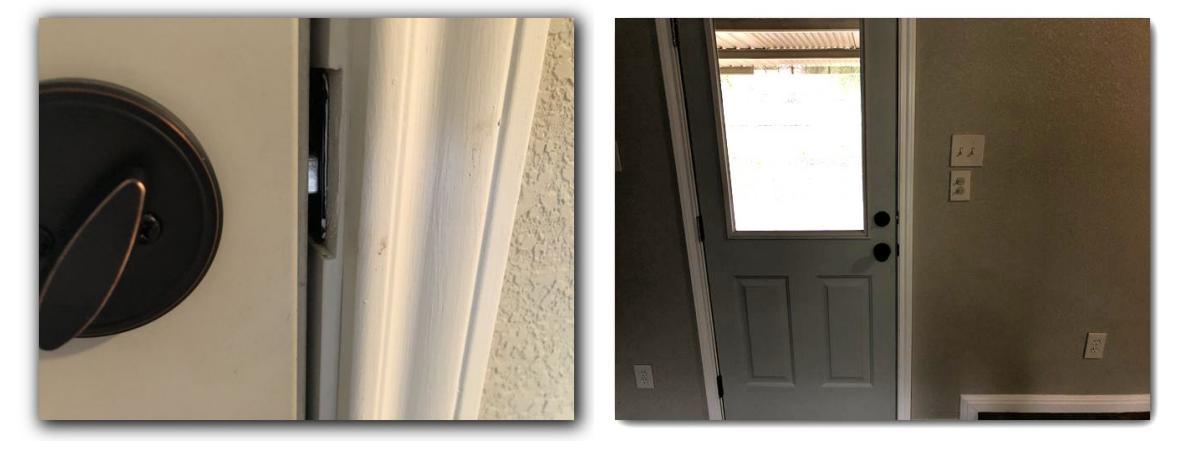
The deadbolt lock is misaligned with the striker plate on the rear entry door.

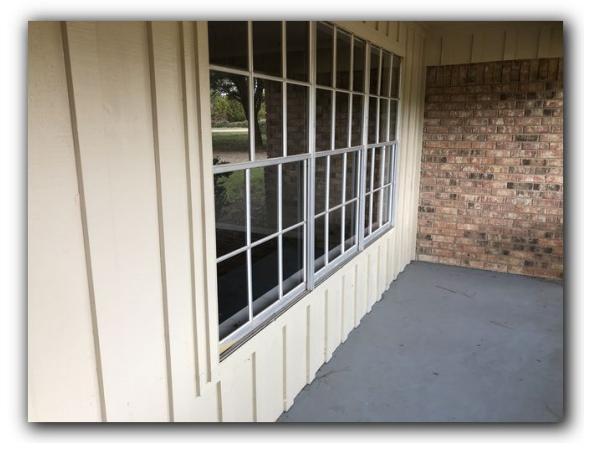
There were no window screens installed on the windows.

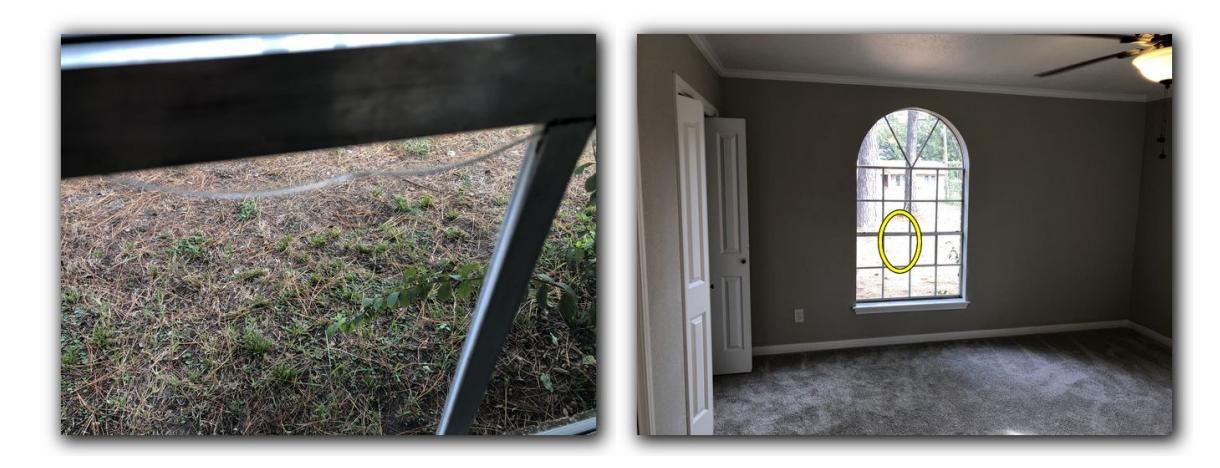
#### There was a cracked window pane in the front bedroom.

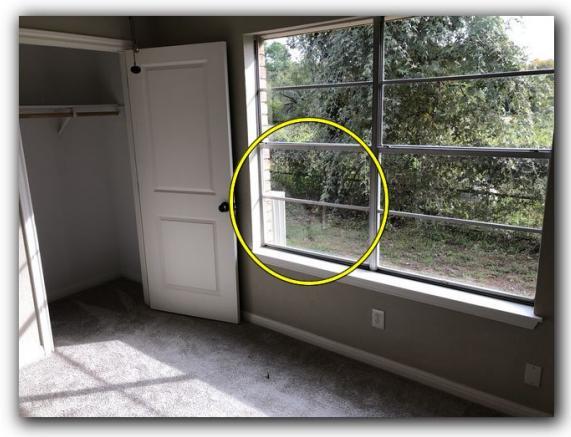
There was a detached \*balance on the left and right sides side of the left side window in the middle bedroom.

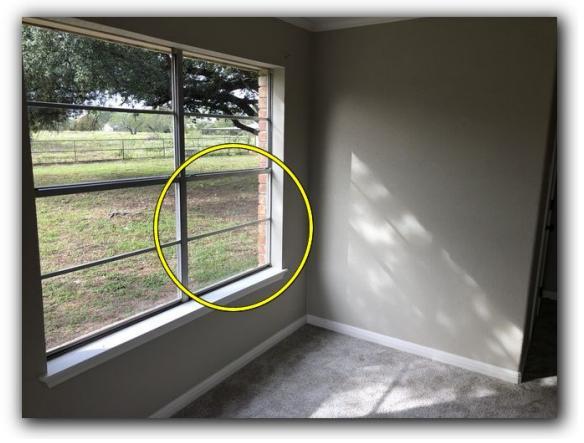
There was a detached \*balance on the left and right sides side of the right side window in the master bedroom.

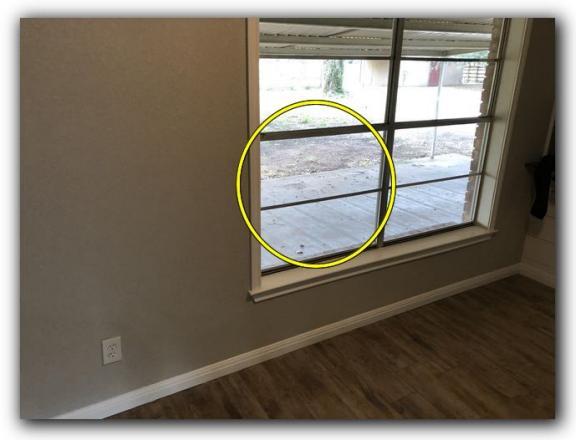
There was a detached \*balance on the left and right sides side of the left side window in the dining room.

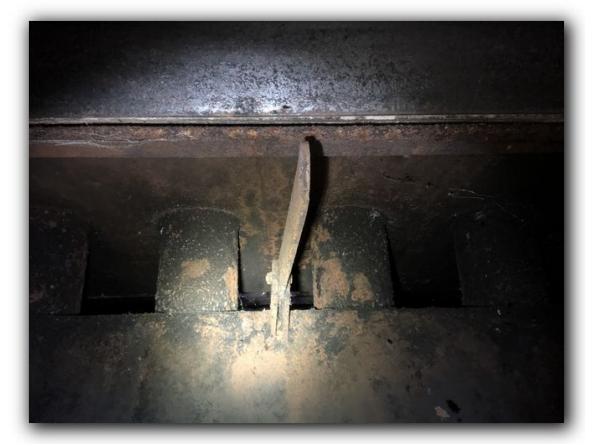
The flue lever would not move.

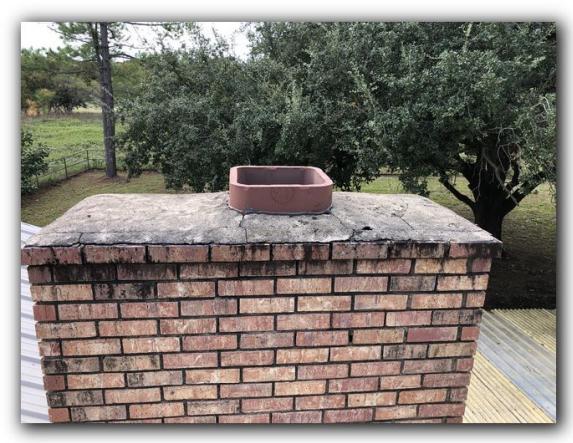
#### There was no spark arrestor in place on the chimney.

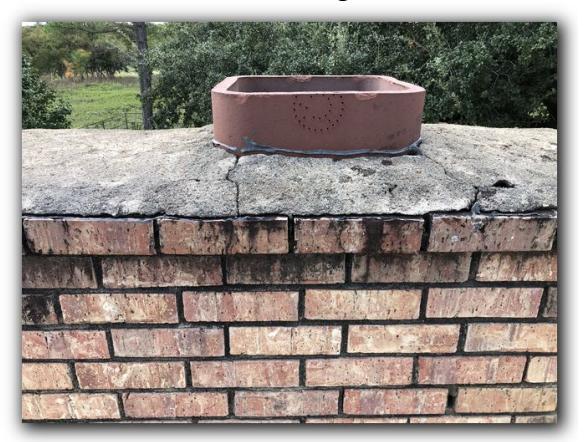
#### There was cracking in the mortar crown on the top of the chimney.

These should be sealed to prevent water damage.

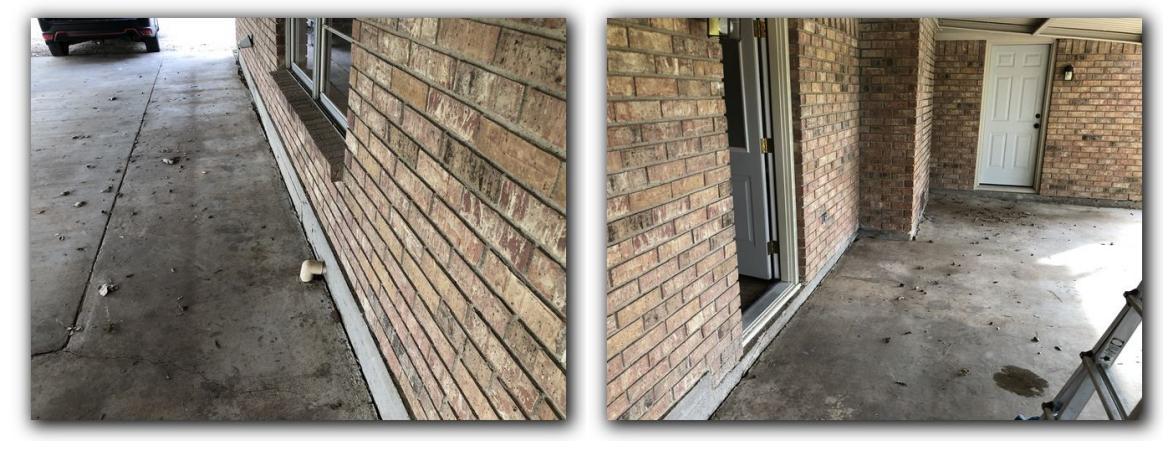
There was separation between the house foundation and the rear porch. This does not have any adverse effect on the house because the are actually separate slabs.

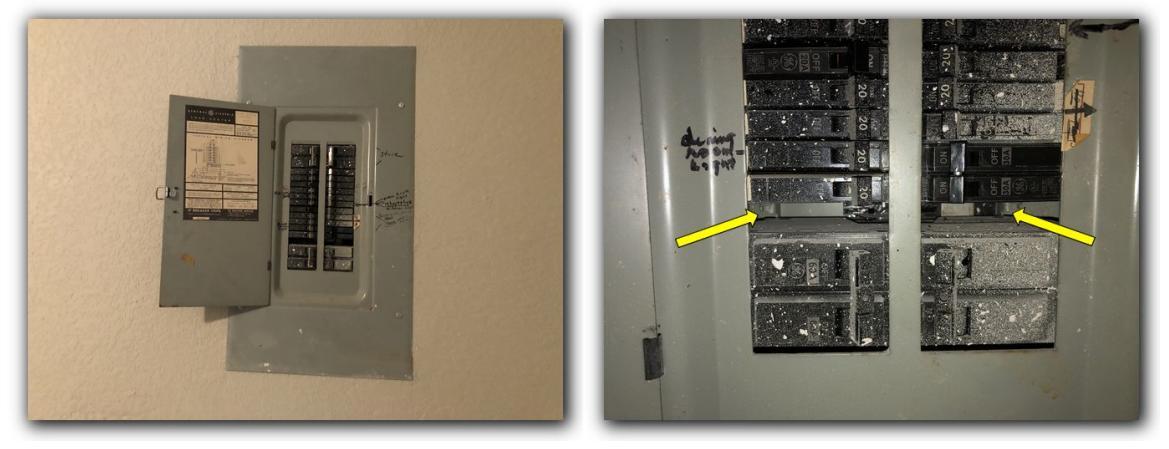
### There were knockout covers missing in the breaker panel in the laundry room.

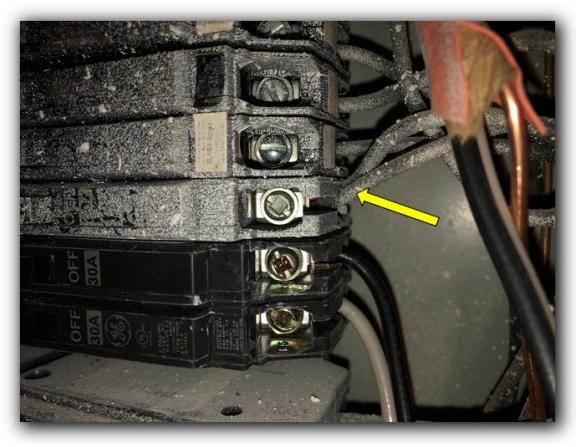
There was a double tapped breaker (two hot wires attached to the same breaker) in the breaker panel in the laundry room.

These are not allowed unless specifically approved by the panel manufacturer.

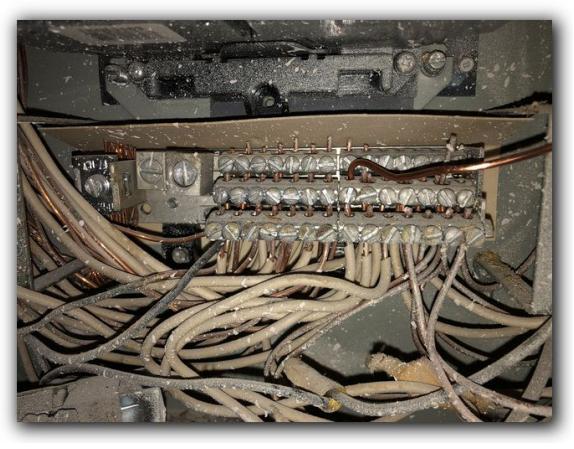
The ground and neutral wires were sharing the same busbar with no main disconnect present.

This is only allowed in panels that have a main breaker.

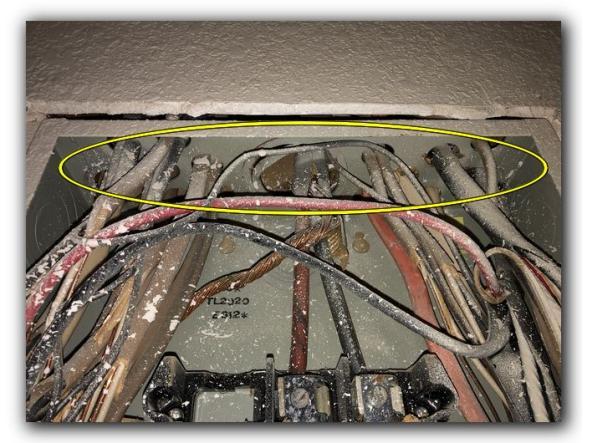
There were wire protection grommets missing in the breaker panel in the laundry room.

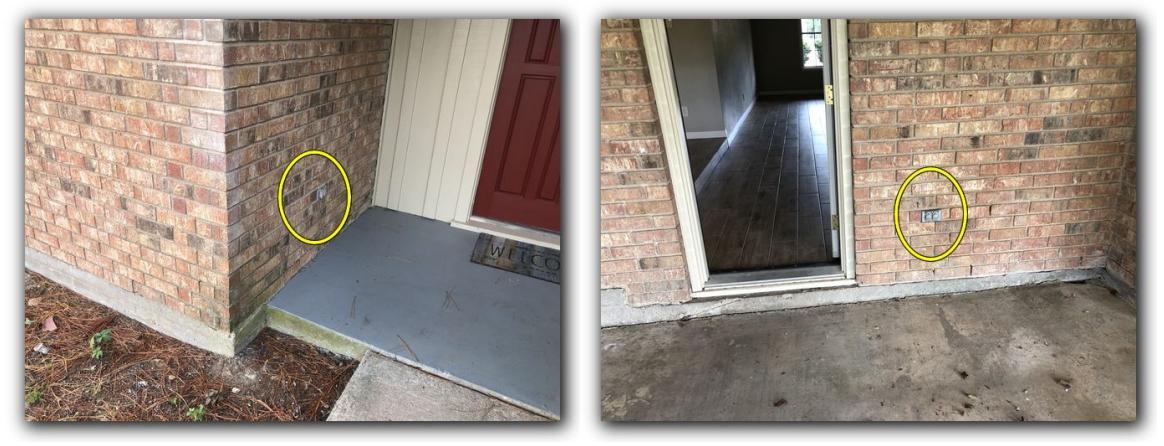
#### The receptacles on the exterior of the home are not GFCI protected.

For safety reasons the addition of GFCI protected outlets is recommended.

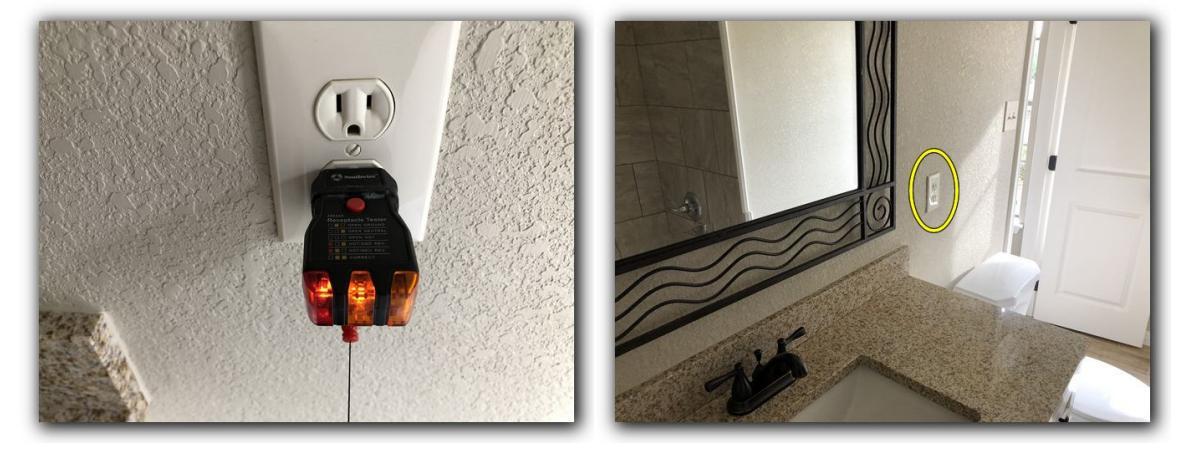
#### The hot and neutral wires were reversed on most of the outlets in the home.

These images are just an example there were many more throughout the home.

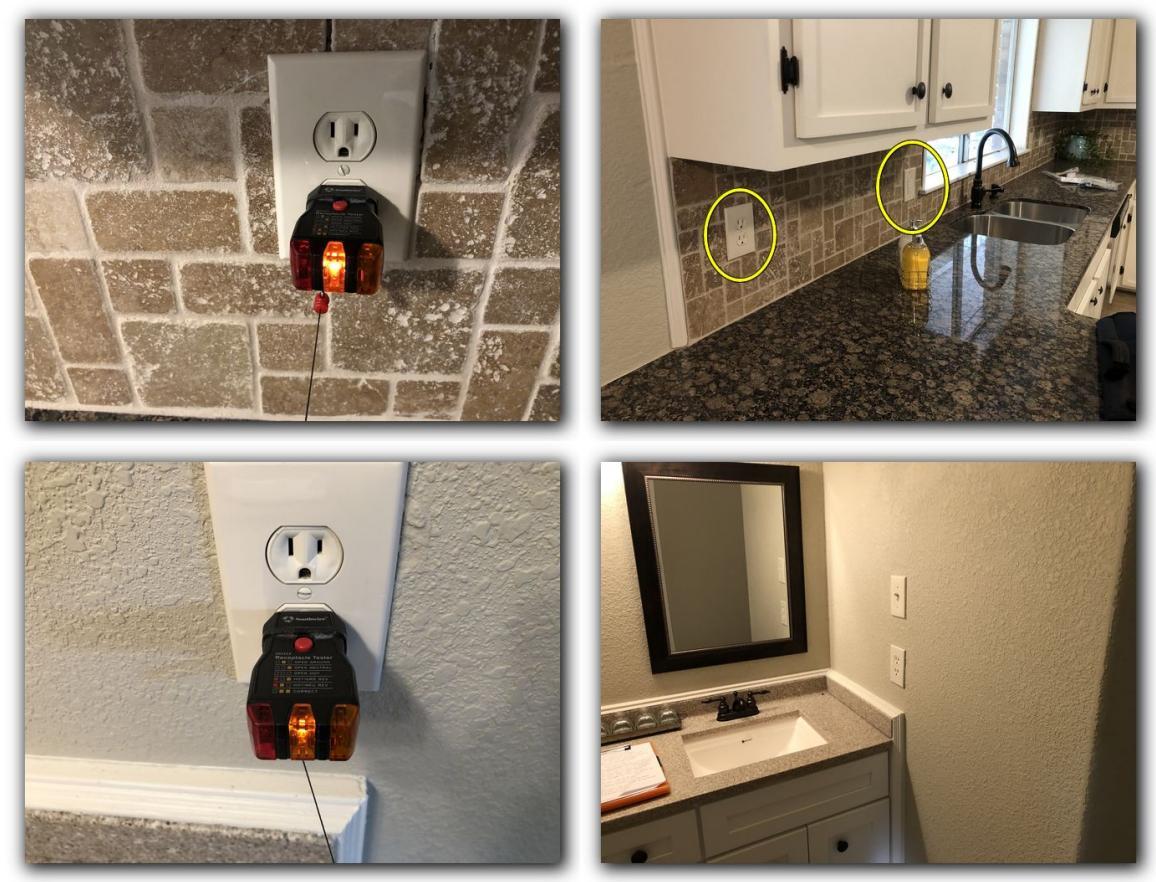
The receptacle in the the kitchen and the master bathroom indicated an open ground condition.

This condition will occur if there is no ground wire present or the ground wire has lost connection with the receptacle.

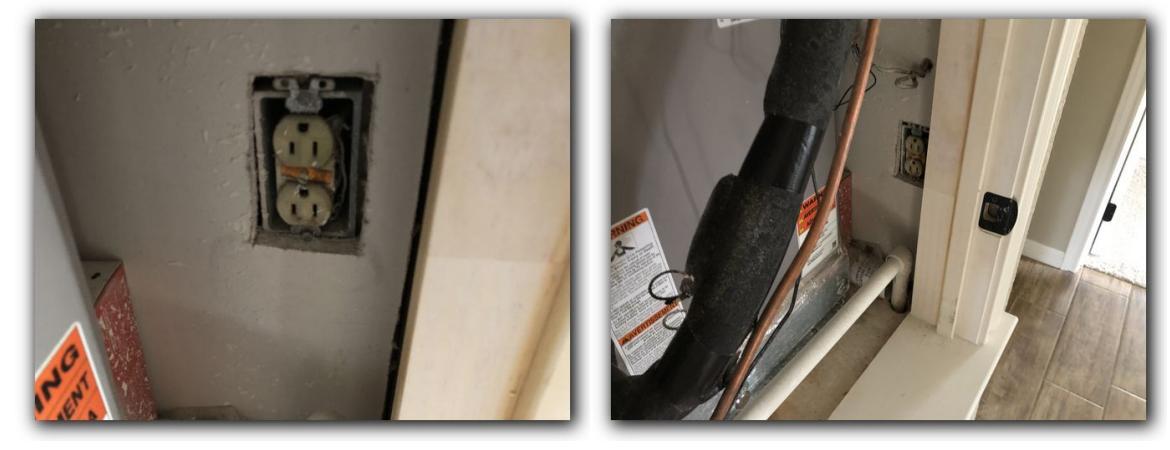
#### There was a missing outlet cover in the air handler closet.

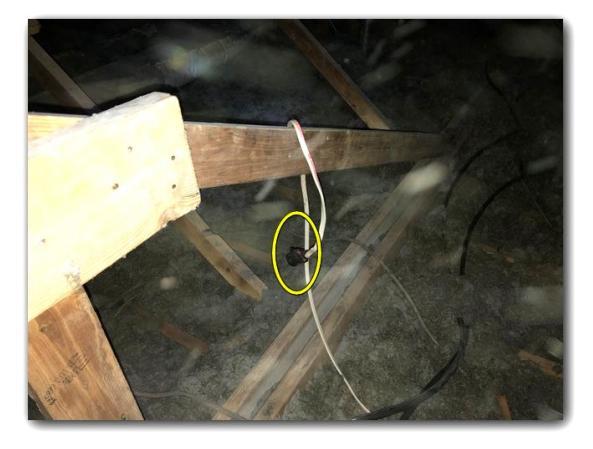
There was an exposed wire splice in the attic.

Exposed splices present a shock and fire hazard and should be placed in a covered junction box by a qualified electrician.

The issues discussed in this section should be further evaluated by a licensed electrician.

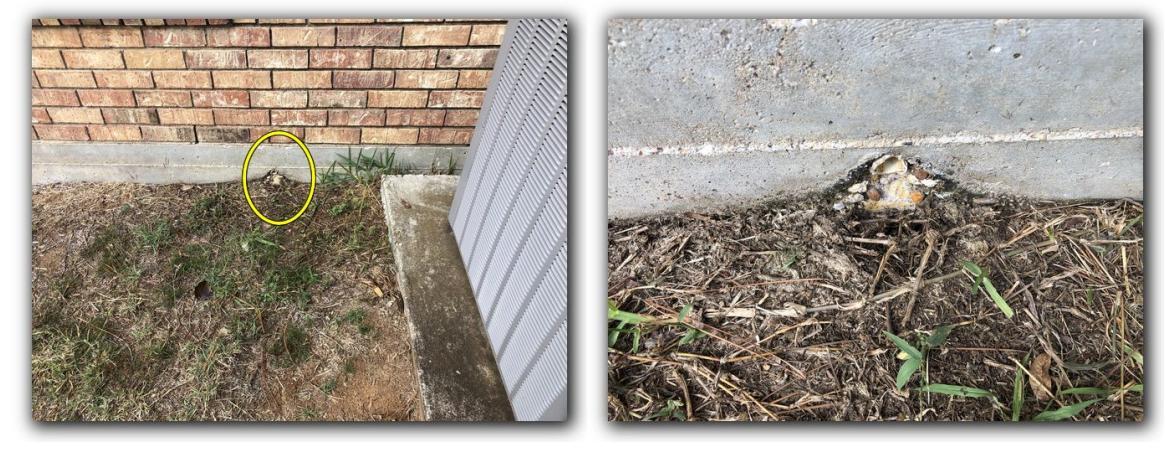
The primary condensation drain line was broken outside on the left side of the home.

This needs to be extended at least three feet away from the foundation or past the AC unit platform.

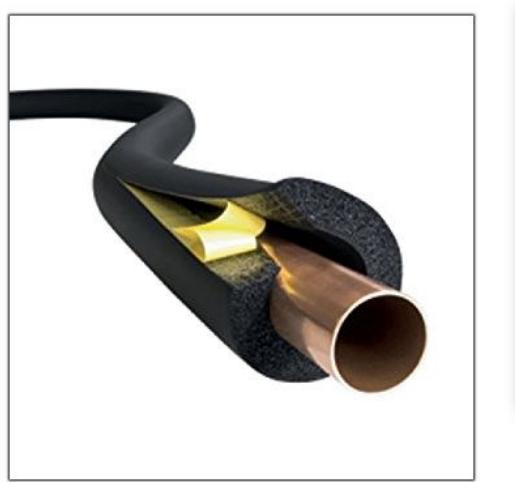
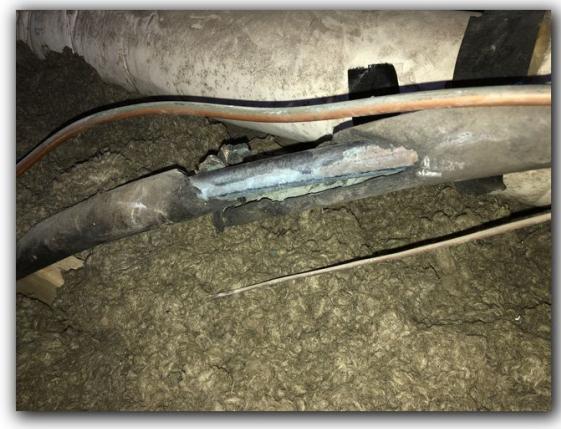
There was deterioration of the insulation on the suction line (the larger refrigerant line) in the attic.

The entire length of copper pipe should be insulated to prevent the refrigerant in the line from picking up additional heat. The warmer the refrigerant is, the harder the unit has to work. DIY pipe insulation will work just fine for this. This pipe will sweat in the attic and condensation could drip onto the ceiling.

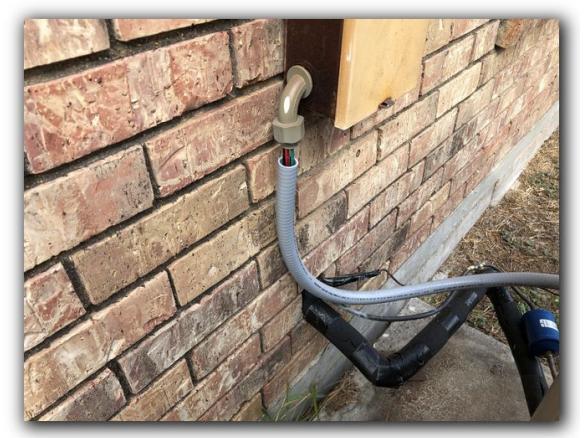
The conduit for the electrical wires is not properly attached to the electrical disconnect or clamped to the wall.

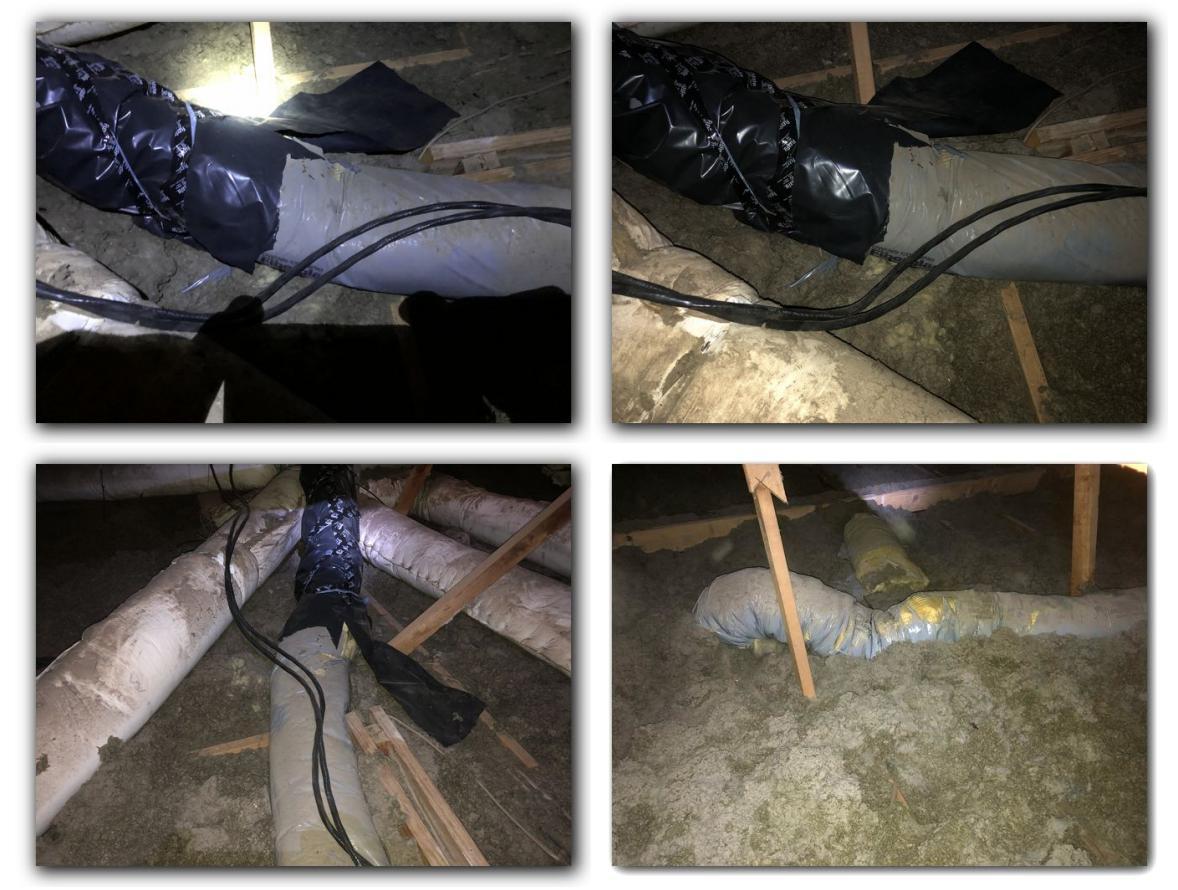
There was some torn insulation on some of the ductwork.

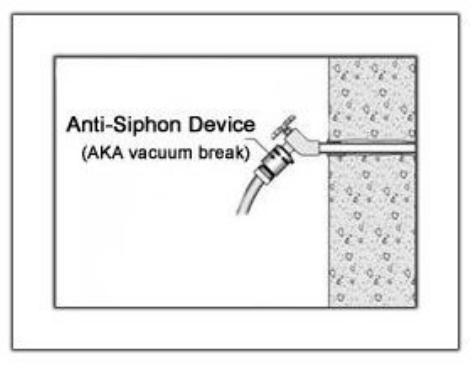
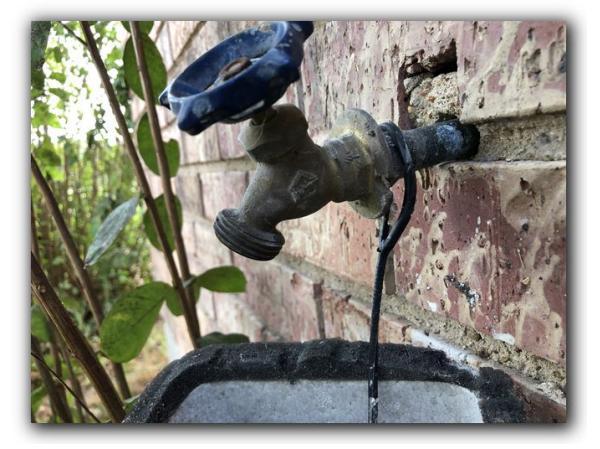
The water pressure measured 79 PSI the rear hose bib.

Normal water pressure is between 40 and 75 PSI and should not exceed 80 PSI.

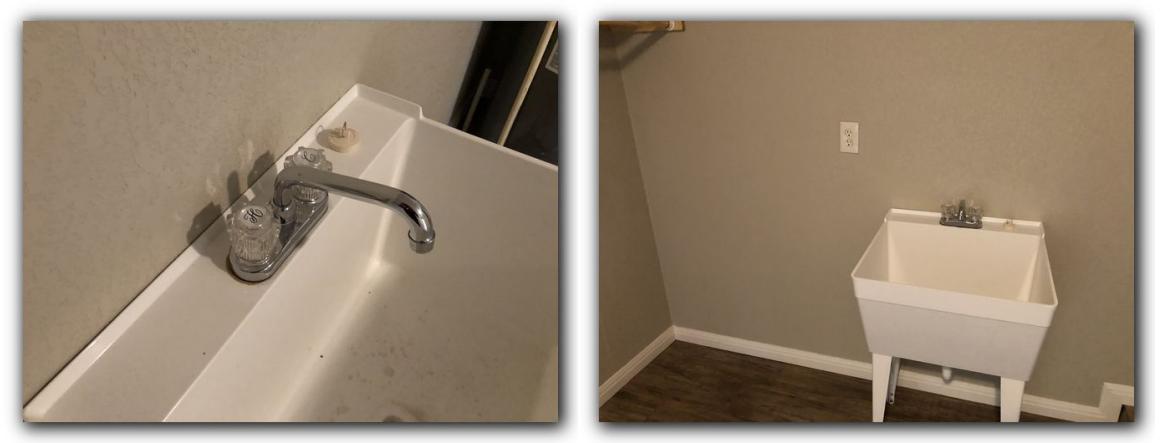
#### There was no water coming from the hot side of the sink in the utility room.

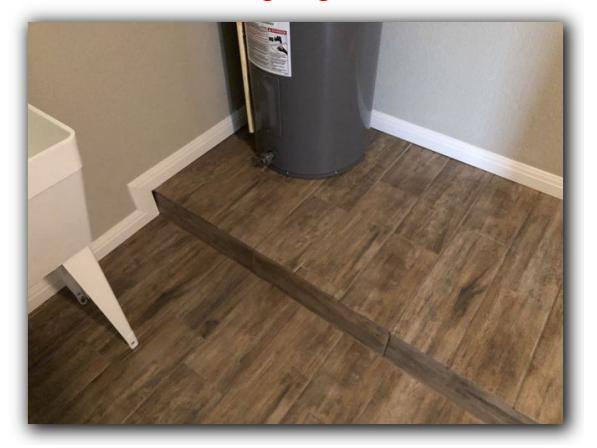
There was no drain pan present under the water heater.

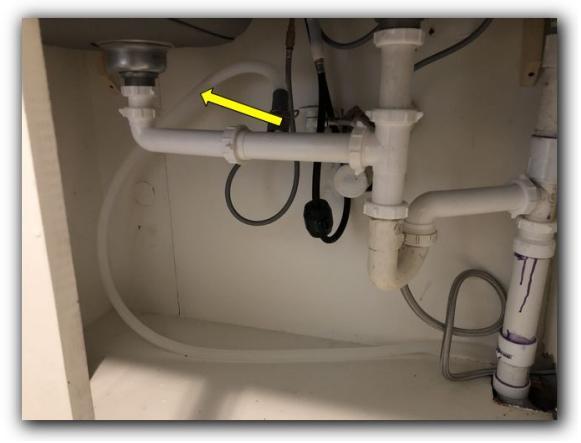
#### The drain line for the dishwasher was not properly configured.

The dishwasher drain line needs to be elevated so the drain line cannot be filled by backedup sink water.

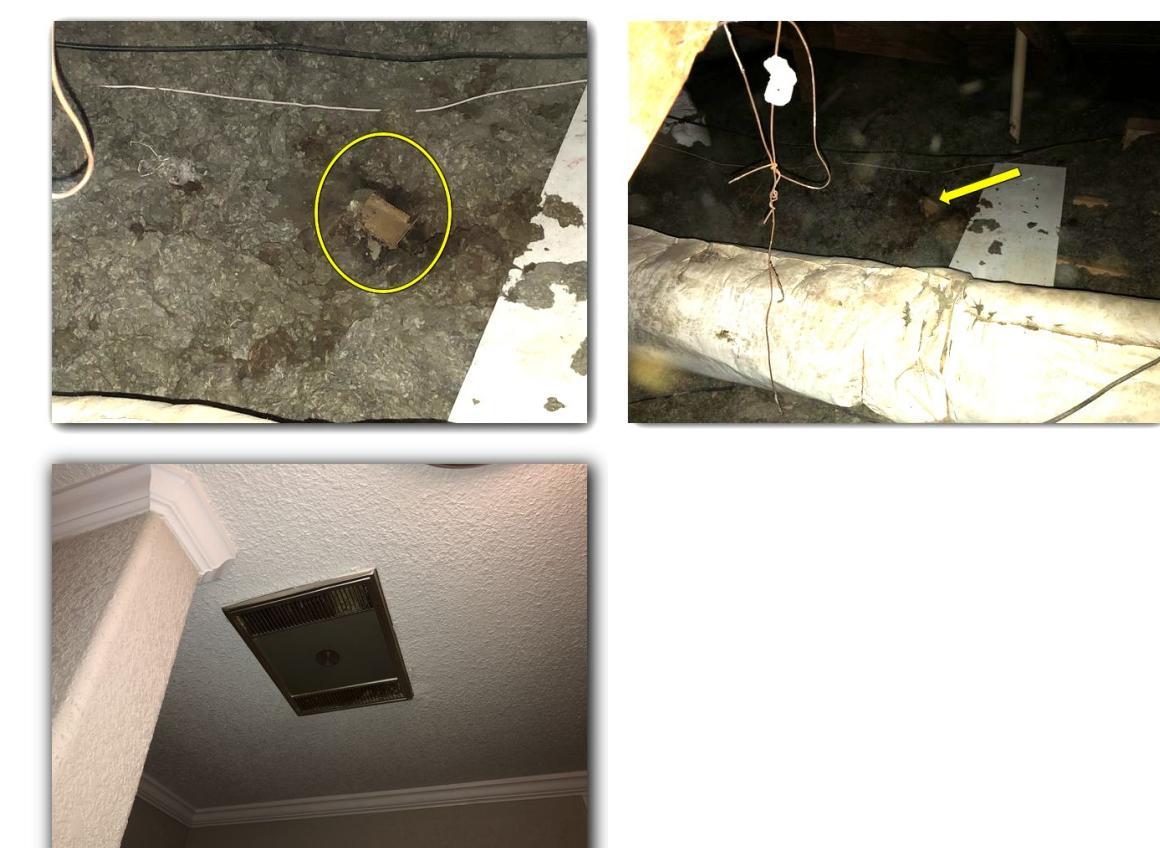
The master bathroom exhaust fan terminates in the attic.

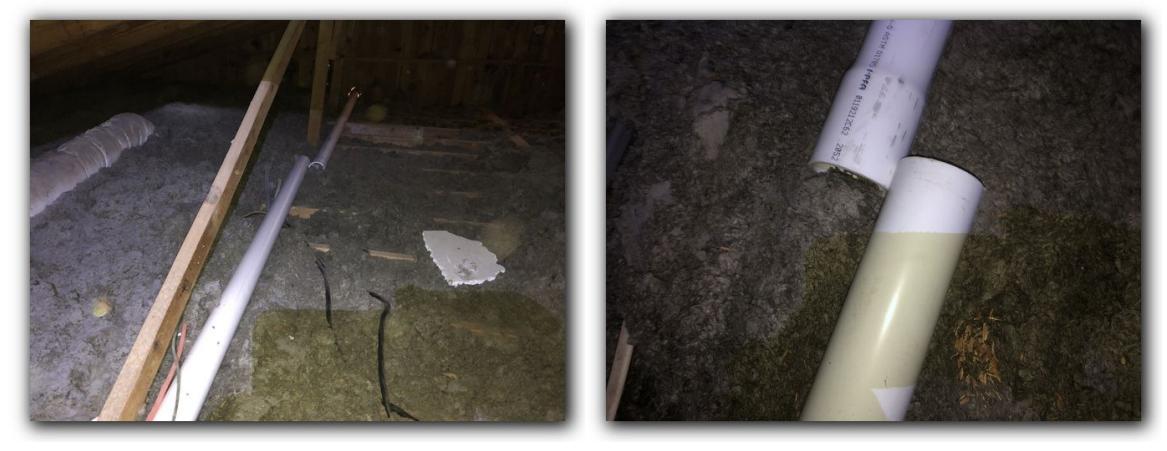
## The dryer vent is PVC.
