## PROPERTY INSPECTION REPORT

**Prepared For:** Howard Brobston  
(Name of Client)

**Concerning:** 1399 School Rd. Three Rivers, Texas  
(Address or Other Identification of Inspected Property)

**By:** Tim Westphal #2501 7/13/2016  
(Name and License Number of Inspector) (Date)

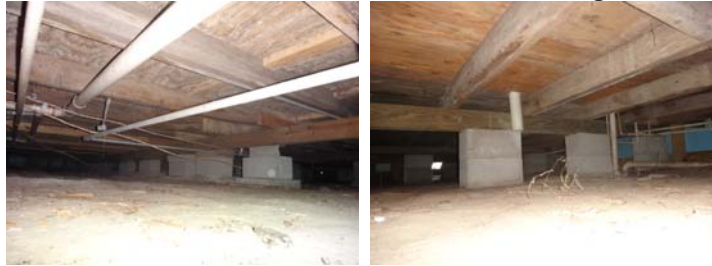
### A. Foundations

*Type of Foundation(s):* Pier and beam on blocks

*Comments:* Some past repairs were observed  
The foundation has movement but is minor for its age.

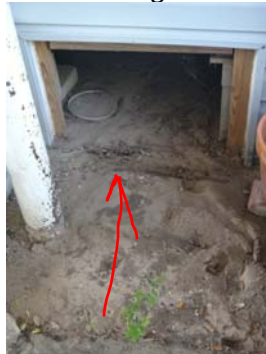
### B. Grading & Drainage *Comments:* Improvements to the drainage are needed to keep storm water from entering the crawlspace. Storm water in the crawlspace can cause settlement.

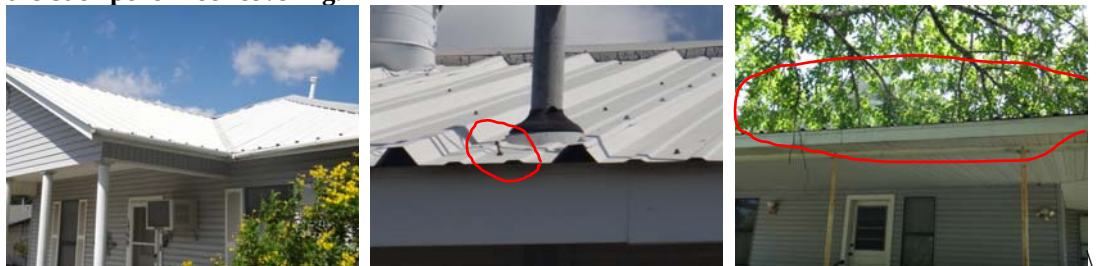
### C. Roof Covering Materials

*Type(s) of Roof Covering:* Metal Roofing Material

*Comments:* Loose screws should be tightened or replaced and tree limbs should be cut back from the back porch roof covering.

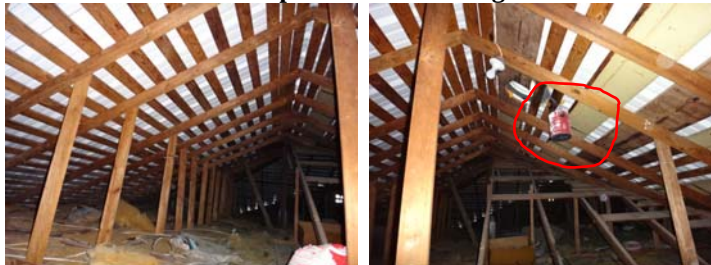
**D. Roof Structure & Attic**

*Comments: Evidence of possible roof leakage was observed at a turbine vent.*

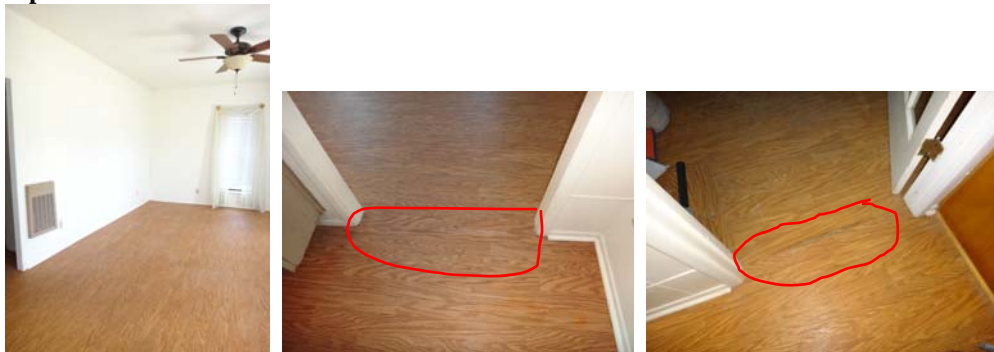
**F. Ceilings & Floors Comments: The ceilings are fair and the flooring has some seams that need repairs.**

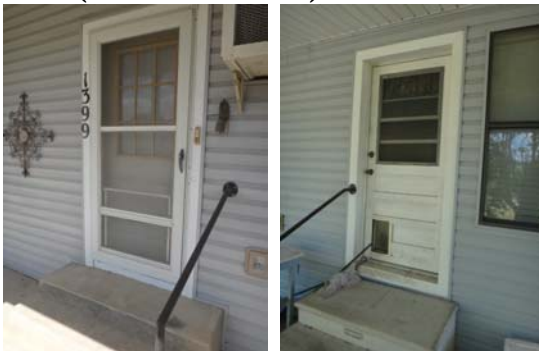
**G. Doors (Interior & Exterior)** *Comments: Minor adjustments are recommended*

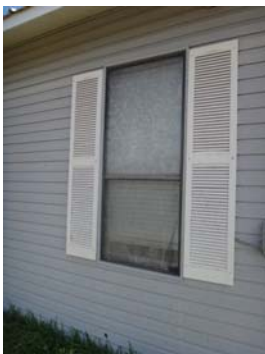
**H. Windows** *Comments: Replacement windows were observed. Screen damage is present.*

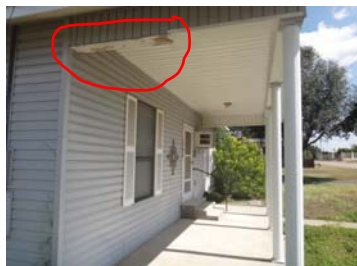
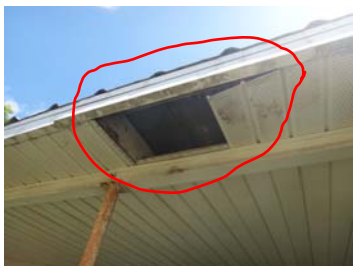
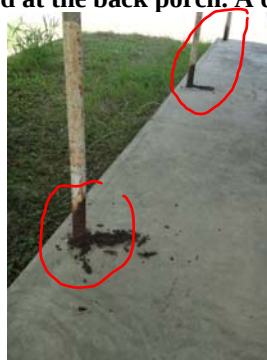
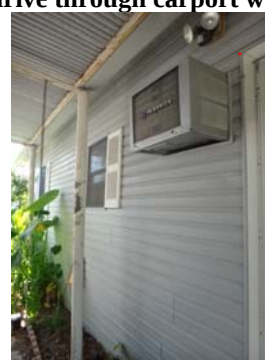
**K. Porches, Balconies, Decks, and Carports** *Comments: Trim damage at the front porch and soffit and column deterioration was observed at the back porch. A drive through carport was observed.*

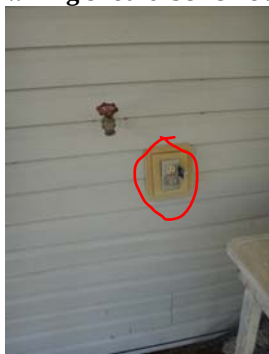
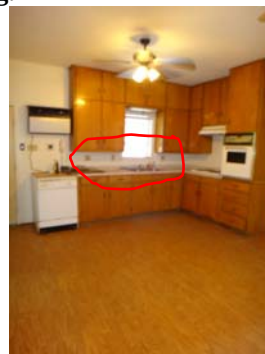
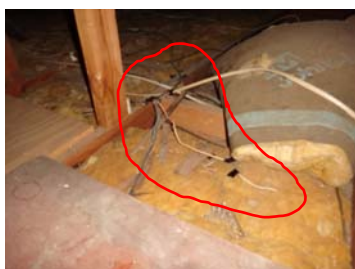
### B. Branch Circuits, Connected Devices, and Fixtures

*Type of Wiring:* Copper

*Comments:* Wet locations ground fault outlets shall be installed in the kitchen, bathrooms and the exterior. The wiring in the attic should be reviewed by a licensed Electrician as various wiring types were observed and some connections at without junction boxes and covers. Knob and tub wiring should be removed and replaced with new wiring.

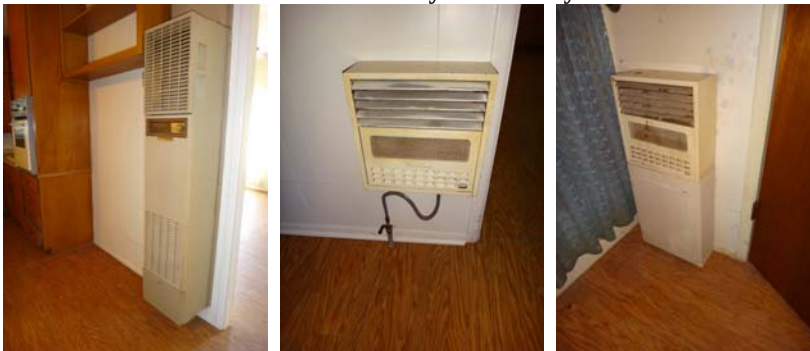
#### A. Heating Equipment

*Type of System:* **Wall furnace**

*Comments:* **These units should be fully serviced by a Technician for safe use.**

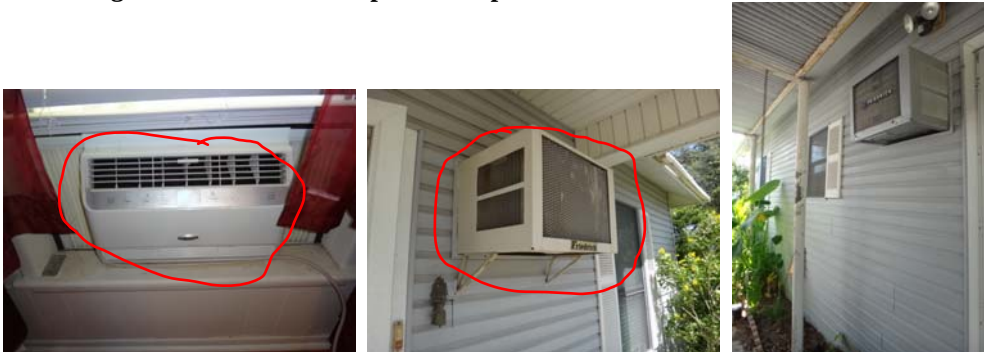
#### B. Cooling Equipment

*Type of System:* **Window Units**

*Comments:* **The small bedroom unit blower does not function and the living room unit has a smell of burning rubber when run. Repairs or replacement units are needed.**

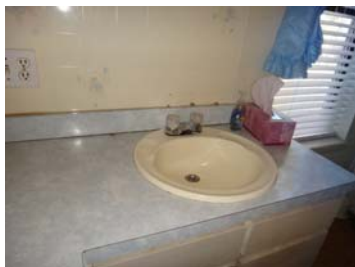
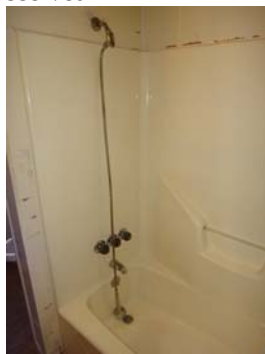
##### A. Water Supply System and Fixtures

*Comments: Older fixtures were observed*

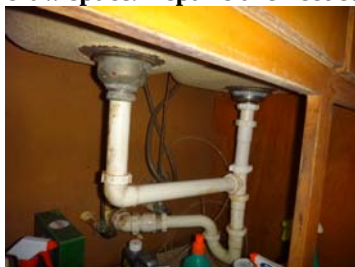
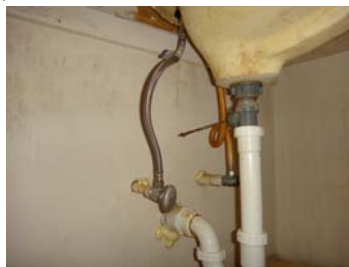
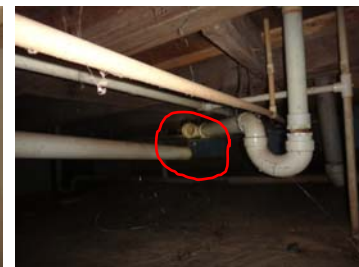
##### B. Drains, Wastes, and Vents *Comments: The bathtub drain piping has a separated drain pipe in the crawlspace. Repairs are needed.*

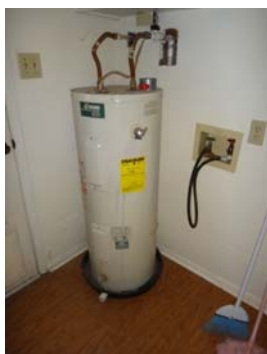
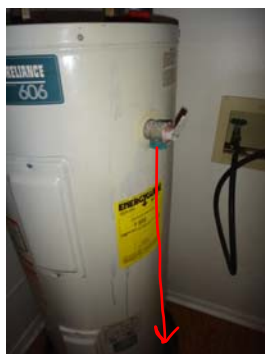
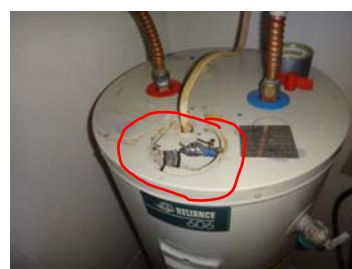
##### C. Water Heating Equipment

*Energy Source: Electricity- 2008 year model*

*Comments: A 3/4" T&P drain line should be installed and wiring connections should be completely in the junction box.*

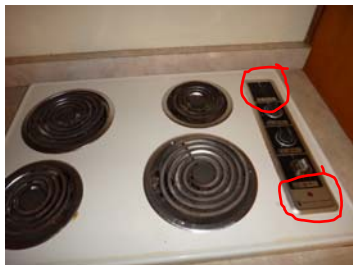
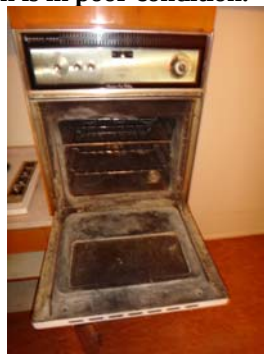
D. Ranges, Cook tops, and Ovens *Comments: A knob is missing at the back control. The indicator light does not function. The oven is in poor condition.*

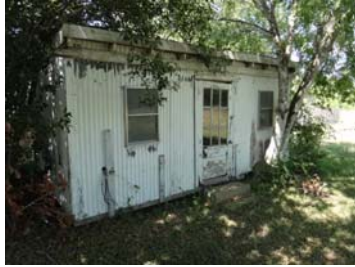
**C. Outbuildings** *Comments: This outbuilding is in poor condition.*
