## RESIDENTIAL INSPECTION

18220 Co Rd 4001

Mabank, TX 75147

# PROPERTY INSPECTION REPORT

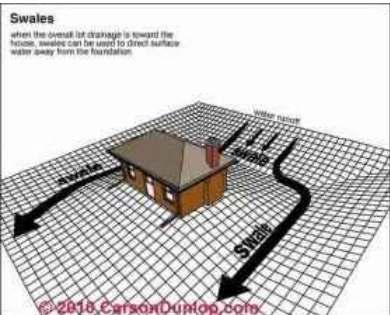
1: Gutters - Splash Blocks Should Be Added Under Downspouts

FYI, Minor Defects, Cosmetic

Splash blocks and extensions should be installed at each downspout termination to help Chanel water away from the foundation of this structure, and prevent erosion next to the foundation.

Recommendation: Recommended DIY Project

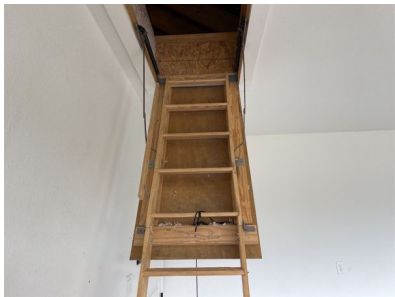
**2: Access- Attic ladder is not properly fire rated**

⚠Maintenance Recommendations, Items To Monitor, Further Evaluation Recommended

The stairway was not labeled as a fire-rated assembly. The Code addresses separation between the garage and attic, garage and dwelling and habitable areas and attic spaces, in terms of gypsum thickness, door thickness or 20-minute fire rated doors including attic stairs

Recommendation: Contact a qualified professional.

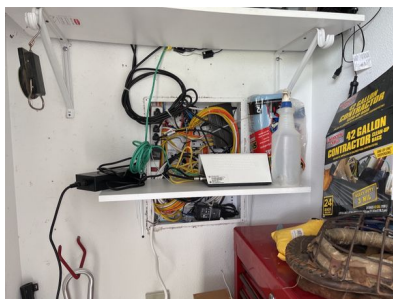
## 2: No cover over cable/communications box

⚠ Maintenance Recommendations, Items To Monitor, Further Evaluation Recommended

No cover over cable/communications box In garage closet. This is technically considered a breach of fire wall protection.

Recommendation: Contact a qualified professional.

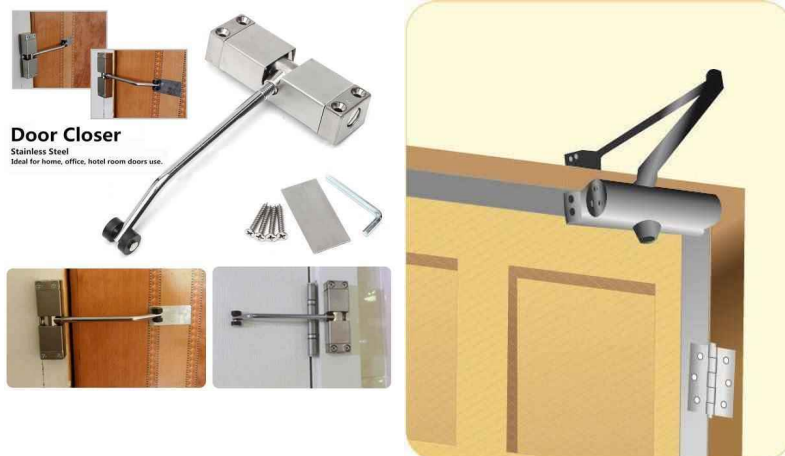
The door between the garage and the interior of the house (garage entry door) should be equipped with an [auto-closer](#) device to prevent automobile fumes from entering the house. This is a good upgrade. However the installations requirements are dependent of authorities having jurisdiction. This device is not a commonly found in our area of the state.

Recommendation: Contact a handyman or DIY project

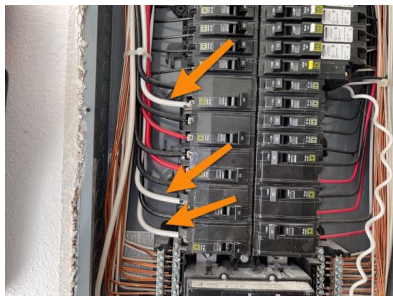
#### 1: Neutral (white) used as hot wires need reidentification

⚠Maintenance Recommendations, Items To Monitor, Further Evaluation Recommended

This is a "newer" requirement however it is a good safety upgrade that should be considered.

Recommendation: Contact a qualified professional.

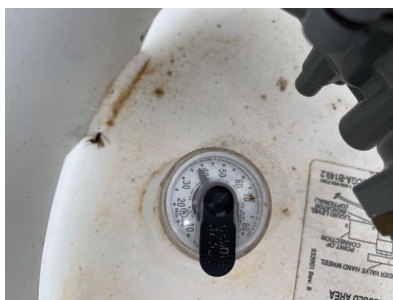
#### 1: No visible bonding or grounding wires on gas system

⚠ Maintenance Recommendations, Items To Monitor, Further Evaluation Recommended

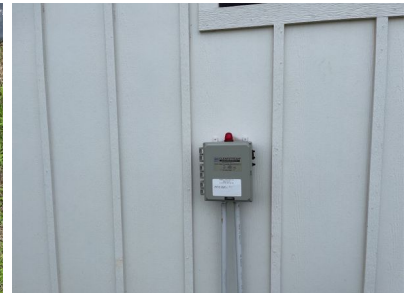
**1: Recommend pumping septic tank**

⚠ Maintenance Recommendations, Items To Monitor, Further Evaluation Recommended
