# Pacific Crest Property Inspections

## SUMMARY REPORT

**Client:** Kyle Latimer  
**Realtor:** Paige Cochrane, Oregon Farm and Home  
**Inspection Address:** 2895 Stoltz Hill Rd, Lebanon, Oregon  
**Inspection Date:** 1/31/2023 Start: 2:00 pm  
**Inspected by:** Bob Byrd

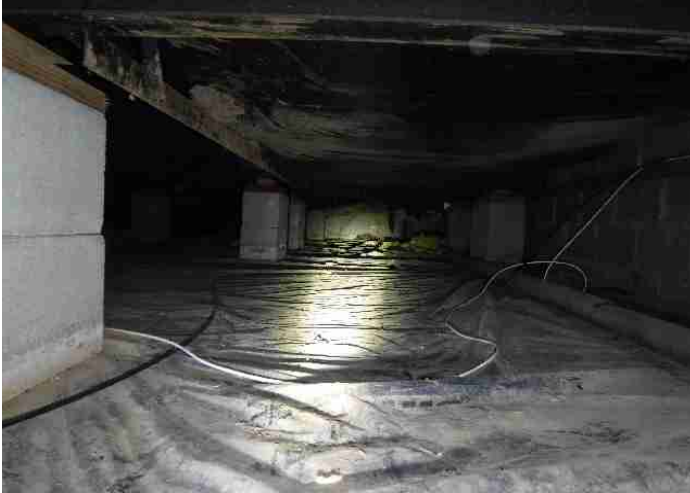
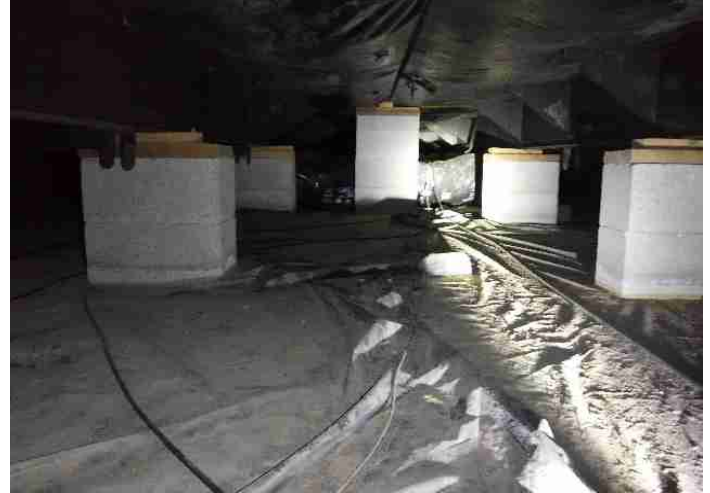
The accessible areas of crawlspace are in acceptable condition.

The crawlspace is accessible and in acceptable condition - *Continued*

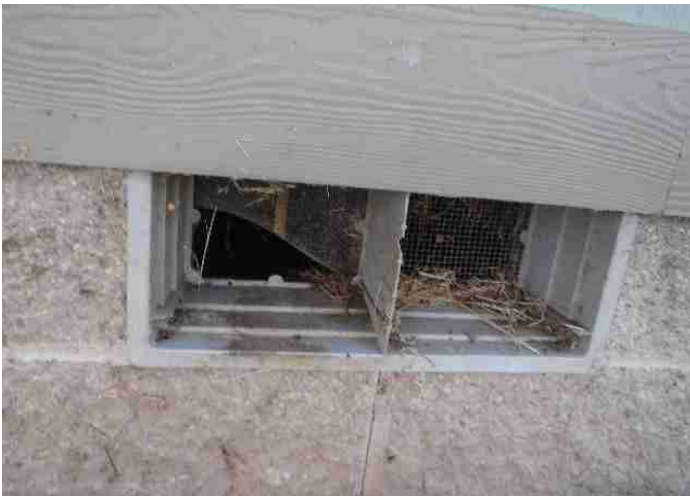
A foundation vent screen at the north side is damaged/missing which should be repaired (screened) to prevent rodents, cats and other small pests from entering the crawlspace.

- 1.2 - A foundation vent screen at the north side is damaged/missing which should be repaired (screened) to prevent rodents, cats and other small pests from entering the crawlspace.

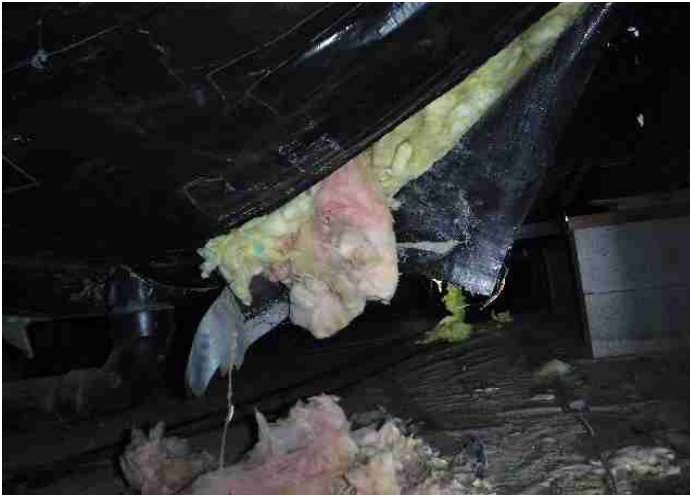
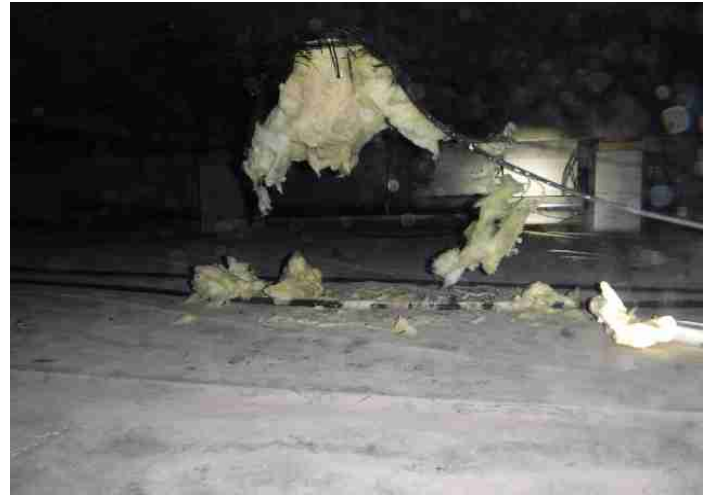
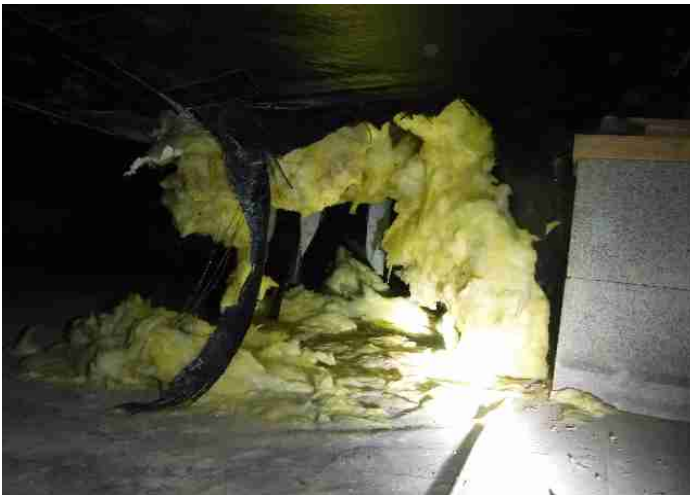
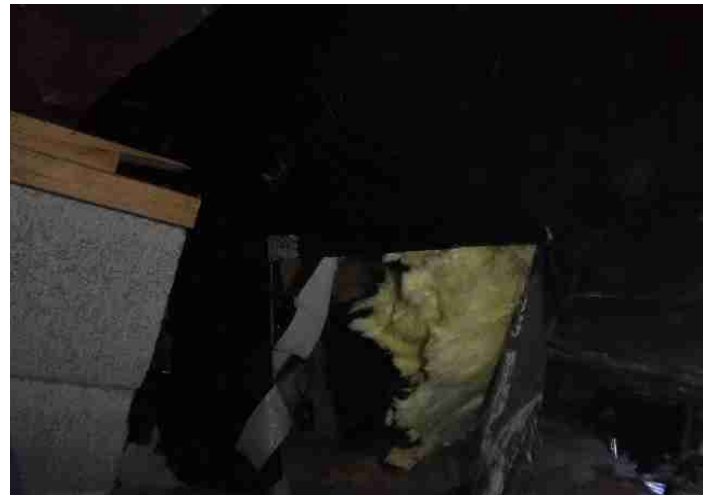
Several sections of the floor barrier/insulation are hanging from the floor area within the crawlspace which should be repaired/replaced to prevent energy loss/freeze damage

**Sections of the floor barrier are detached damaged - Continued**

- 1.3 - Several sections of the floor barrier/insulation are hanging from the floor area within the crawlspace which should be repaired/replaced to prevent energy loss/freezing damage

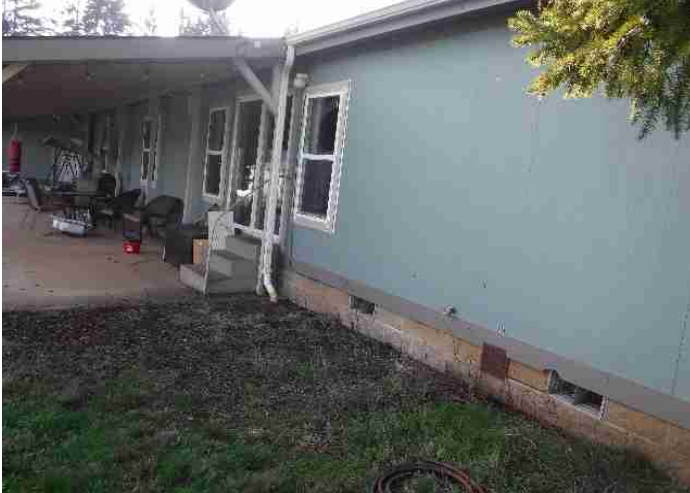
The house walls are finished with cement fiber board panel siding. (Hardi -Plank type)

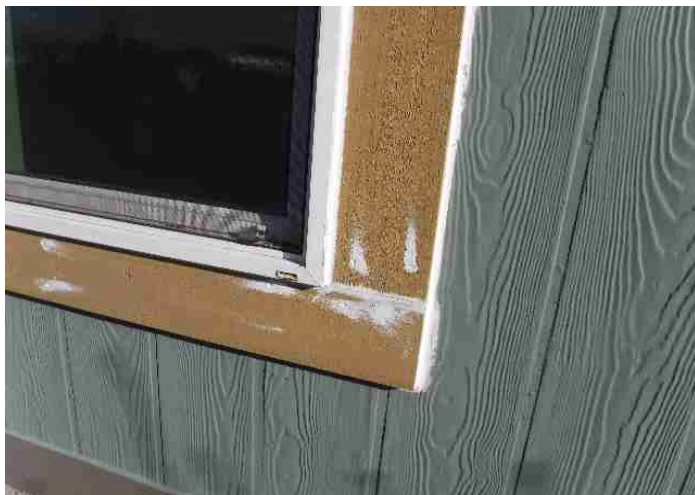
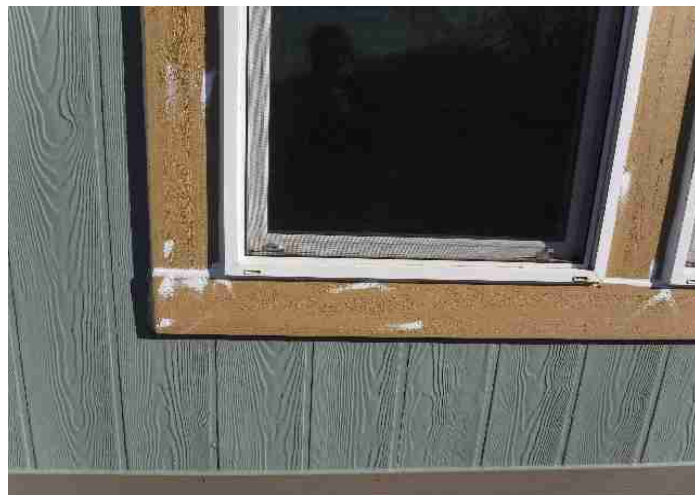
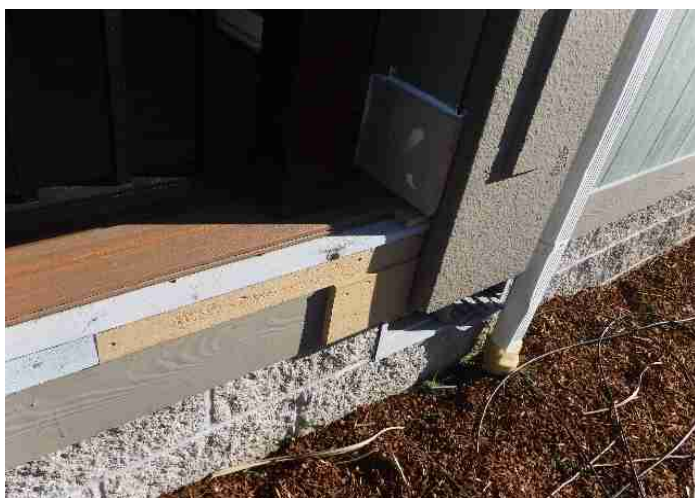
Sections of the exterior trim paint were not finished or needed touch up at the time of inspection

Sections of the exterior trim and siding paint were not finished or needed touch up at the time of inspection - *Continued*

- 2.1 - Sections of the exterior trim paint were not finished or needed touch up at the time of inspection

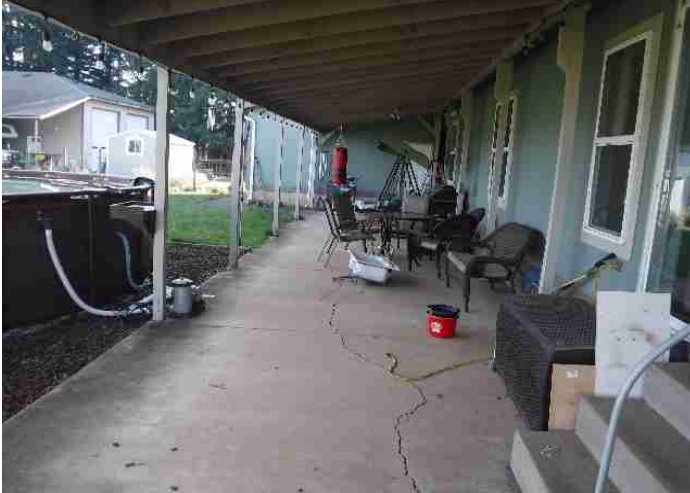
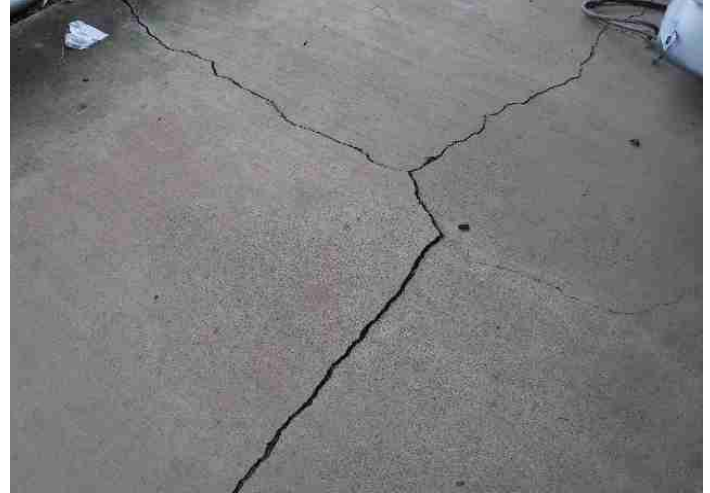
There are stress cracks and movement in the concrete patio that typically result from expansive soils, the absence of expansion joints, root movement, or an improperly packed base, and we are not able to determine what caused the movement, however you should have this repaired/replaced.

There are stress fractures in the patio that have resulted from movement - *Continued*

- 2.2 - There are stress cracks and movement in the concrete patio that typically result from expansive soils, the absence of expansion joints, root movement, or an improperly packed base, and we are not able to determine what caused the movement, however you should have this repaired/replaced.

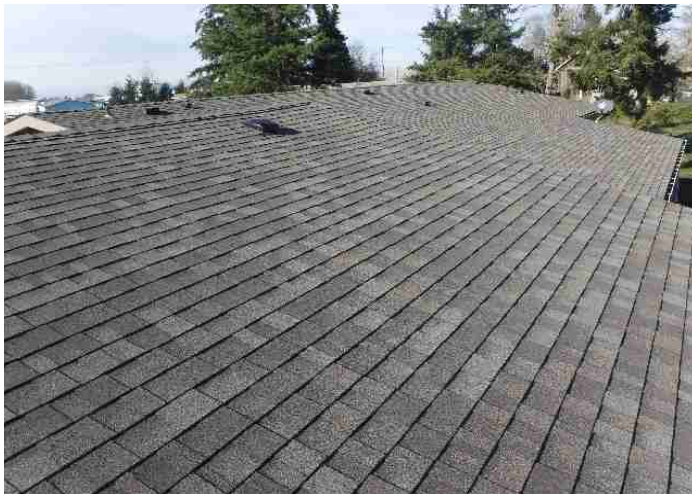
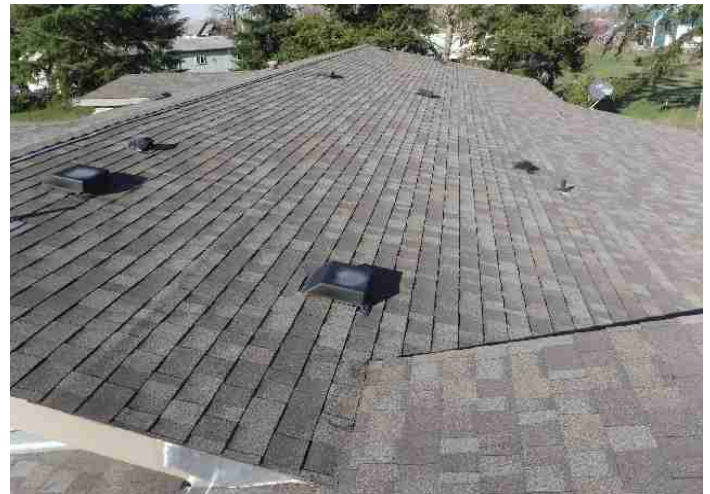
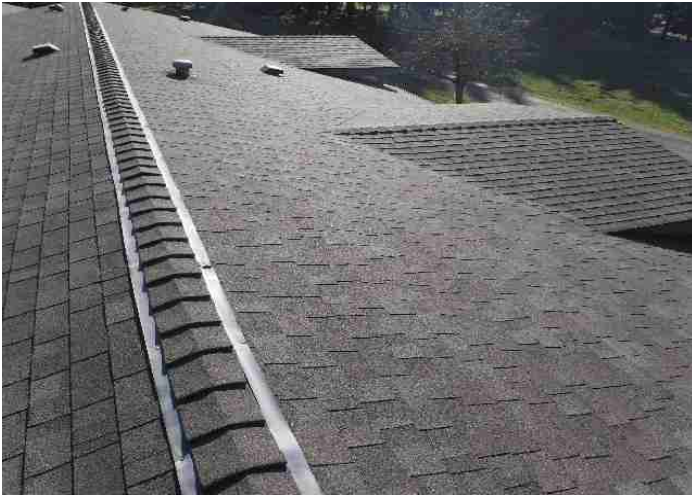
The roofing is in acceptable condition, with no visible leaks noted at the time of inspection, but this is not a guarantee against leaks. For a guarantee, you would need to have a roofing company issue a roof certification.

The roof is in acceptable condition but this is not a guarantee against leaks - *Continued*

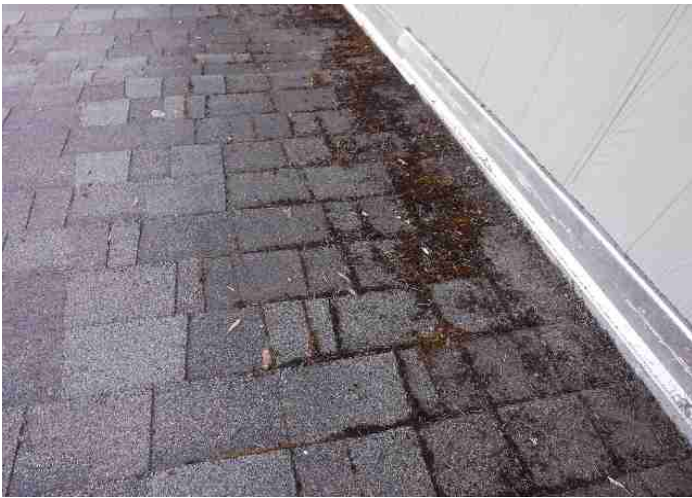
There is moss on the roof which should be removed to prevent the shingles from deteriorating prematurely. We recommend chemically treating the moss as part of routine maintenance which will prolong the life of the roofing materials.

3.1 - There is moss on the roof which should be removed to prevent the shingles from deteriorating prematurely. We recommend chemically treating the moss as part of routine maintenance which will prolong the life of the roofing materials.

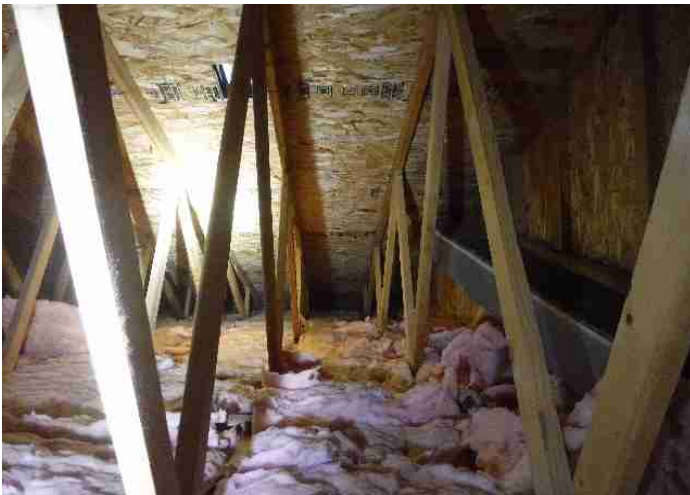
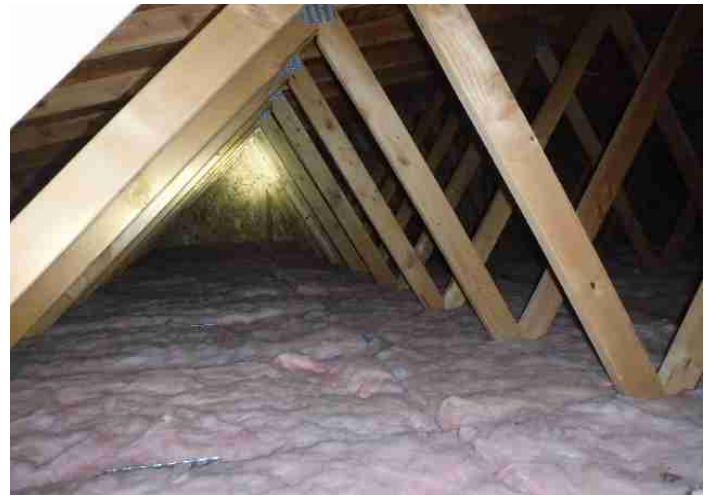
The roof framing consists of a truss system, comprised of components called chords, webs, and struts that are connected by wood or metal gussets nailed or glued in place. Each component of the truss is designed for a specific purpose, and cannot be removed or modified without compromising the integrity of the entire truss. The lowest component, which is called the chord and to which the ceiling is attached, can move by thermal expansion and contraction and cause creaking sounds, which are more pronounced in the mornings and evenings along with temperature changes. Such movement has no structural significance, but can result in small cracks or divots in the drywall or plaster.

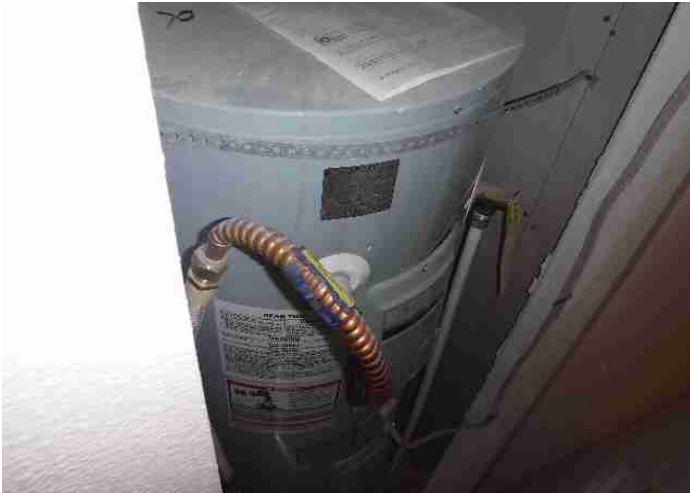
Hot water is provided by a 25 year old, 50 gallon water heater that is located in a bedroom closet

The water heater is functional but beyond its warranty period and should be monitored for leaks.

The water heater is not equipped with a drip pan or overflow pipe, which is recommended, and which is designed to prevent or minimize water damage from a leak.

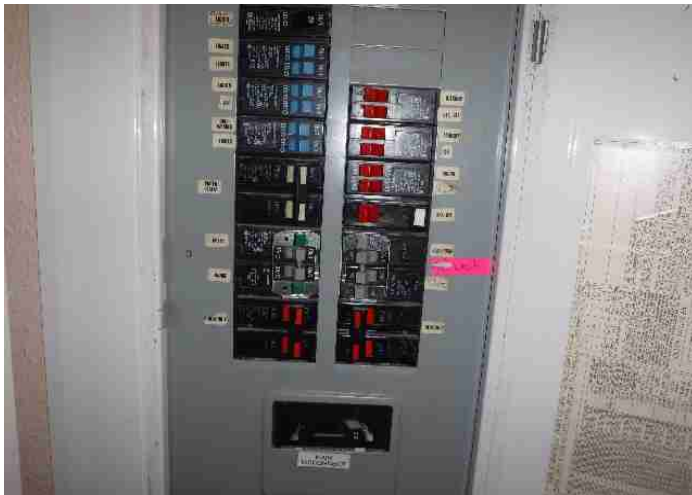
The residence is serviced by a 200 amp panel located in the laundry area

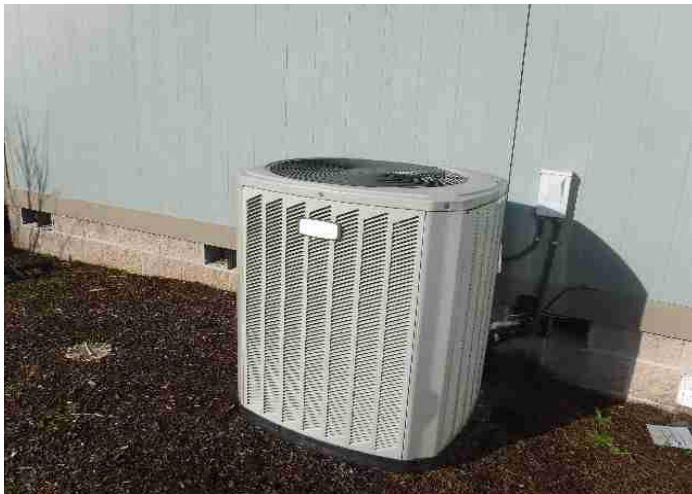
Central heat and air-conditioning are provided by an 11 year old heat pump located in the front yard, with a 4 year old furnace/air-handler located in the laundry area

The heating system was functional, however we did not test the air-conditioning system because the ambient temperature was too low at the time of inspection, and testing it when the temperature is below 60 degrees could damage the coil. You should have the cooling side evaluated by a licensed HVAC technician when the weather permits.

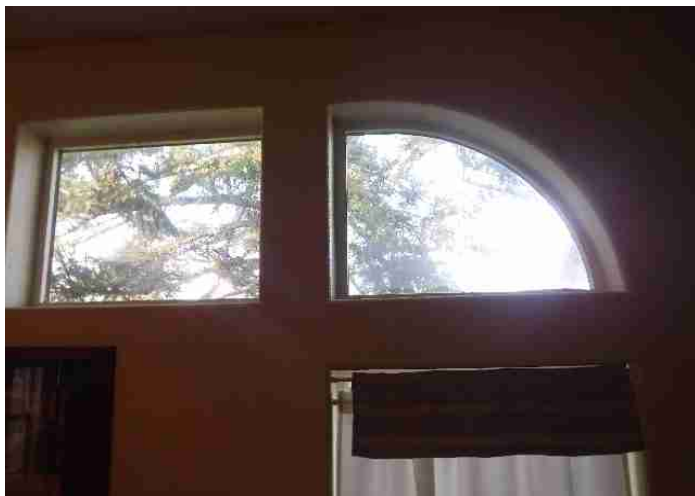
A window has a broken hermetic seal, and should be evaluated for replacement. This is evident from fogging, or condensation forming between the panes of glass, that confirms that the seal has failed.

11.1 - A window has a broken hermetic seal, and should be evaluated for replacement. This is evident from fogging, or condensation forming between the panes of glass, that confirms that the seal has failed.

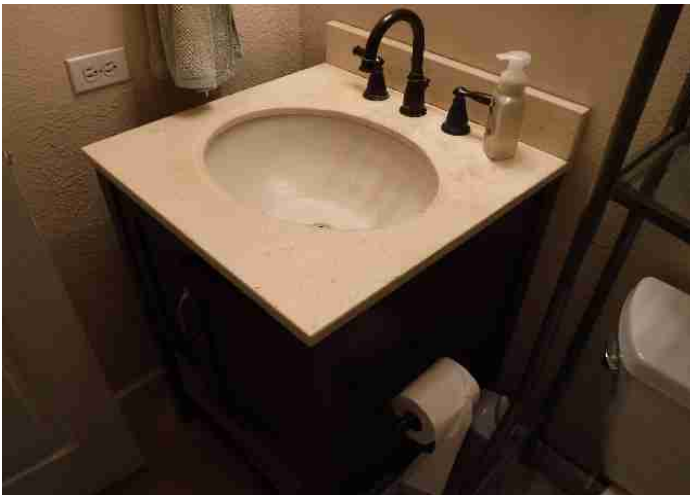
The sink cabinet is not properly attached to the wall and should be serviced.

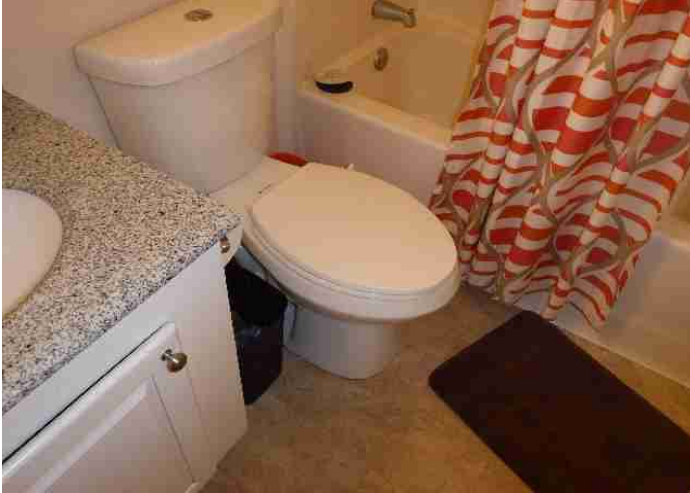
The toilet is loose, and should be re-secured and caulked at the base.

The toilet is loose and should be secured - *Continued*

12.2 - The toilet is loose, and should be re-secured and caulked at the base.

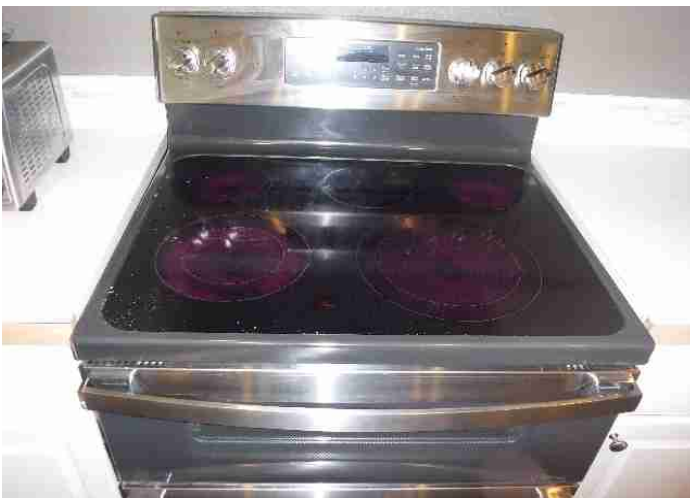
The electric range is functional, but was neither calibrated nor tested for its performance.

13.1 - The range is not equipped with an anti-tip device, which prevents the range from tipping, or its contents from spilling, should a child attempt to climb on it or its open door. This is a recommended safety feature that should be installed, and particularly if small children occupy or visit the residence.

The range is not equipped with an anti-tip device, which prevents the range from tipping, or its contents from spilling, should a child attempt to climb on it or its open door. This is a recommended safety feature that should be installed, and particularly if small children occupy or visit the residence.

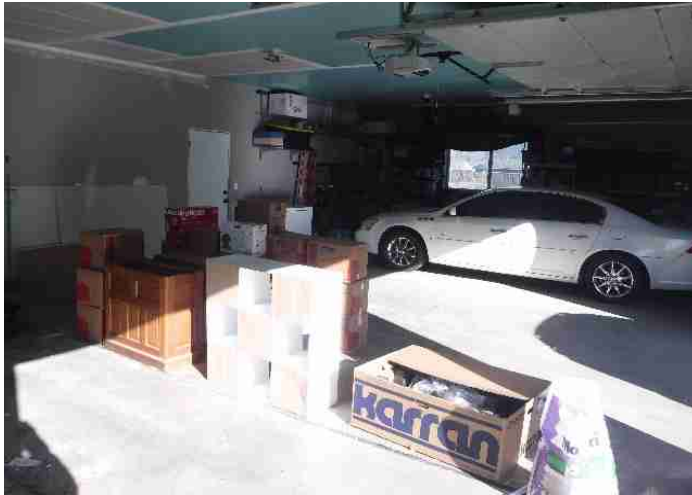
The slab floor is in acceptable condition. Small cracks are common and result as a consequence of the curing process, seismic activity, common settling, or the presence expansive soils, but are not structurally threatening. Also, you may notice some salt crystal formations that are activated by moisture penetrating the slab.

The slab floor is in acceptable condition - *Continued*

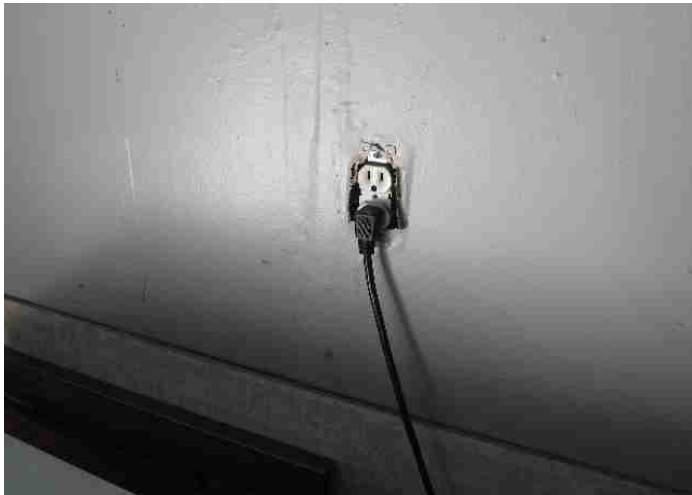
**An outlet cover is missing and should be replaced.**

17.2 - An outlet cover is missing and should be replaced.
