LONE STAR INSPECTIONS REPORT

1012 McCartney Dr
Kingsland, TX 78639

PROPERTY INSPECTION REPORT FORM

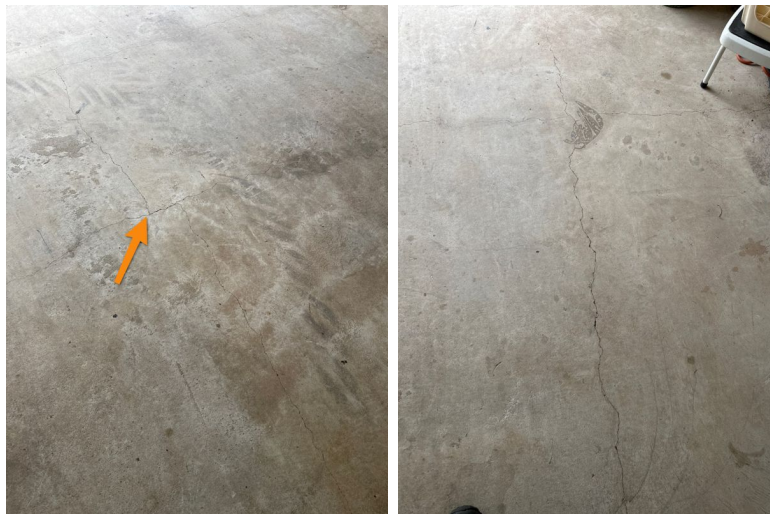
2: Evidence of shrinkage cracks found throughout the concrete slab**Deficiencies**

Please monitor all shrinkage cracks found throughout the concrete slab foundation. Shrinkage cracks occur over the years and throughout the concrete curing process. A general rule of thumb is if you can stick a nickel or a quarter in the crack then you should consult with a structural engineer! If you cannot stick a nickel or a quarter in the crack and they just appear as hairline surface cracks that is exactly what they are, they are not through and through the concrete and do not generally represent a significant foundation problem. Please be advised shrinkage cracks within the concrete foundations actually occur on almost every foundation this is the result of the curing process over the years of the concrete drying process and settling! With a newly poured concrete foundation, shrinkage cracks can occur because of the consistency of the mix, whether related, for example, too hot or too cold during the curing process including the moisture consistency throughout the pour process!

Recommendation: Contact a qualified professional.

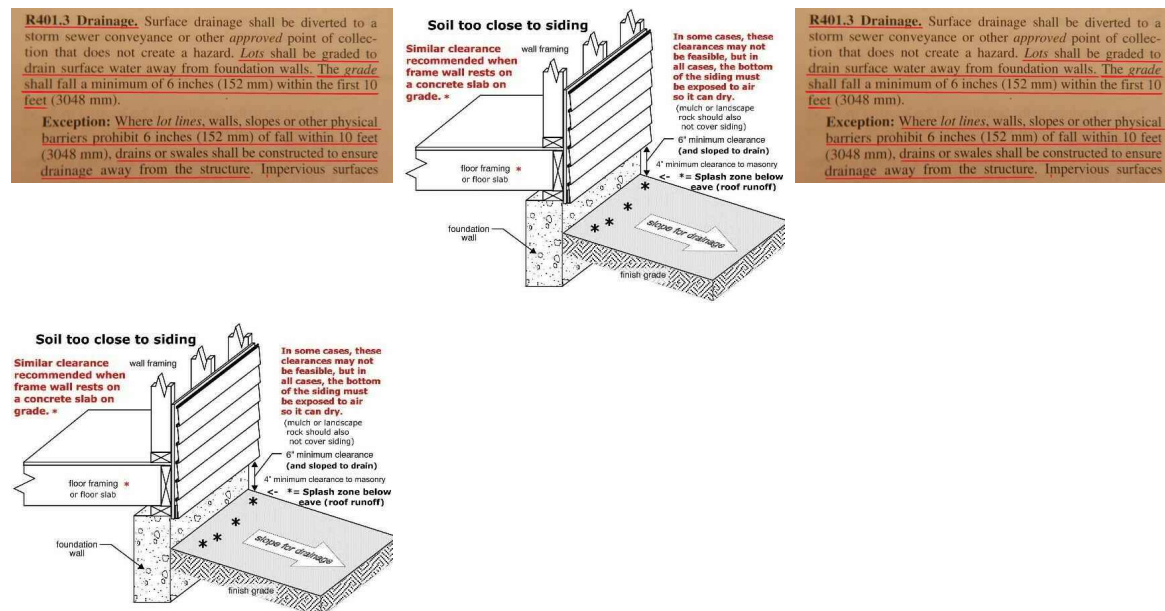
1: Inadequate drainage slope away from the foundation was observed in one or more locations

The lot does not appear to slope away at a 2% grade or drop 6" over 10' as required on all four sides, this may lead to foundation distress. Consider the benefit of rain gutters to control the rain run-off from the roof. The conditions above may contribute to future structural settling/movement if not improved

Recommendation: Contact a qualified professional.

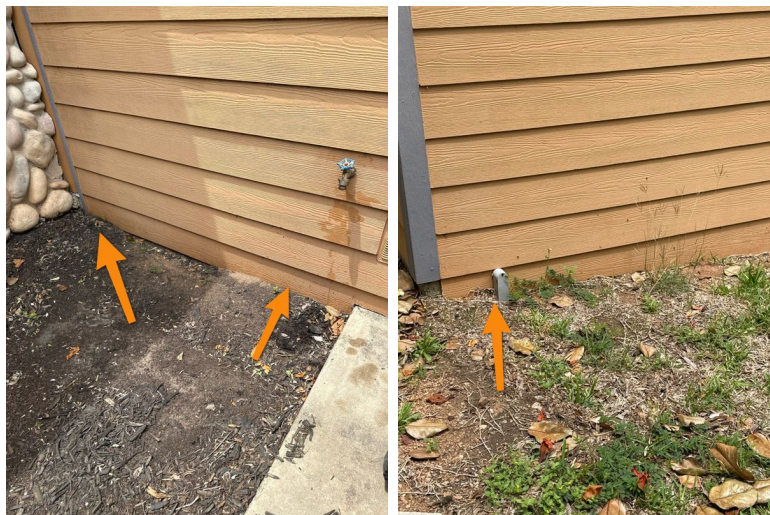
All siding materials should be a minimum of 4-6 inches from the soil or grade.

Recommendation: Contact a qualified professional.

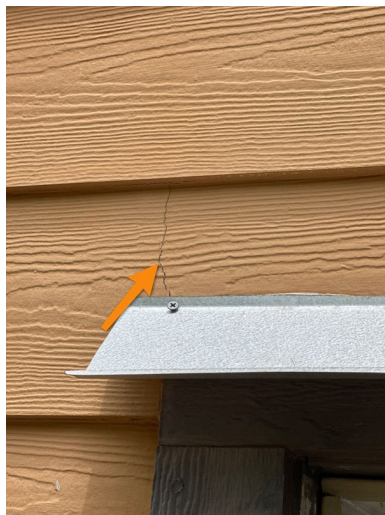
Right rear corner above the back door

3: Damaged/loose siding observed in one or more areas

Recommendation: Contact a qualified professional.

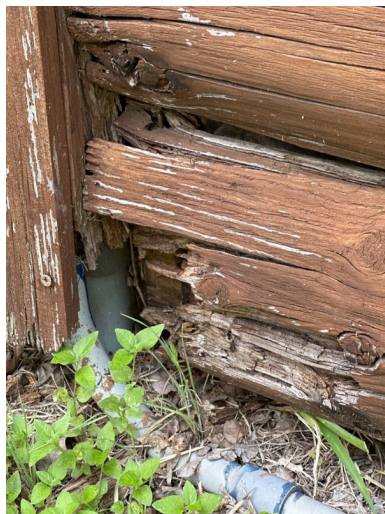
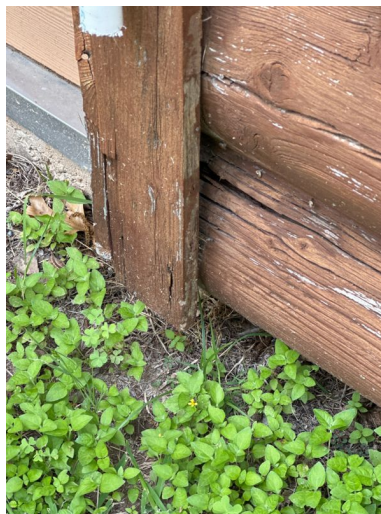
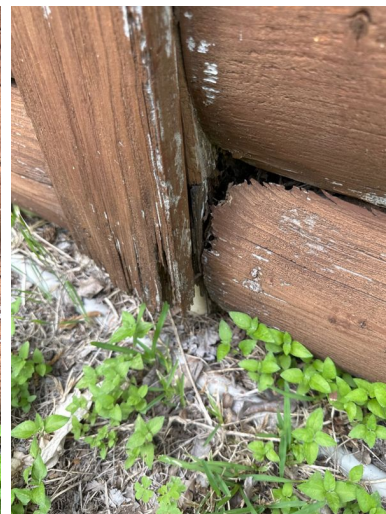
Left rear corner

4: Exterior wood rot on siding and trim

Evidence of wood rot including damaged siding materials and wood trim noted. Therefore these areas will need to be repaired or replaced at some point. Please be advised photographs found in this report are only examples and random samples around the structure and do not represent every single deficiency. Please be advised I observed wood rot in one or more locations around the exterior perimeter of the structure.

Recommendation: Contact a qualified professional.

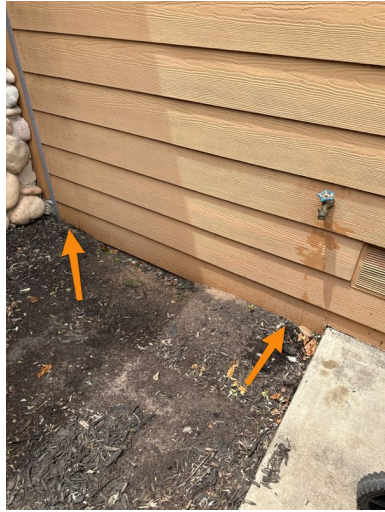
5: Exterior wall sill/sole plate in contact with grade

Warning please be advised the sill/sole plate should not be in contact with the grade. Technically It should be a minimum of 4 to 6 inches above grade attached and secured to concrete slab foundation. This is to prevent water penetration from flooding, wood rot and wood destroying insects such as termites.

Recommendation: Contact your builder.

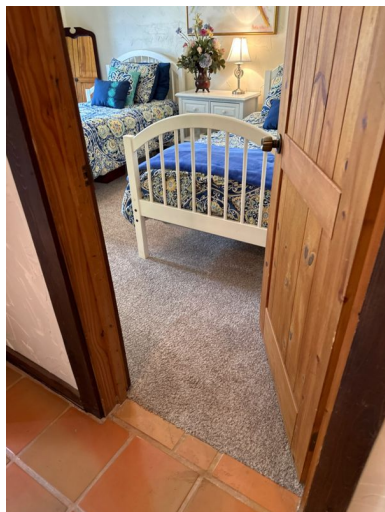
1: Multiple doors are out of alignment, not closing & latching properly, and or damaged.

Striker plate needs adjustment, doors not latching properly or Deadbolt does not operate smoothly on one or more doors throughout. Repairs and adjustments needed. Door frames, possibly out of square.

bedroom door does not latch

Recommendation: Contact a qualified handyman.

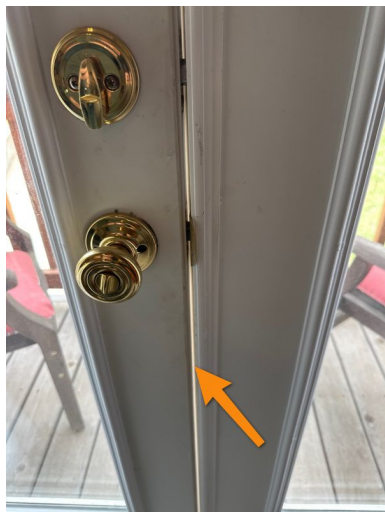
2: Weather Stripping / top and bottom seal is damaged and or missing at exterior doors.

[Here is a DIY guide on weatherstripping.](#) Weather stripping, gaskets or other air barrier repairs and replacement needed on one or more exterior doors.

Daylight between the French doors
right front second level bedroom

Recommendation: Recommended DIY Project

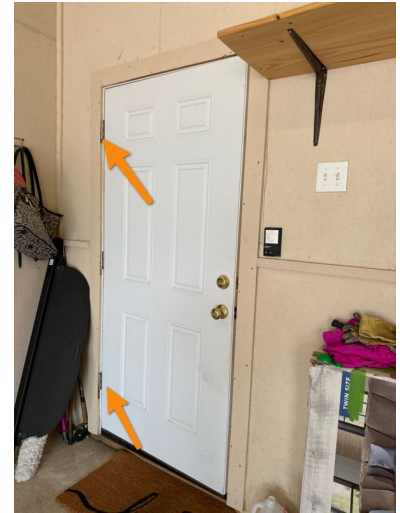
Garage Living Room

3: Self closing hinges needed at garage and attic doors

No self closing hinges on the door leading from the living area(s) into the garage. Warning please be advised this is code and a safety hazard protection from carbon monoxide poisoning is needed separation from garage, attics and living space!

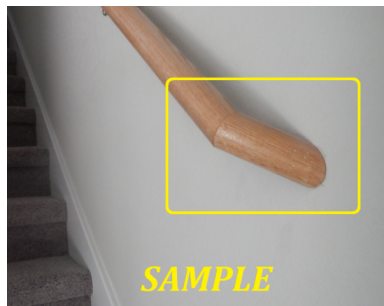
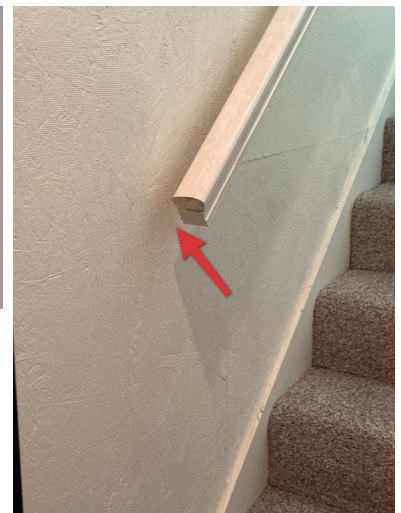
1: Hand railings do not terminate to wall

Recommendation: Contact a qualified carpenter.

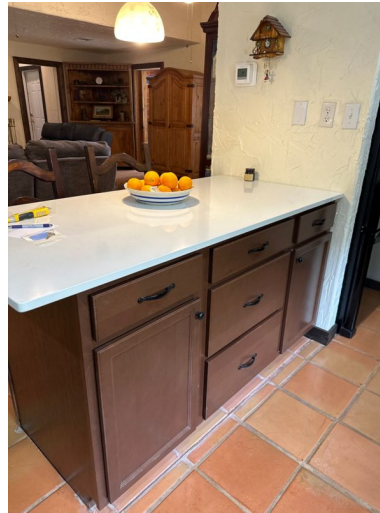
Kitchen

No GFCI protection found on the kitchen island
