# Phase I Environmental Site Assessment for the Fernandez San Marcos Property Hays County, Texas

Prepared for Tomás Fernandez 7400 Elm Forest Road Austin, Texas 78745

June 2016

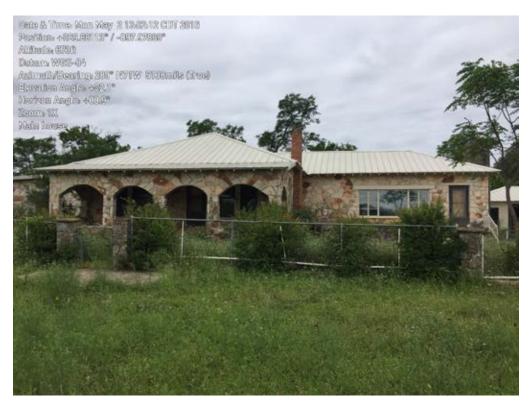
Photo 1. Main house.

The exteriors of each of the houses located on the subject property were in fair condition (**Photos 1, 12**). Two transformers in fair condition were observed (**Photos 13, 20**), one near each house. Both transformers appeared to be more than a few years old, and were not marked "no PCBs," therefore they may contain PCBs. Two propane tanks (**Photos 14, 21**) in fair condition were associated with the houses. A roll-off dumpster from Green Guy Recycling is currently located across from the main house (**Photo 19**). There was no evidence of liquids, odors or residues in the vicinity of these structures. Conditions observed were typical for a homestead associated with agricultural activities and did not indicate a recognized environmental condition.

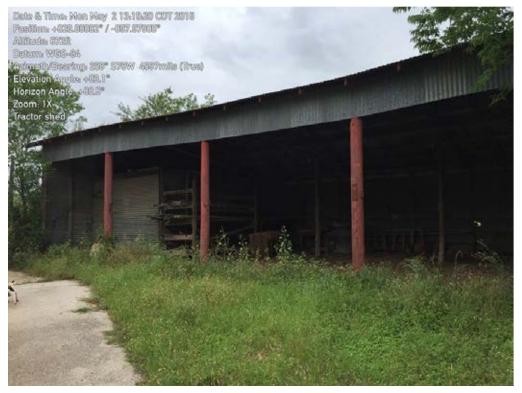
Photo 2. Tractor shed

The tractor shed appeared in fair condition (**Photo 2**). Items and materials observed are typically associated with agricultural activities. *De minimis* conditions were observed involving a 55-gallon drum containing approximately 14 gallons of an unknown chemical, likely a pesticide or herbicide for agricultural use (**Photos 3, 4**). No odors, visible residues or stressed vegetation were observed in the vicinity of these structures or materials and conditions did not indicate a recognized environmental condition.

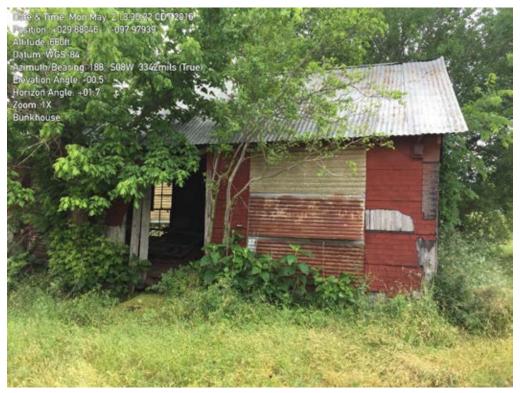
Photo 5. Bunkhouse

The pump house (**Photo 15**), chicken coop (**Photo 11**) and barn (**Photos 6**, **7**, and **10**) appeared in fair condition. The bunkhouse was in poor condition (**Photo 5**). Items and materials typically associated with agricultural activities were observed in the vicinity of these structures. An old cotton gin is currently stored on the backside of the barn (**Photo 9**). An open 55-gallon drum containing metal wire was observed near the barn (**Photo 8**). No odors, visible residues or stressed vegetation were observed in the vicinity of these structures or materials and conditions did not indicate a recognized environmental condition.

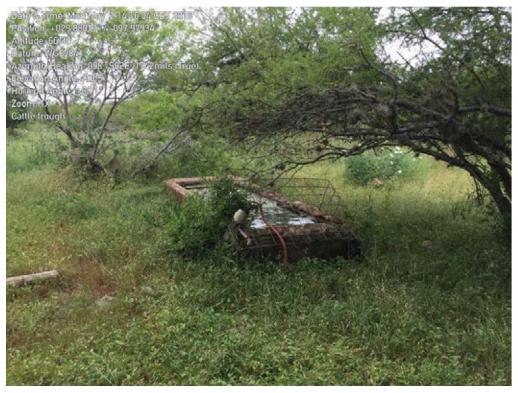
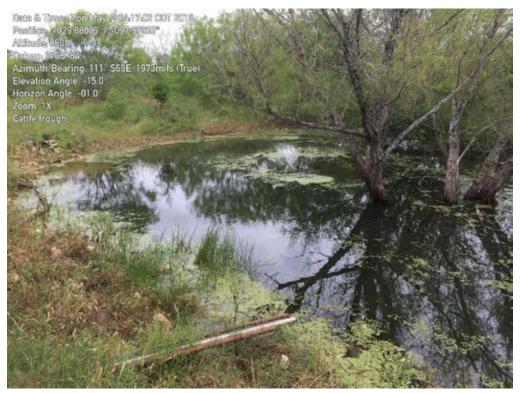
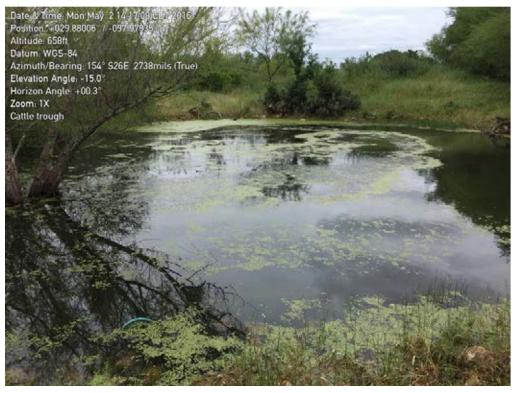
A water well and a man-made, isolated stock tank occur on the northern half of the subject property (**Photos 17**, **18**). A cattle trough is located near the stock tank (**Photo 16**). No odors, visible residues or stressed vegetation were observed in the vicinity of these features. Conditions did not indicate a recognized environmental condition.

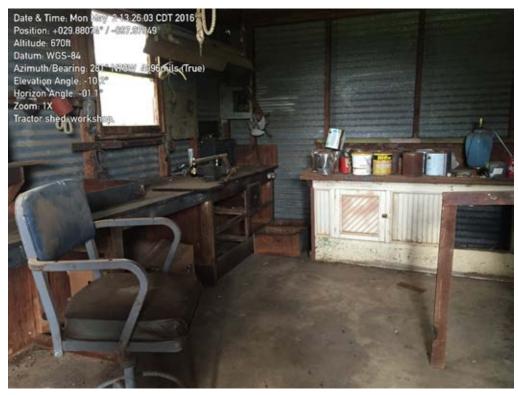
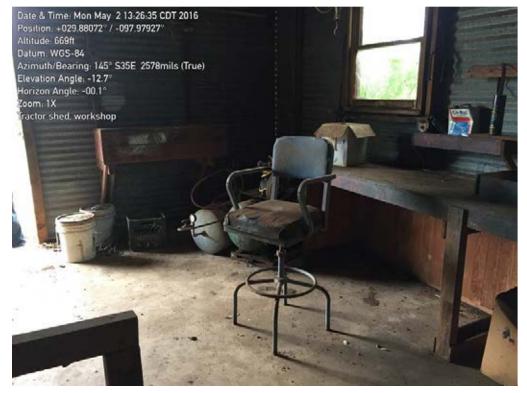
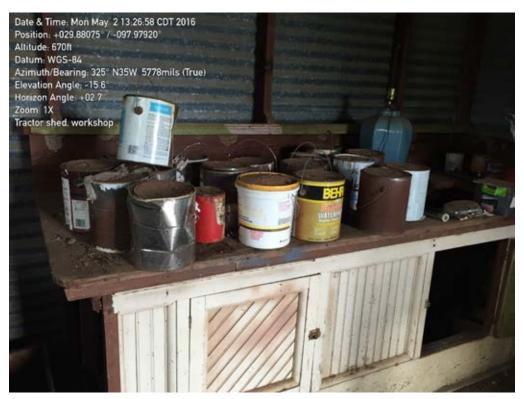
The tractor shed contained various construction materials, hand tools, and an air compressor with an extra tank. There were DE *minims* conditions associated with approximately 27 cans (both 1-quart and 1-gallon size) of paint, stain and sealant, most of which were empty (**Photos 31-33**).

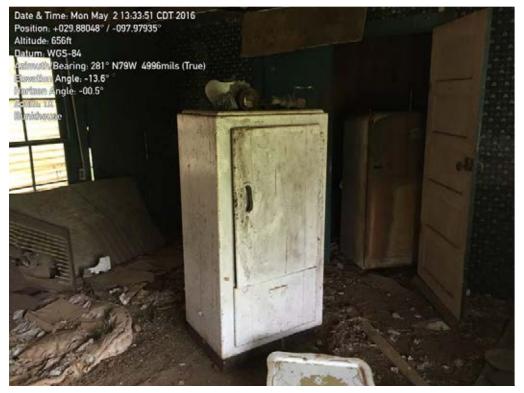
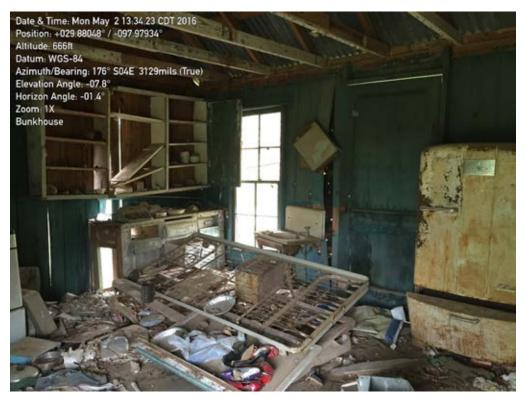
The bunkhouse was in poor condition and contained old appliances and trash (Photos 34, 35).

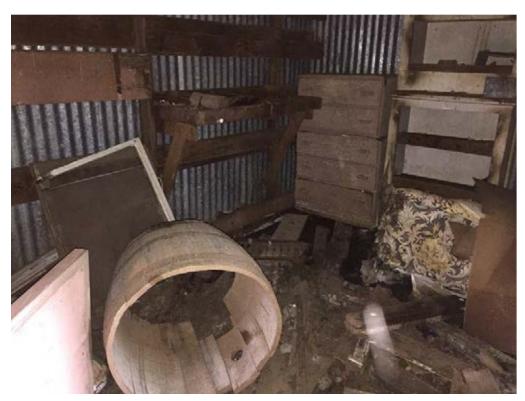
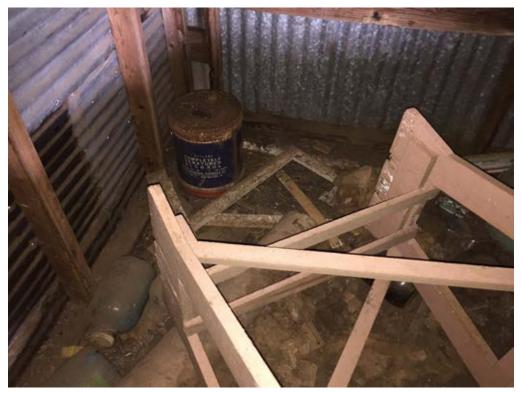
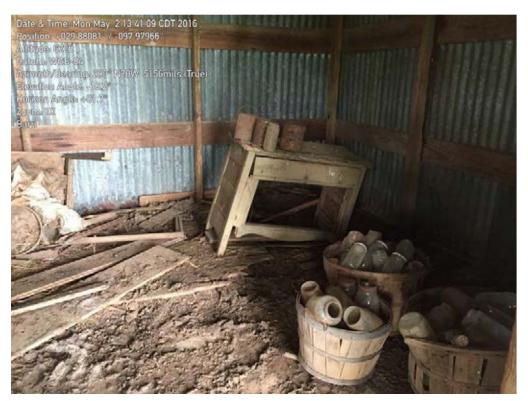
The barn was in fair condition. Old furniture, trash, three baskets containing several empty glass jars, six empty 1-gallon jugs and one empty 1-gallon jug were observed (**Photos 36-38**).

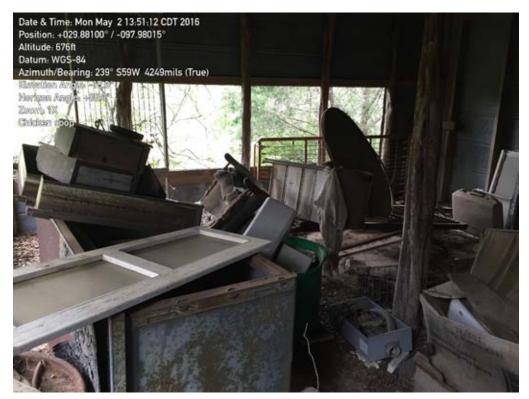
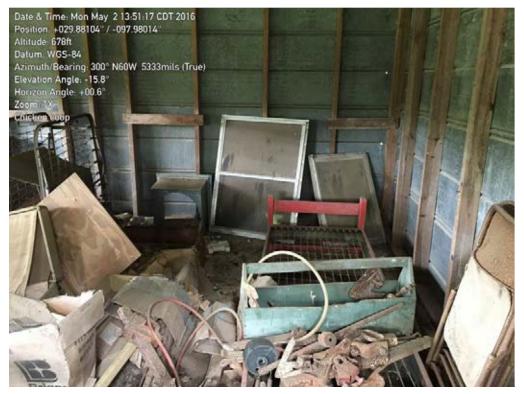
The chicken coop has not been in use for several years, was in fair condition, and contained furniture, housewares and agricultural and plumbing parts (Photos 39, 40).

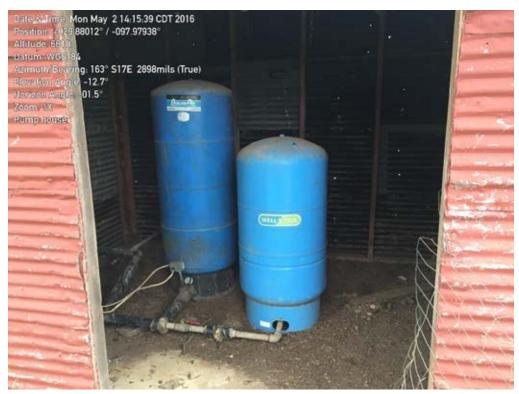
Photo 49. Pump house

The pump house is located next to the stock tank and was in fair condition. Two reservoir tanks and a pump were observed (**Photo 49**).
