STRONG HOLD INSPECTIONS & SEPTIC PUMPING

HOME REPORT

14725 Violet Dr.
Lynchburg, MO 65543

07/15/2025

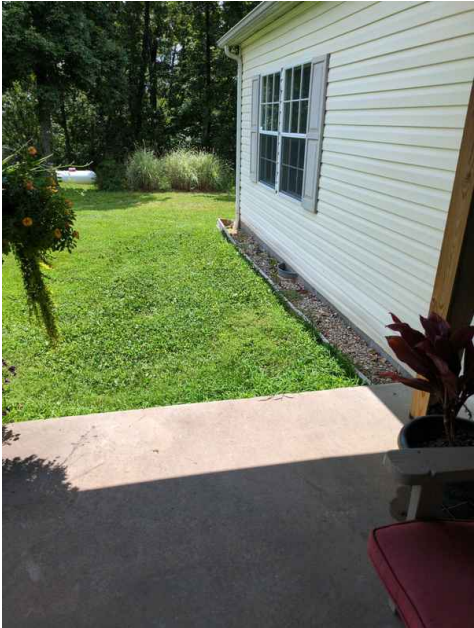
2.1.1 Grading, Drainage, & Retaining Walls

GRADING - INADEQUATE SLOPE

The grading does not slope away from the building sufficiently in one or more areas. This could lead to water intrusion and foundation issues. A 1/2" fall every foot for the first 10 feet away from the home is recommended.

Repair Recommended

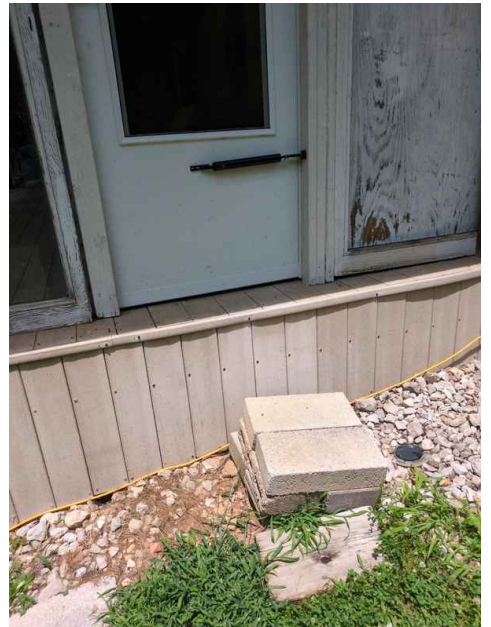
2.3.1 Entrances

STEPS

The rise and tread on the steps are not correct.

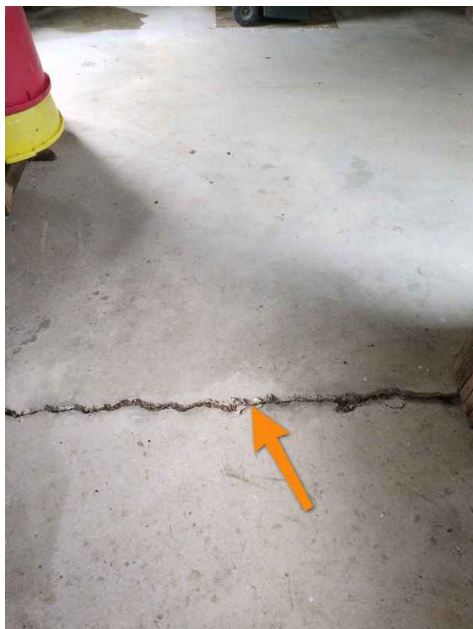
2.3.2 Entrances

TRIP HAZARD

Settlement cracks have occurred, causing a trip hazard.

Repair Recommended

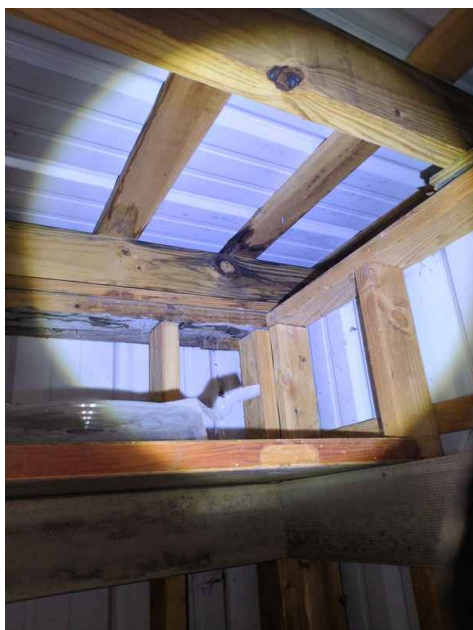
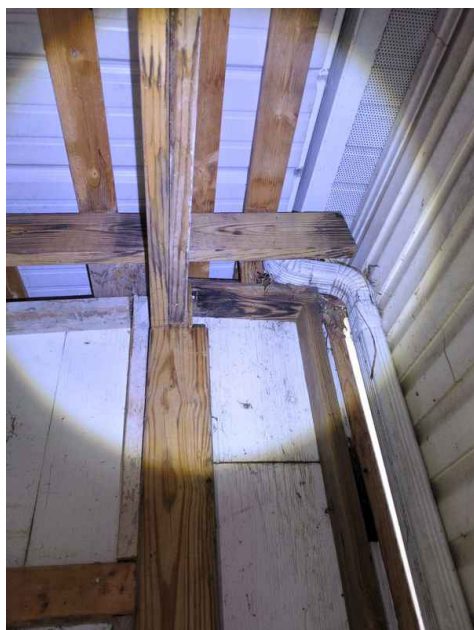
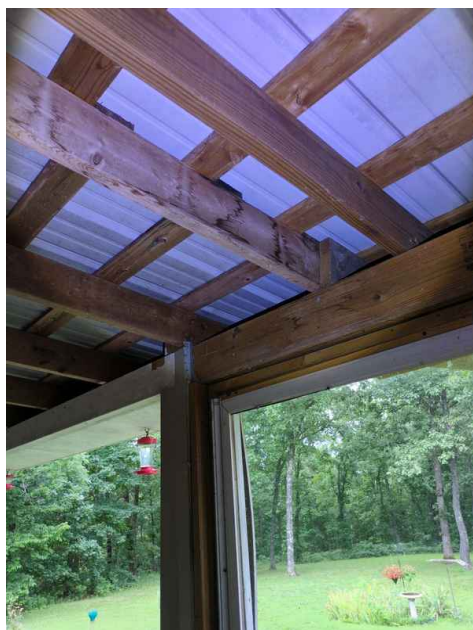
2.3.3 Entrances

MOISTURE DAMAGE

Moisture damage was observed see Roof section.

Repair Recommended

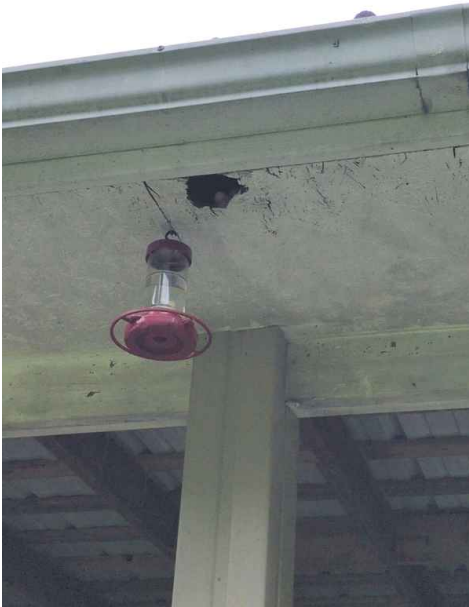
2.4.1 Siding, Flashing, Trim, Eaves, Soffit, & Fascia

FASCIA/SOFFIT - DAMAGED

One or more sections of the fascia/soffit are damaged or have moisture damage.

Repair Recommended

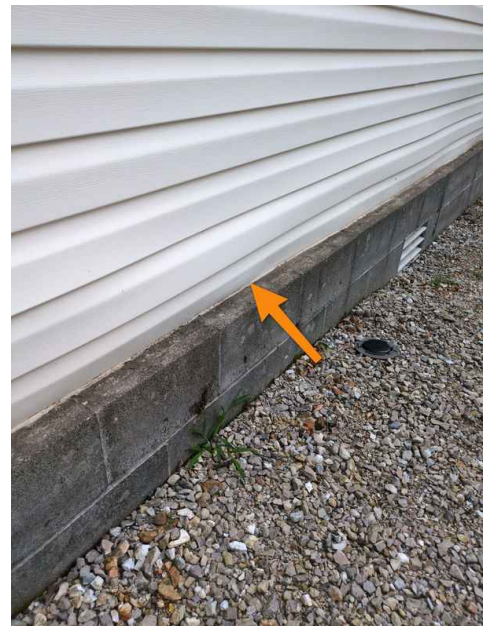
2.4.2 Siding, Flashing, Trim, Eaves, Soffit, & Fascia

FLASHING/TRIM - IMPROPERLY INSTALLED OR SHORT

Flashing and trim pieces are improperly installed, loose, missing, or cut short, which could result in moisture intrusion and damaging leaks.

Repair Recommended

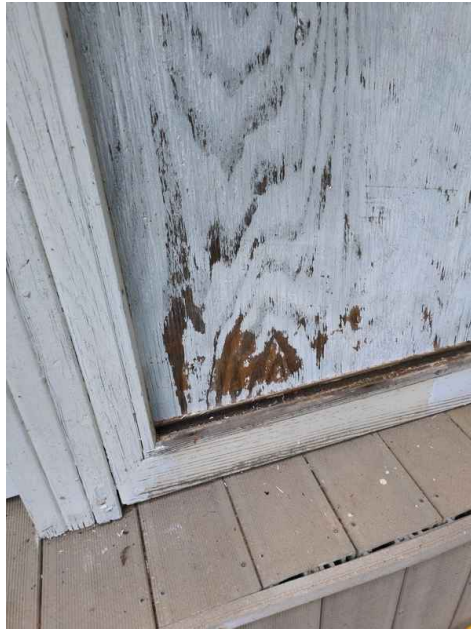
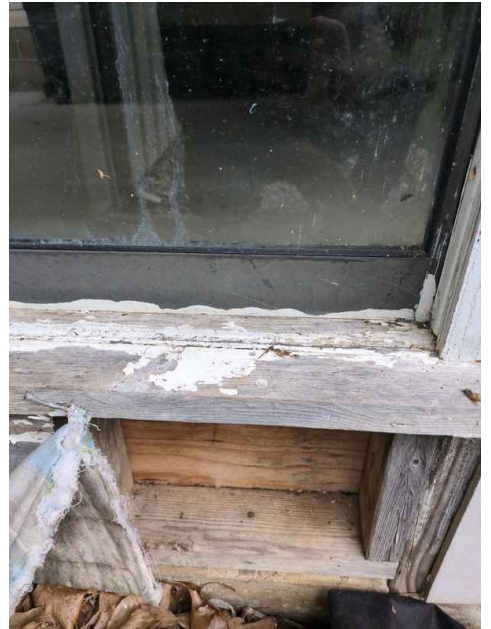
2.4.3 Siding, Flashing, Trim, Eaves, Soffit, & Fascia

GENERAL - EXPOSED WOOD - PEELING PAINT

Paint is peeling, leaving exposed wood. Repainting to prevent further water penetration and damage to the wood is recommended.

Repair Recommended

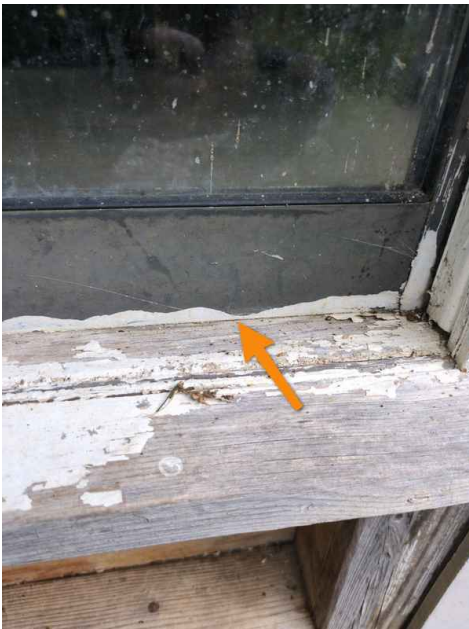
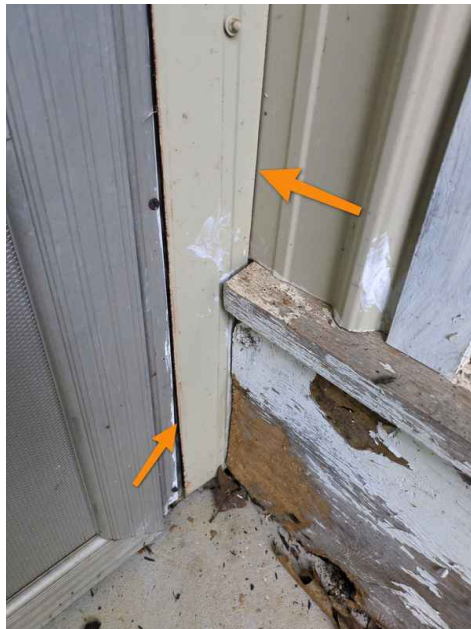
2.4.4 Siding, Flashing, Trim, Eaves, Soffit, & Fascia

GENERAL - SEAL

Sealing all areas where siding meets brick or stone, trim, windows, doors, soffits, and all penetration points to reduce the possibility of water damage and insect entry is recommended.

Repair Recommended

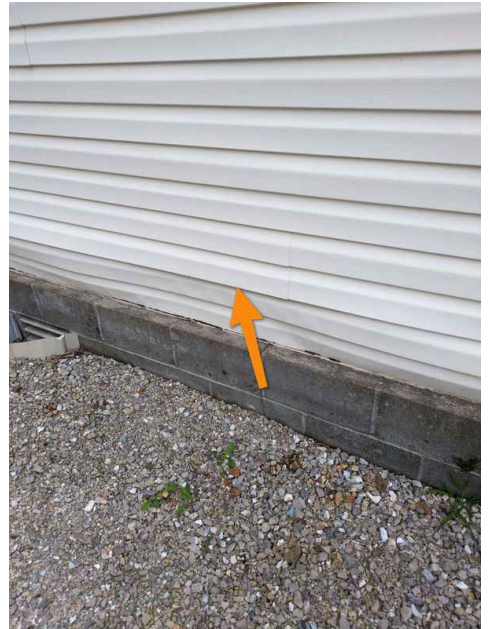
2.4.6 Siding, Flashing, Trim, Eaves, Soffit, & Fascia

SIDING - LOOSE, MISSING, NOT OVERLAPPED, SHORT

The siding is loose, cut short, missing, or not correctly overlapped in one or more locations.

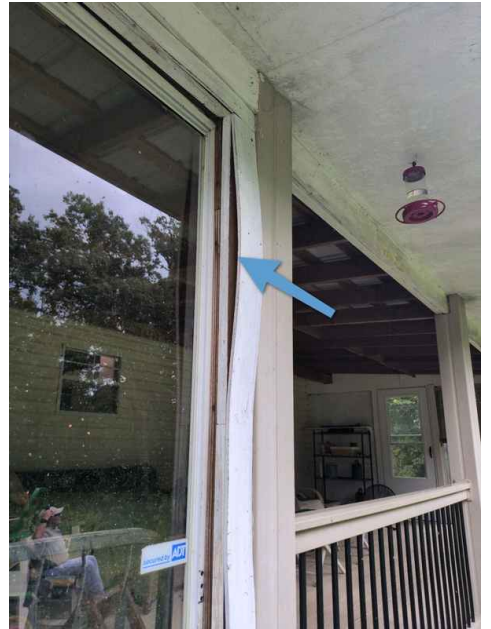
2.4.7 Siding, Flashing, Trim, Eaves, Soffit, & Fascia

SIDING/TRIM- WARPING/BUCKLING

The siding/trim is warping or buckling in one or more areas.

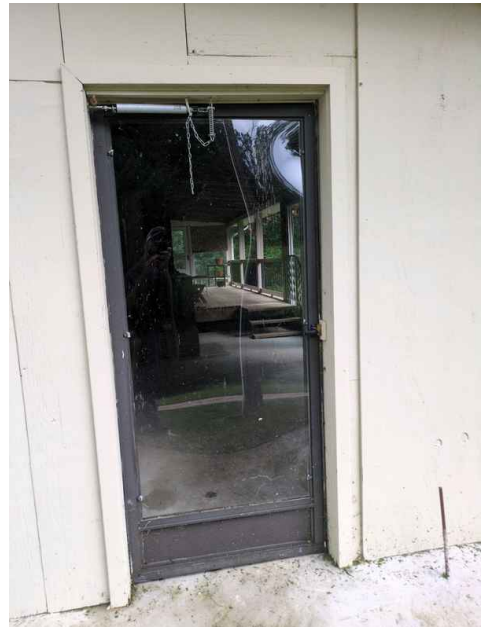
2.5.1 Exterior Doors & Windows

DAYLIGHT

Daylight can be seen around all the back deck doors.

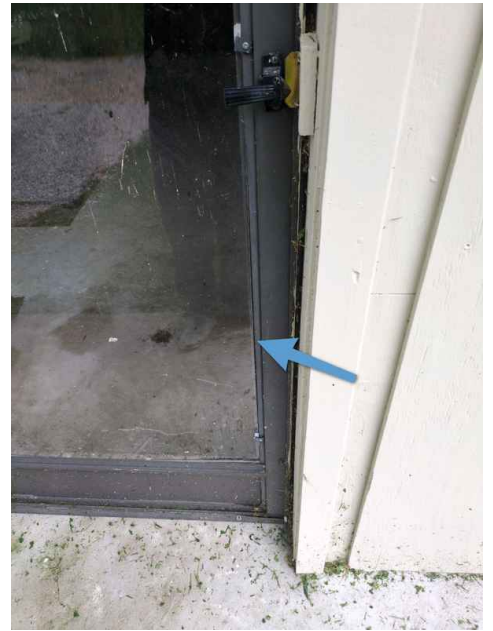
2.5.2 Exterior Doors & Windows

GLASS BOWED

Section(s) of glass are missing or broken.

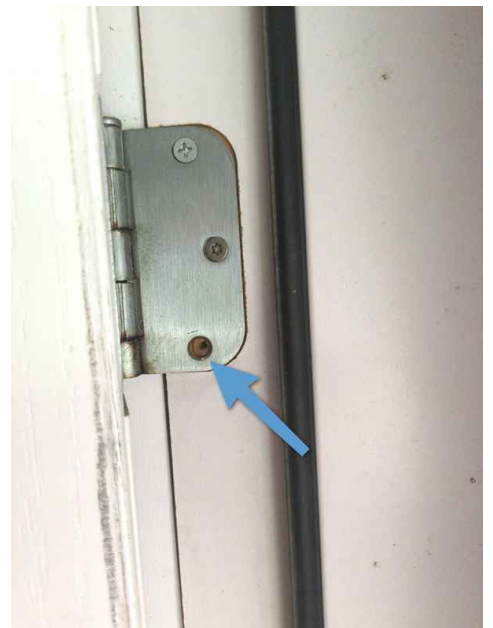
2.5.3 Exterior Doors & Windows

HARDWARE

Hardware is damaged, loose, or missing.

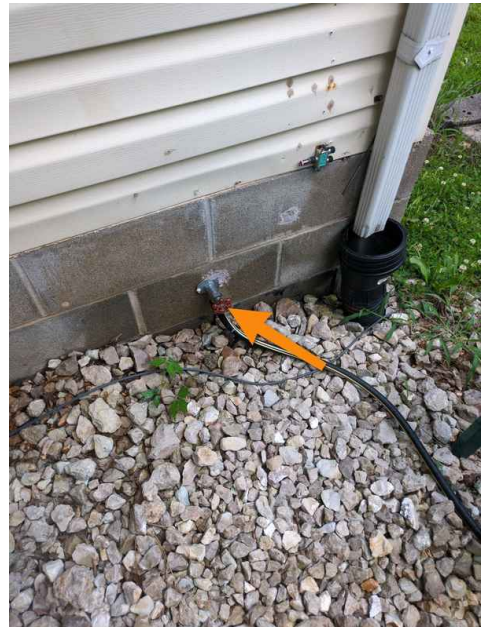
2.7.1 Spigots

LEAK

Spigot(s) have an active leak or drip.

Repair Recommended

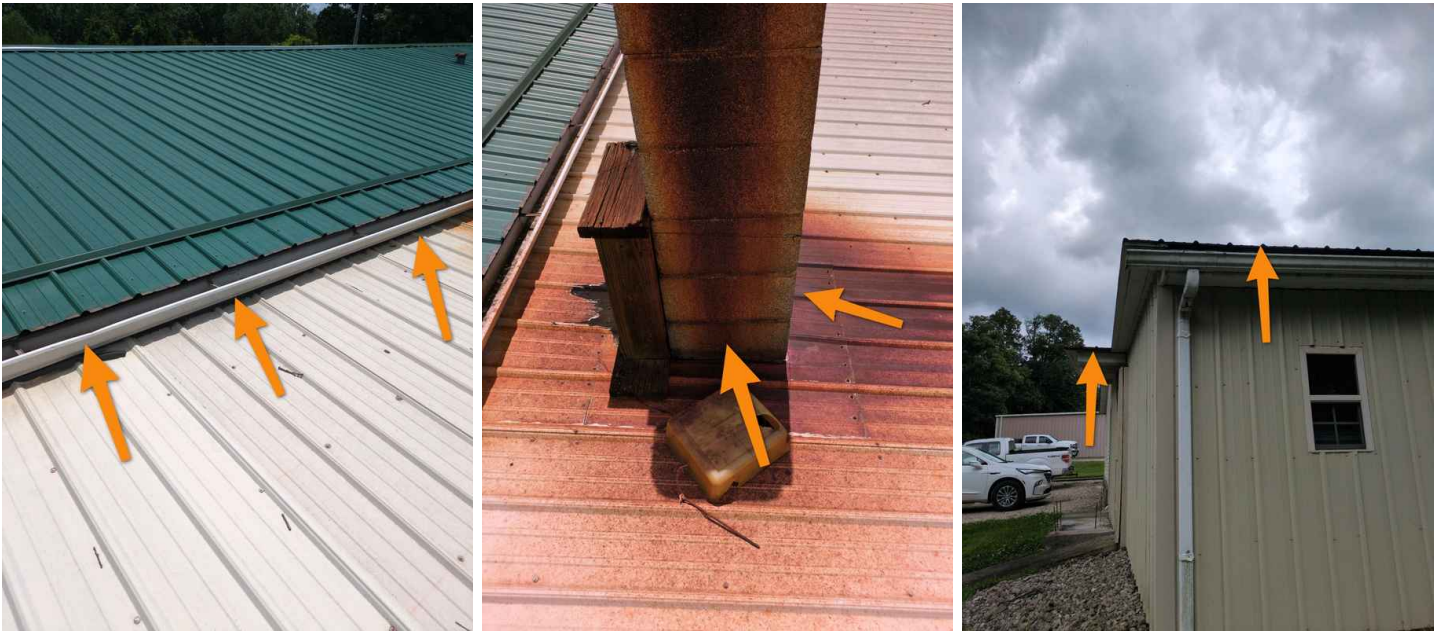
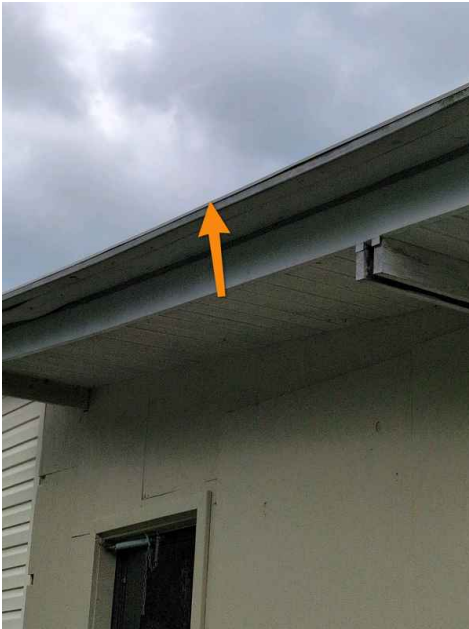
3.1.1 Coverings

FLASHING - LOOSE/MISSING/SEPARATED

Flashing(s) are loose, missing, not properly installed, or separated, which can lead to water intrusion or mold.

No rake trim

Repair Recommended

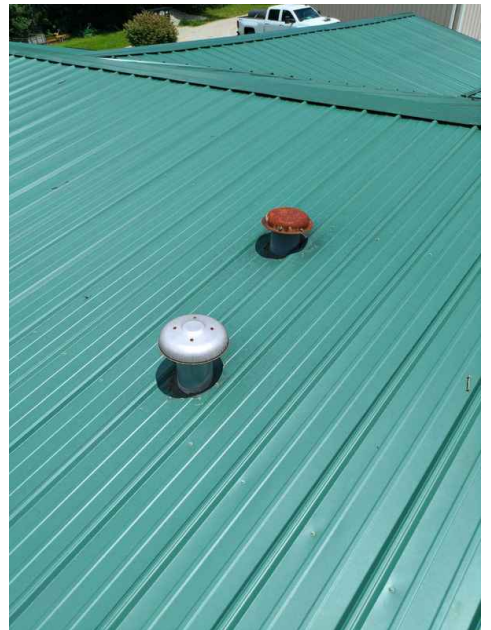
3.1.2 Coverings

GENERAL - VENT BOOT

No vent boot(s) observed.

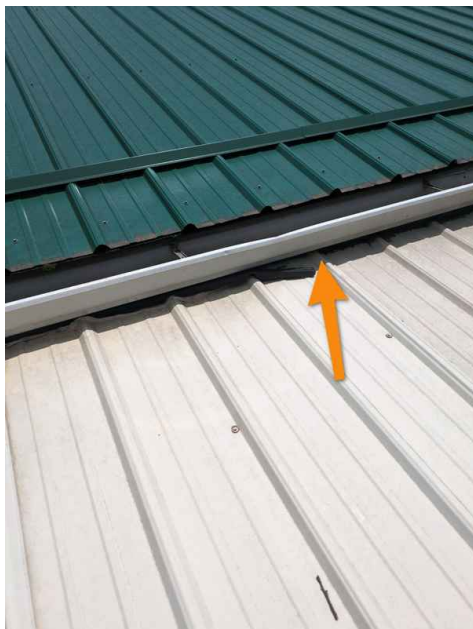
3.1.3 Coverings

METAL - FOAM CLOSURES LOOSE

Foam closures are out of position or coming loose.

Repair Recommended

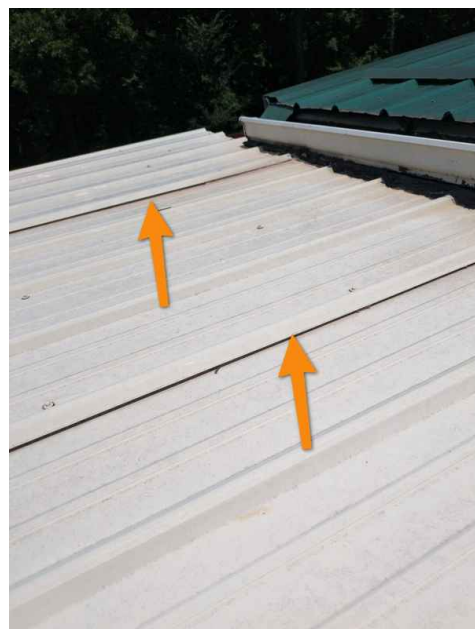
3.1.4 Coverings

METAL - IMPROPER OVERLAP

One or more roof sheets were incorrectly overlapped at installation.

Contact a qualified roofing professional

Repair Recommended

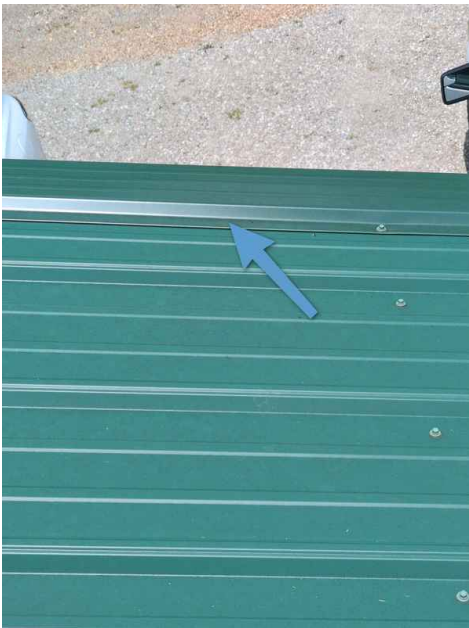
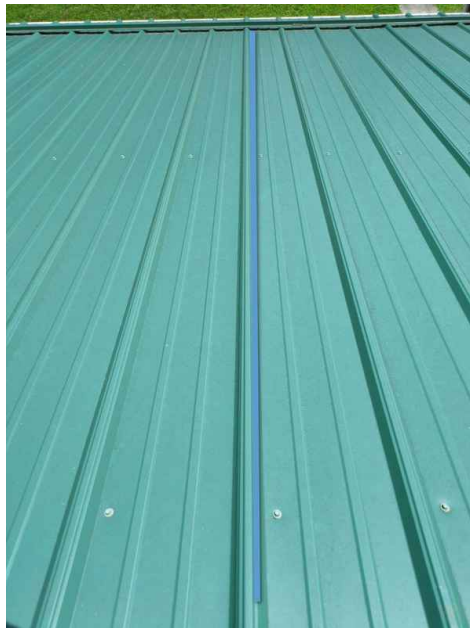
3.1.6 Coverings

METAL - NO TAPE

No tape mastic was used on the laps of the sheets or trim.

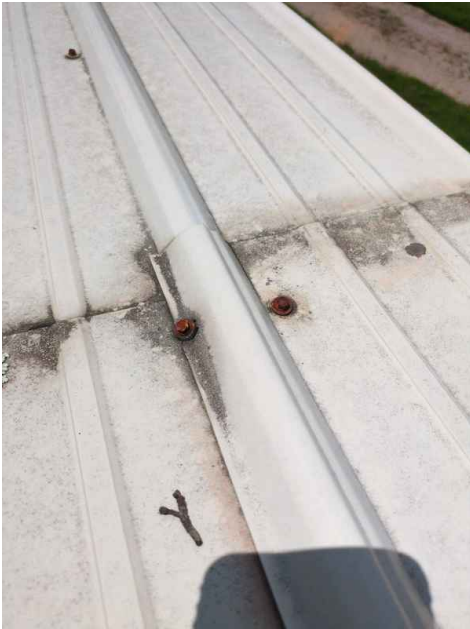
3.1.7 Coverings

METAL - RUSTED FASTENERS

Fastener(s) are rusted, which could lead to water leaks.

Repair Recommended

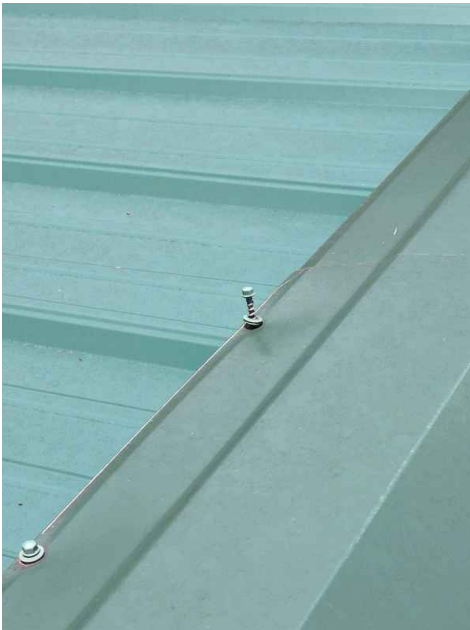
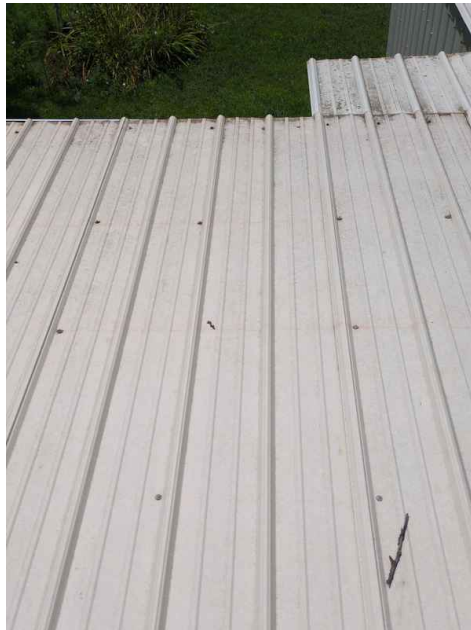
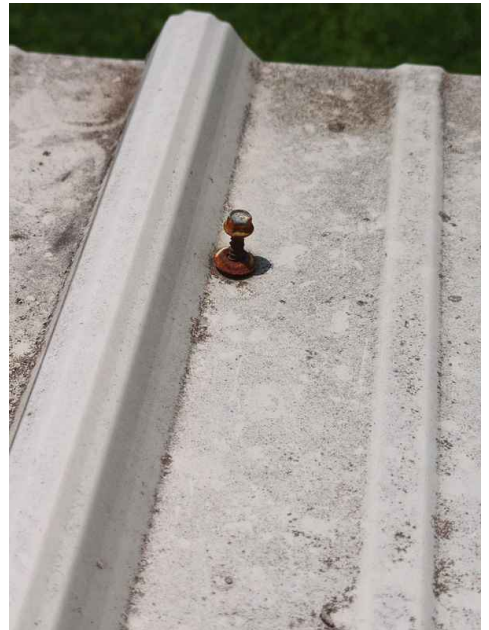
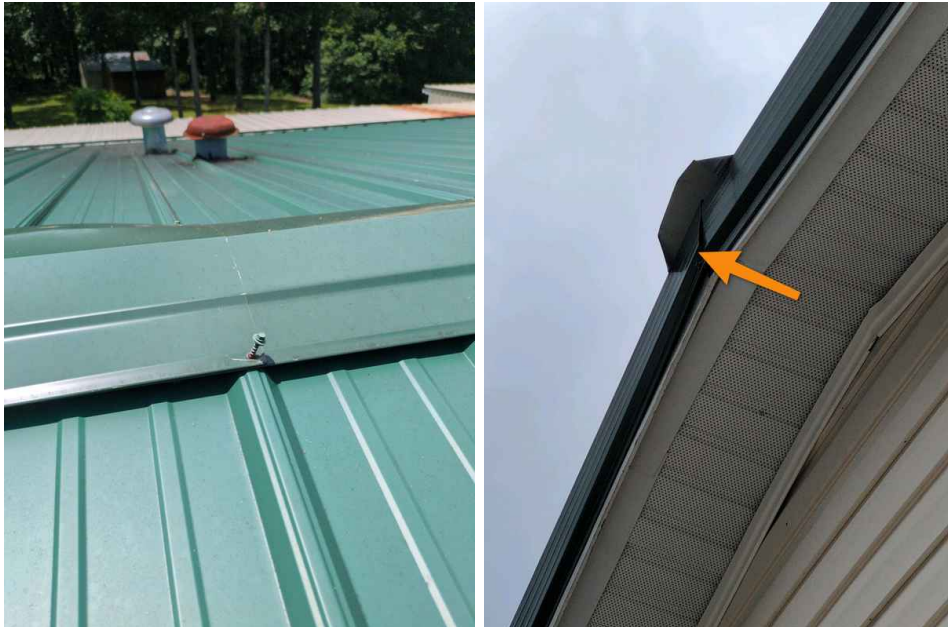
3.1.8 Coverings

METAL - SCREWS INCORRECT

Screws are missing, backing out, improperly installed, or not secured well.

Loose

Repair Recommended

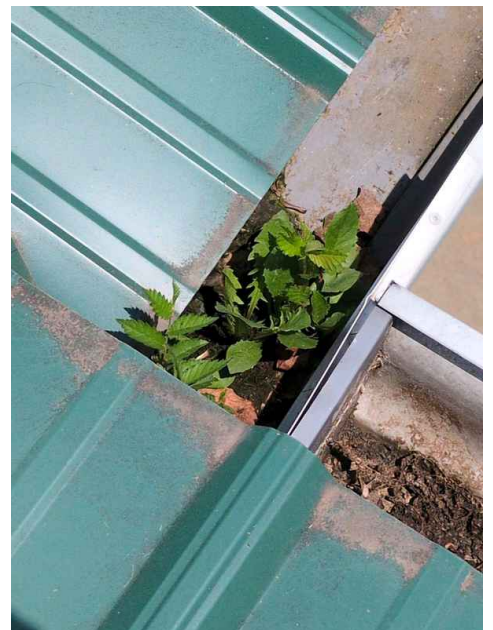
3.2.1 Roof Drainage Systems

DEBRIS

The gutters were filled with leaves and debris at the time of the inspection. Cleaning and removal of debris on a regular basis is recommended. This condition can cause water penetration at the eave.

**Repair Recommended**

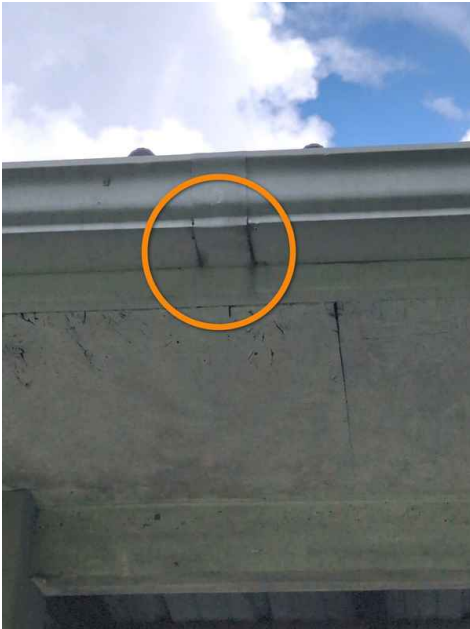
3.2.2 Roof Drainage Systems

LEAK

Gutters have stains in one or more areas that could indicate leak(s). Leak(s) can result in excessive moisture in the soil at the foundation. Water seepage into crawlspaces, basements, and under foundations can be caused by inadequate removal of rainwater from the perimeter of the house, which can lead to foundation/structural movement.

**Repair Recommended**

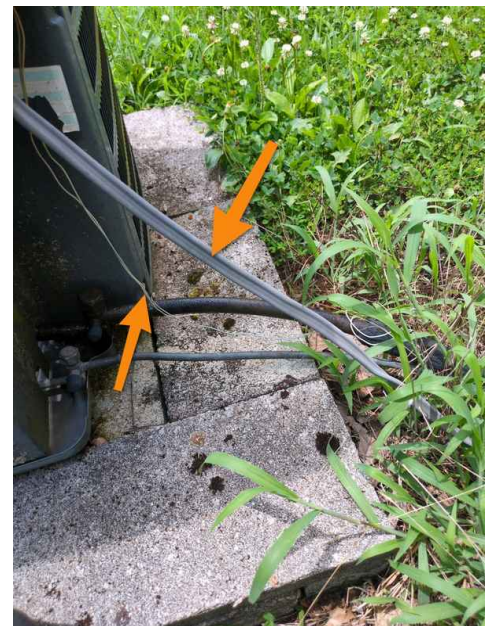
5.4.1 Cooling Equipment

ELECTRIC - DAMAGE

The electrical conduit and/or thermostat wiring have minor damage or exposed wiring.

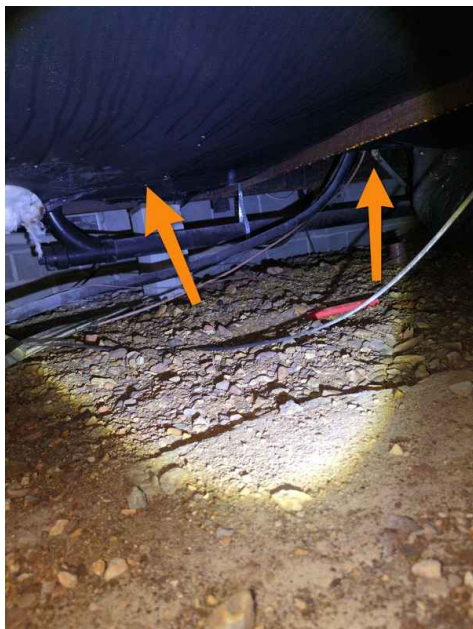
5.4.2 Cooling Equipment

LEAKING

The unit is leaking.

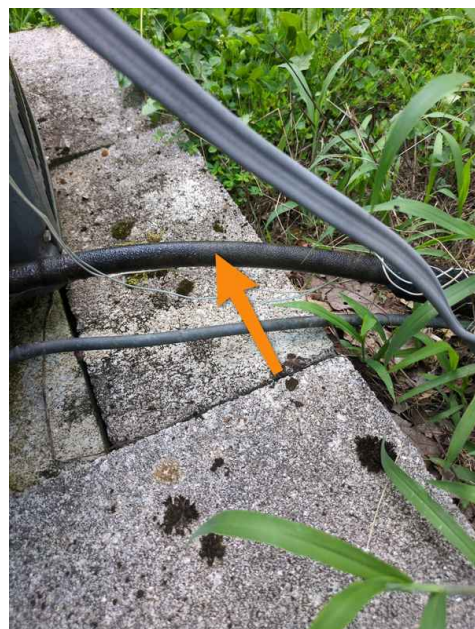
5.4.3 Cooling Equipment

LINE - INSULATION MISSING OR DAMAGED

The insulation on the refrigerant line is missing or damaged, which can cause energy loss and condensation.

Repair Recommended

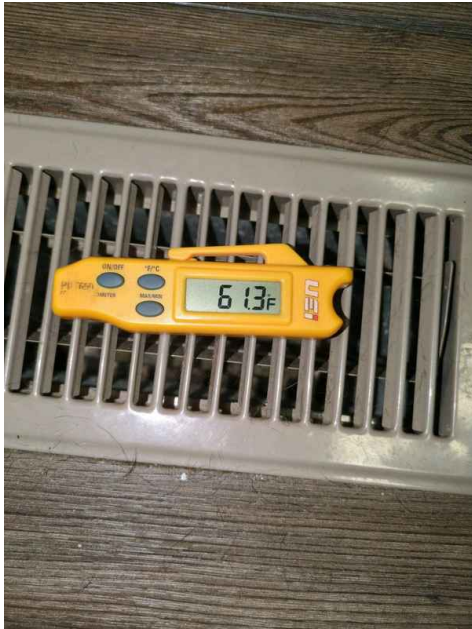
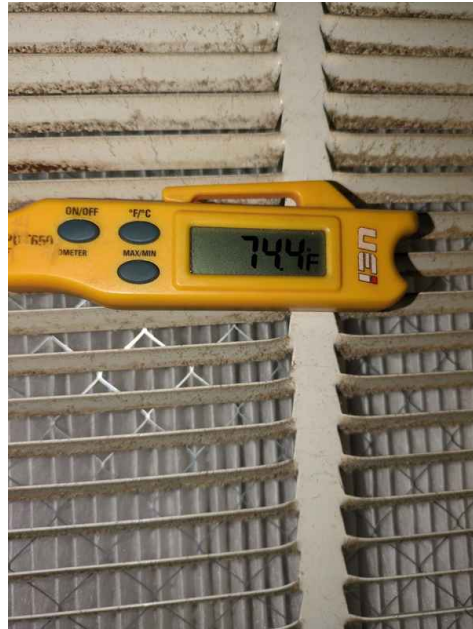
5.4.4 Cooling Equipment

TEMP - INCORRECT COOLING

The temperature difference between the return air and air output of the cooling system should be 15-20 degrees. At the time of inspection, the difference was more or less than that.

Repair Recommended

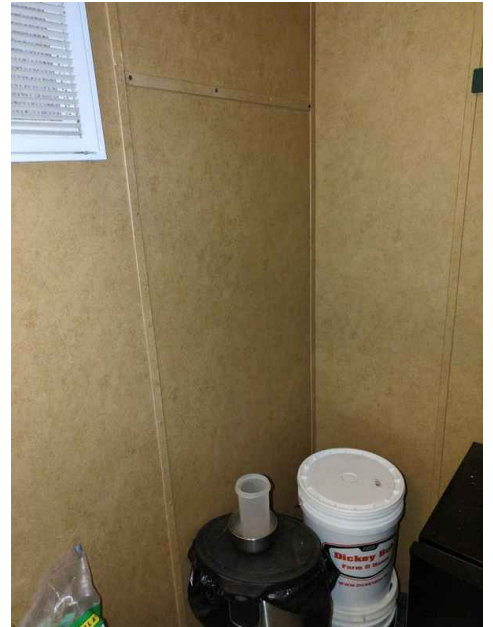
Hot Water System(s)

ACCESS BLOCKED

Access to water heater was blocked.

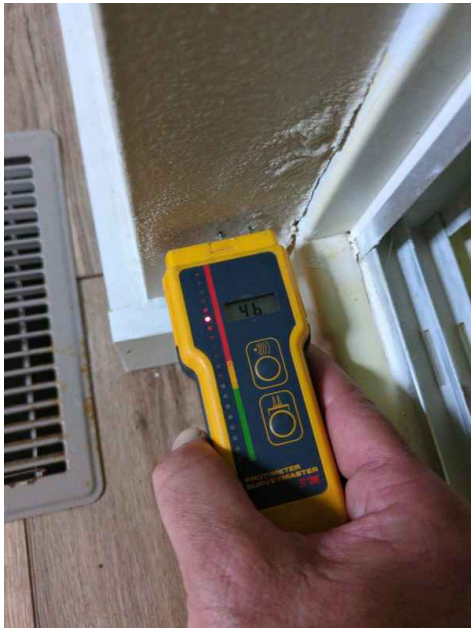
9.1.3 Walls

MOISTURE DAMAGE WET

Moisture stains or damage is visible on the wall(s). At the time of inspection, they're wet.

46%

Master on both sides

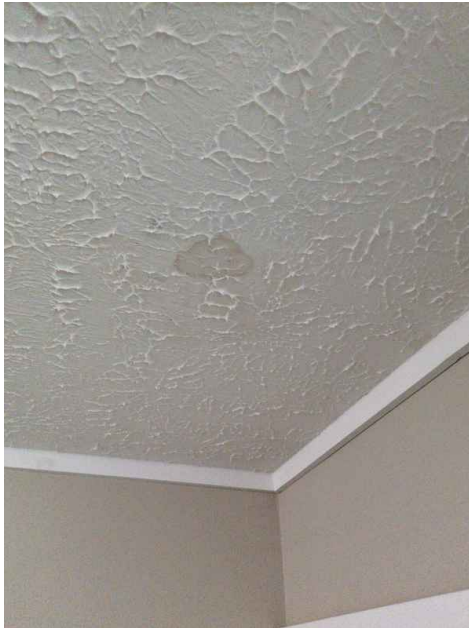
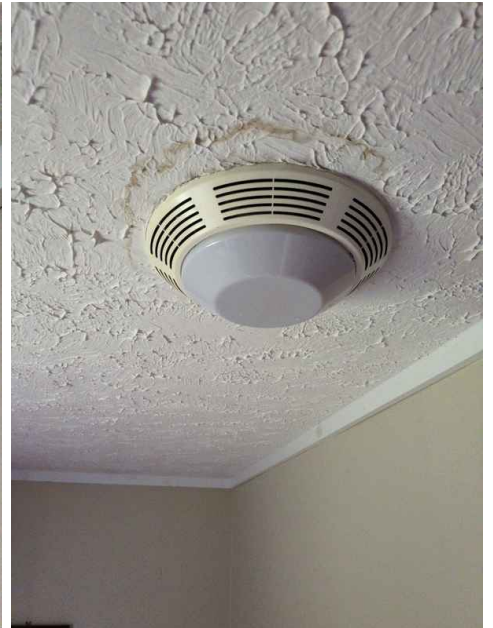
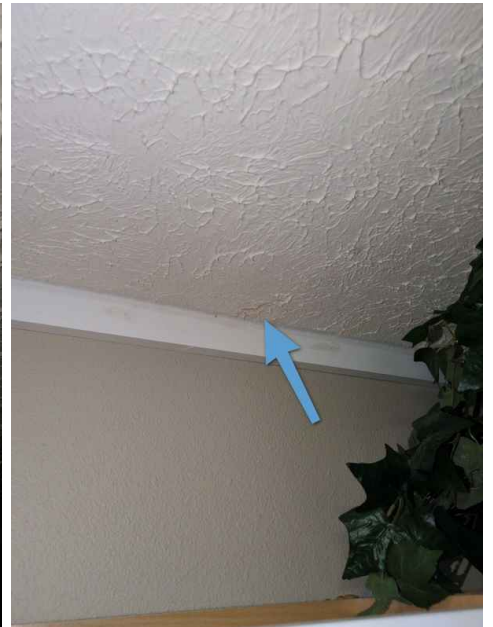
9.3.2 Ceilings

MOISTURE DAMAGE/STAINS DRY

Moisture stain(s) are visible on the ceiling. At the time of inspection, they are dry.

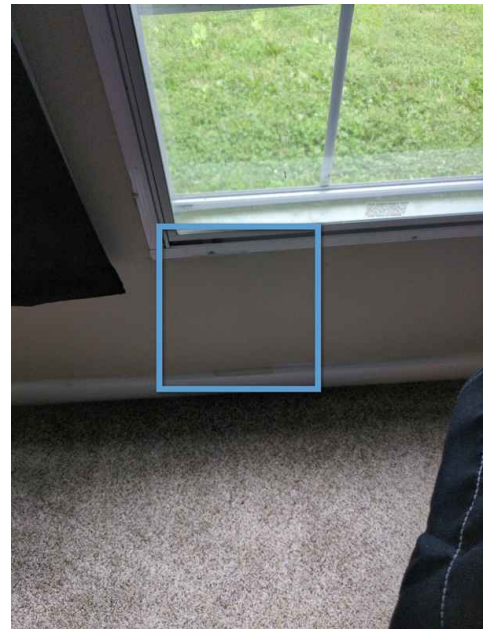
9.4.1 Windows

MOISTURE STAINING

Window(s) have moisture stains. At the time of inspection, they were dry.

Master Bedroom

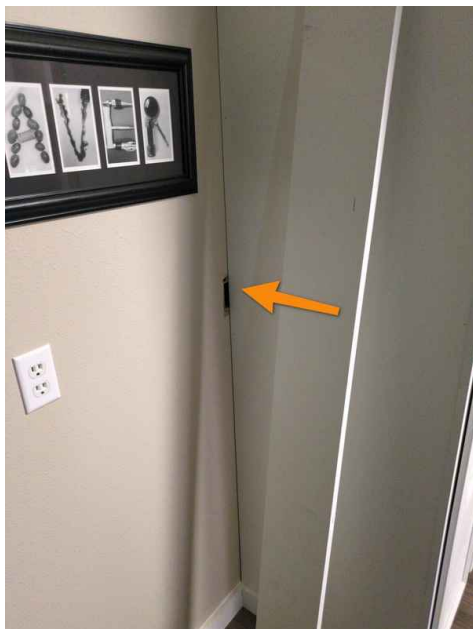
9.6.1 Electrical

COVER PLATE - DAMAGED/MISSING/LOOSE

Cover plate(s) are missing, loose, or broken on outlets, switches, or junction boxes and should be secured or replaced.

Repair Recommended

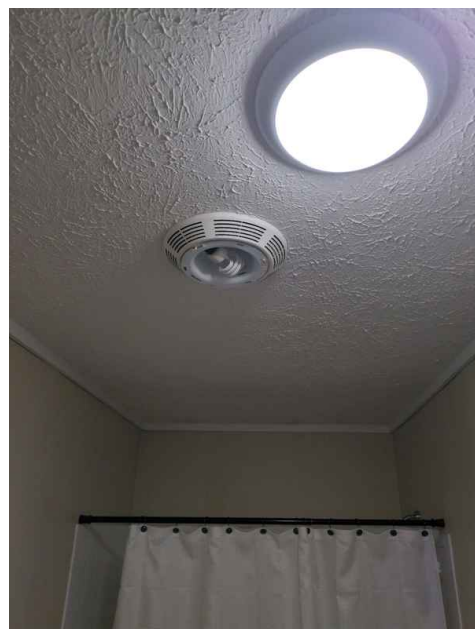
9.6.2 Electrical

EXHAUST FAN -

The exhaust fan is working but is extremely noisy.

Hall

Repair Recommended

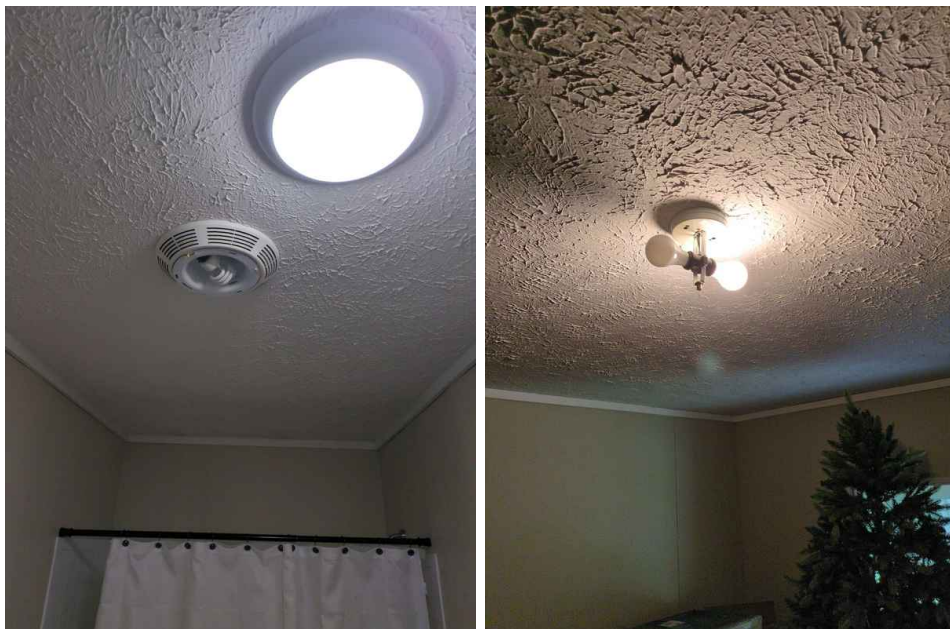
9.6.3 Electrical

GLOBE(S) MISSING

Globe(s) are missing from fixtures.

Hall

Contact a qualified professional

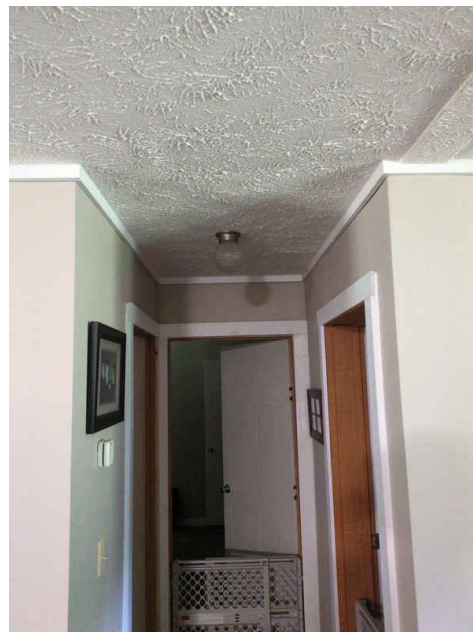
9.7.1 Smoke/Carbon Monoxide Detectors

SMOKE DETECTORS RECOMMENDED

A working smoke detector in each applicable area is recommended. This includes every bedroom, hallway, each level of a home (including a basement), and any room with a fireplace.

Missing from hallway

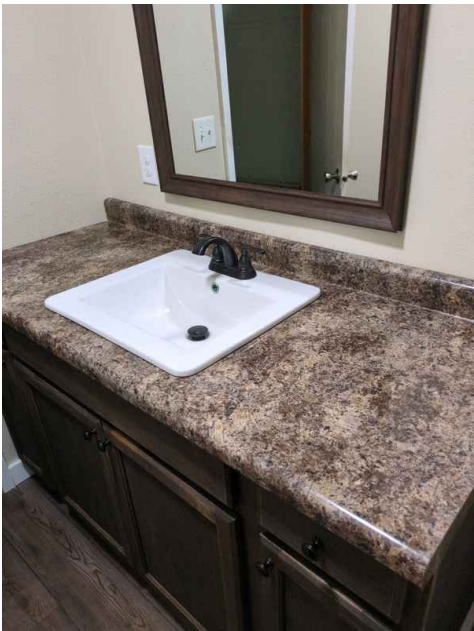
11.1.1 Counters/Cabinets

COUNTER/BACKSPLASH LOOSE

The countertop/ backsplash isn't secured well.

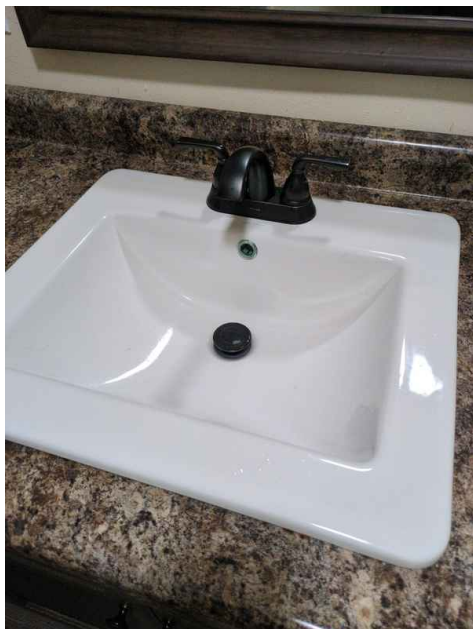
11.2.1 Sink

DRAIN - STOPPER
BROKEN/MISSING

Sink drain stopper(s) do not work correctly or are missing.

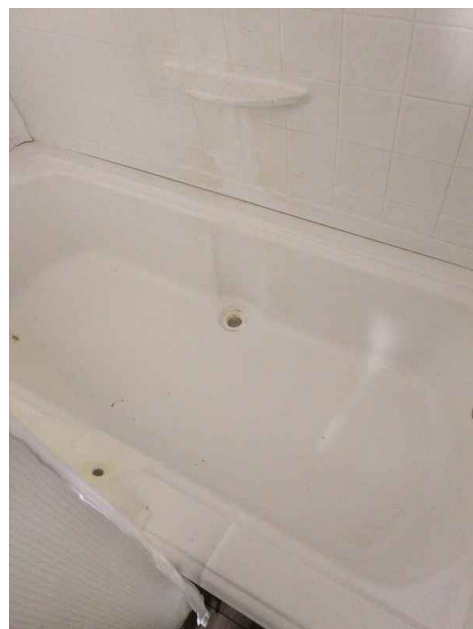
11.3.1 Shower/Tub

DRAIN - STOPPER

Drain stopper(s) don't function properly or are missing.

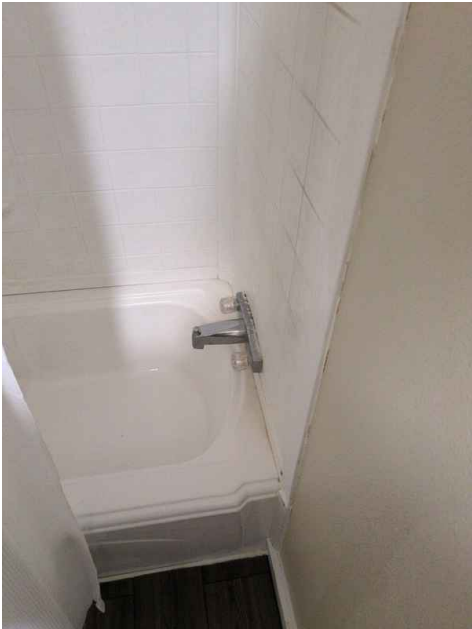
11.3.2 Shower/Tub

FAUCET/SHOWER - DIVERTER VALVE

When the water is diverted from the tub to the shower head, some water is still running from the faucet or vice versa.

Repair Recommended

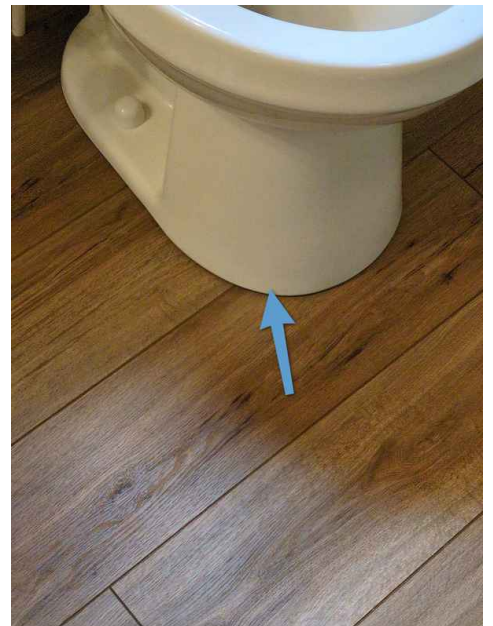
11.4.1 Toilet

BASE - CAULKING

Caulking where the toilet meets the floor is recommended.

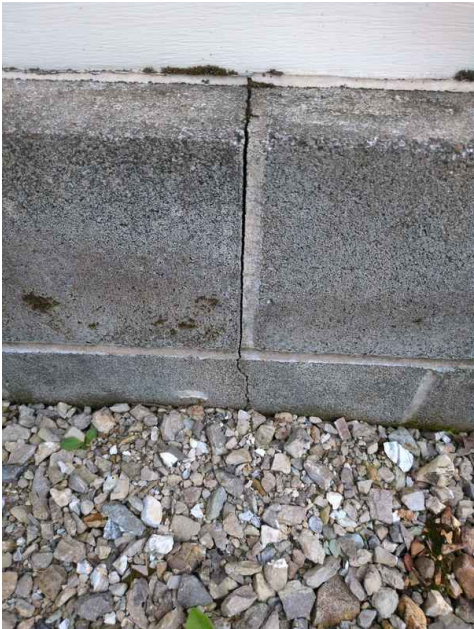
13.1.1 Foundation

CRACKS

Settlement cracks were observed. Properly sealing them, monitoring for further movement, and contacting a qualified contractor if the cracks enlarge is recommended.

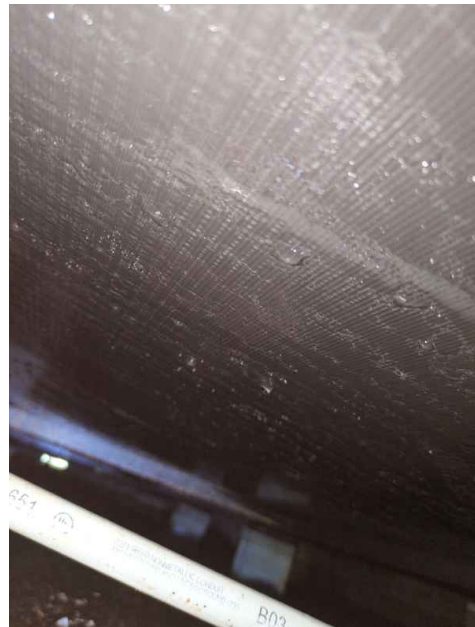
13.3.1 Crawlspace

DAMP

The crawlspace is damp at the time of inspection. Proper grading, ventilation, and redirecting the downspouts may help with the moisture.

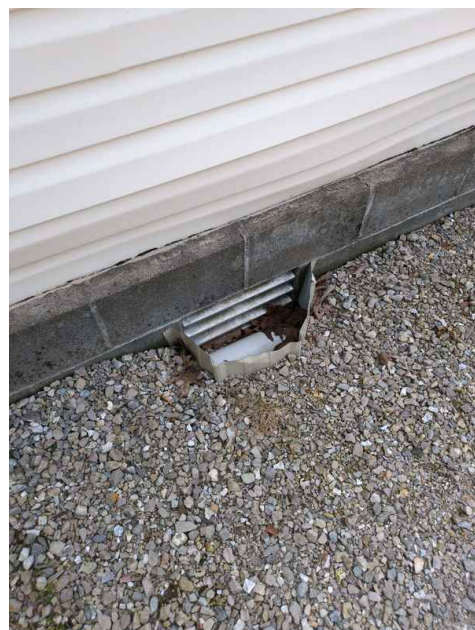
13.3.2 Crawlspace

VENTS - BELOW GRADE

Crawl space vents are at or below grade which can allow water to penetrate.
