Duane F. Christopher &
Associates, LLC
2424 India Hook Road, Suite 220
Rock Hill, South Carolina 29732

Project# 2734

Regarding: **Site consultation; due diligence, research, and report on wetland or jurisdictional wetland / stream for property located in York County tax map number, parcel ID: 499-00-00-001. 5.803 acres. Providence Heights Subdivision, no address, York, SC 29745.**
Owner; RLV22, LLC

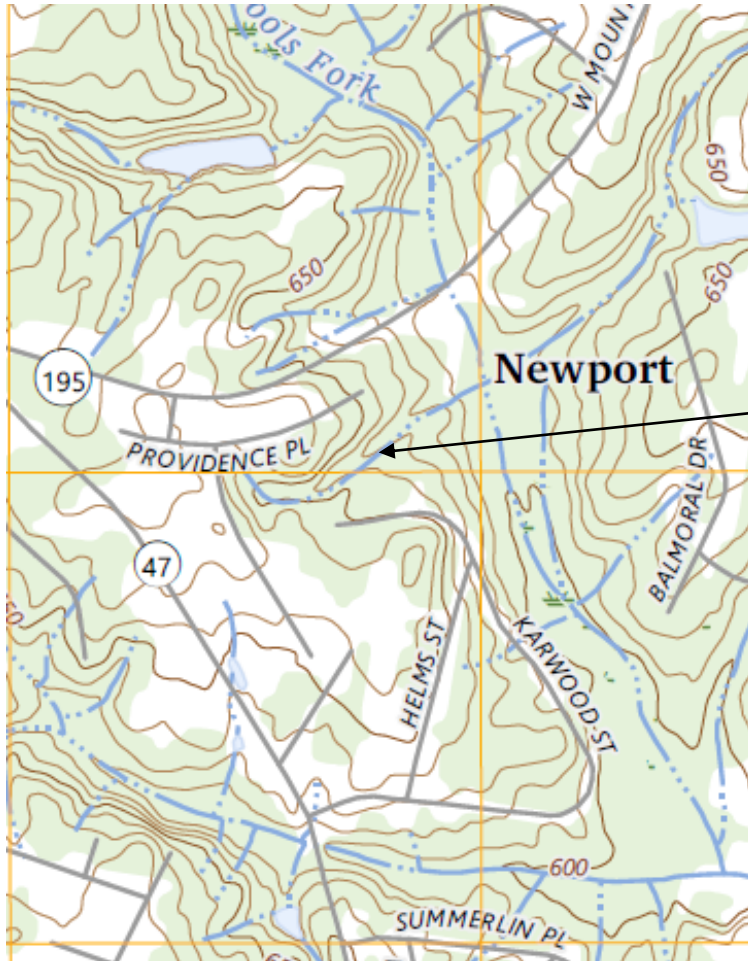
Part of TIRZAH, S.C. 2024 USGS MAP.

The site location on
USGS Map.

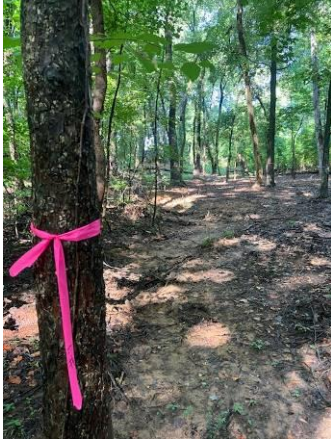
The photo above is northeast at the start of the flat area through the subject area; shows the canopy and very few middle-tier plant groups. Many of the small trees and shrubs have been bush hogged by the previous owner.

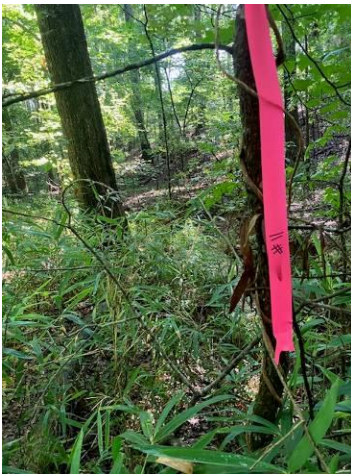
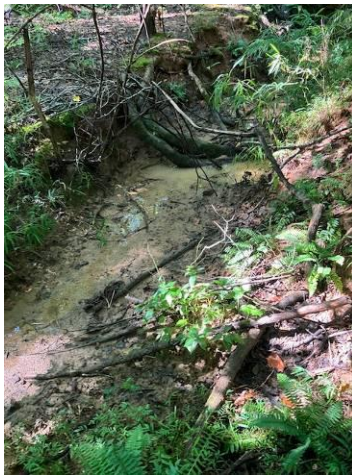
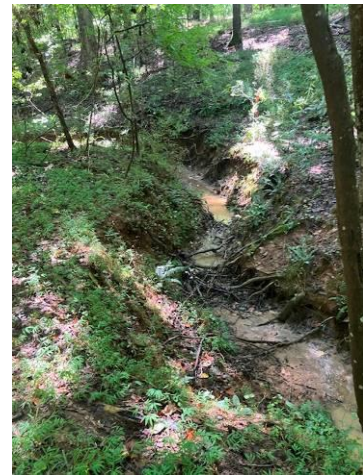
Area of stream bed that is defined by 3' banks with silt in the stream bed.

I recommend that as part of the physical survey of the property when making the topographic mapping that the flagging performed be located and included so as to be available to make any future grading or construction decisions on the site plan design. I recommend that structures not be located within low lying area. If the site grading design warrants filling, water flow will need to be considered. Avoid developing and filling in the stream bed.

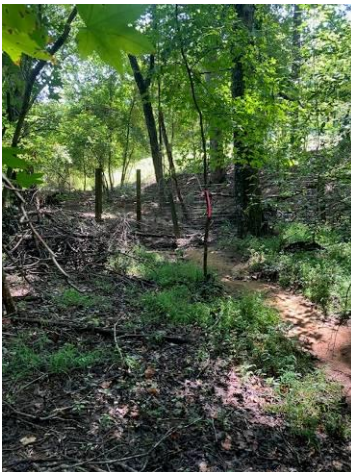
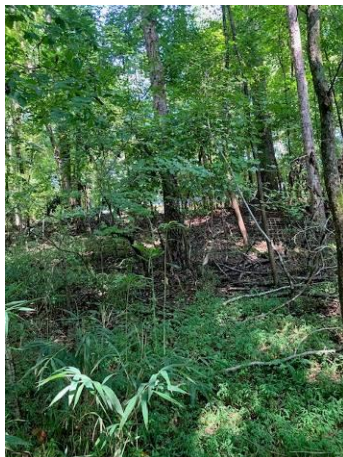
View looking at the property line at the northeast corner where the stream leaves the property.

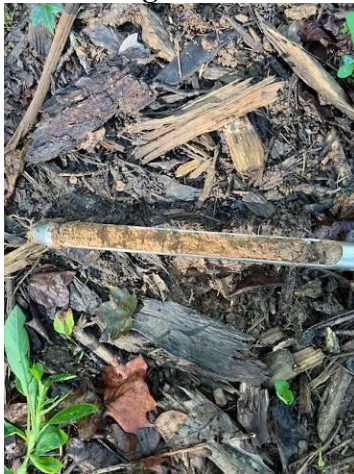
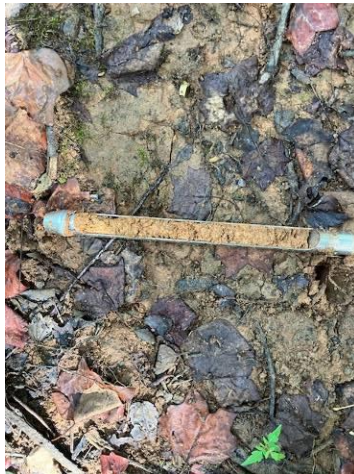
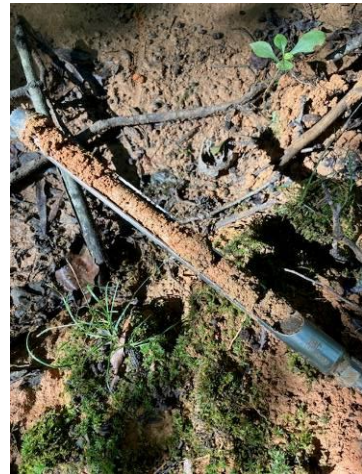
Soil Borings.

The area is limited in the variety of tree, shrubs, and herbaceous species. The soils are draining and appears to not hold water for very long periods based on the leaves on the ground. Soil borings shown very limited or no hydric soils and no concretions in the ten borings I made. More soil borings may provide a different result or may not. The water table is below 10-12”.

The soil borings shown above are typical for the area from station #1 to #12. The soils did not have any indications of being hydric in any of the 12 locations where I did the samples.

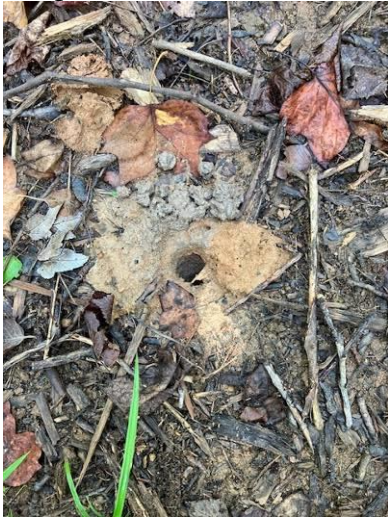
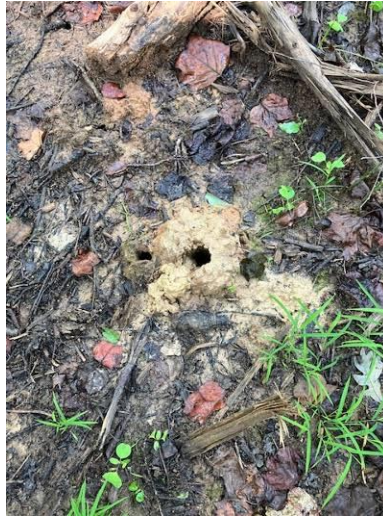
There are a limited number of *Crayfish on the flat area through #1 - #4. These animals are also one indication of wetland. Crayfish are not an absolute indicator but is associated with wetland areas. There were about six holes in the area.

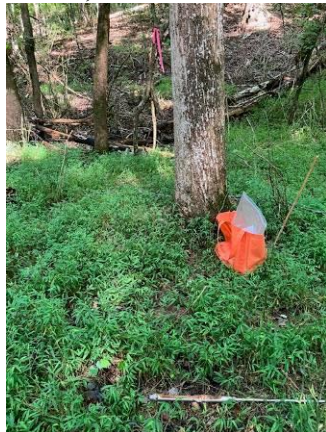
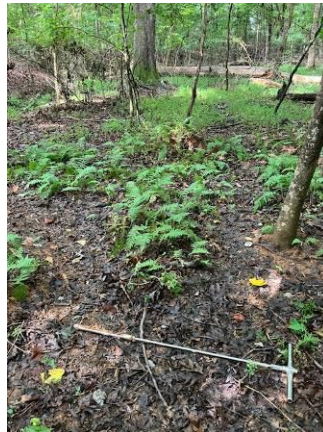
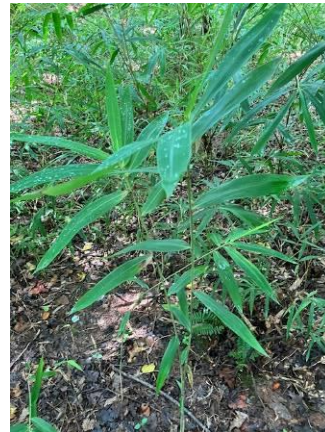
Plants;

The site has very limited diversity of grasses and ferns. There are also limited Herb, Shrub, and Sapling stratum of species. Areas of Japanese Stiltgrass, *Microstegium vimineum*, and Virginia Chain Fern.

Smilax bon-nox and Graybark Grape were two vines identified.

The trees identified are typical for this type of drainage area. Large trees are Tulip Popular, White Oak, Sweet Gum, White Ash, Sugarberry, and Sourwood.
