Report: 082919-shearer

Inspection Address: 18700 182nd St., Tonganoxie, KS 66086

Date: August 29, 2019

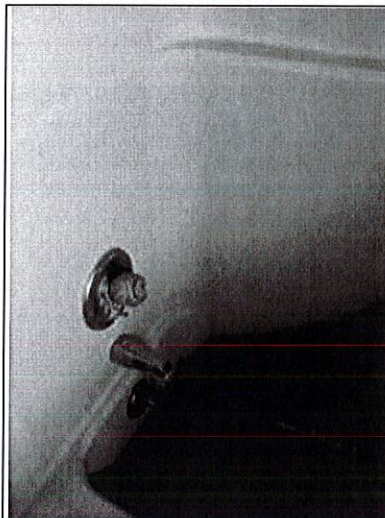
Shower/ Tub

The shower diverter does not fully divert water to the shower head. Recommend having a plumber replace diverter faucet. A loose tub faucet was noted on the following bathrooms. Recommend properly securing and caulking around the tub faucet.
