# 301 River Oaks Dr Gatesville, TX 76528

# **PROPERTY INSPECTION REPORT**

<b>Prepared For:</b>	Nichole Munday	
•	(Name of Client)	
Concerning: By:	301 River Oaks Dr, Gatesville, TX 76528	
	(Address or Other Identification of Inspected Property)	
	Brian Healy, Lic #21734	10/17/2019
	(Name and License Number of Inspector)	(Date)

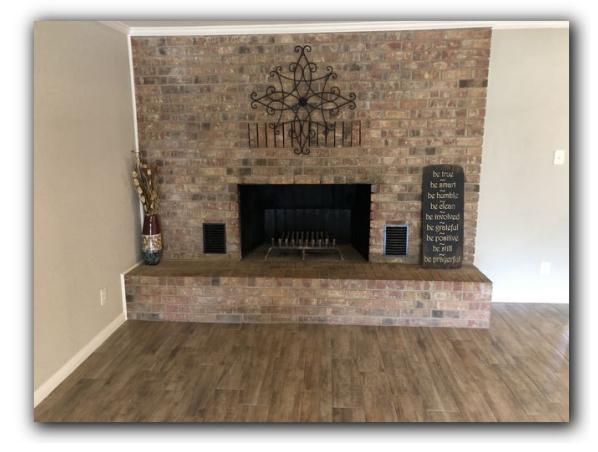
There was a wood burning fireplace in the living room.

This unit is equipped with a warm air circulator fan. A fireplace insert that transforms standard built wood-burning fireplaces into a more efficient heat producer for the home.

The switch for the fan is located to the right side side of the fireplace.

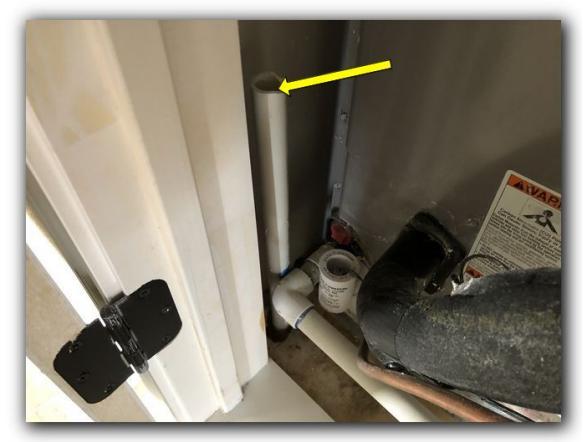
A vent stack has been added to the primary condensate drain line at the air handler, this vent is used to add a cup of vinegar once a month in the warmer months, to aid in keeping the line free of mold and mildew.

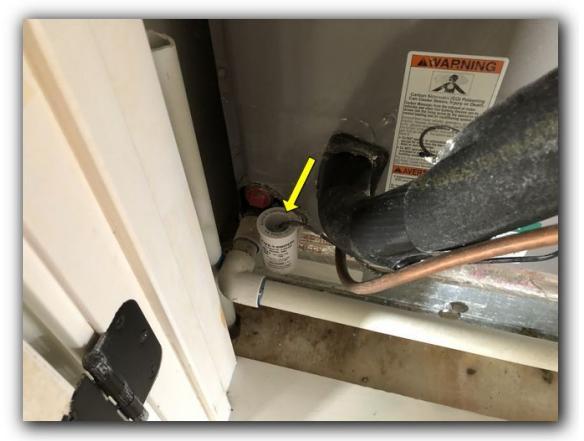
An overflow shut off switch has been installed on the secondary condensation drain line. The switch was tested and performed as intended.

This switch should be tested occasionally to ensure it is working. Pull the switch out of the housing and lift up on the float, the system and thermostat should shut down momentarily. Once the float is returned to its normal position the system should resume operation. This switch housing can be used to add a cup of vinegar once a month in the warmer months, to aid in keeping the line free of mold and mildew.

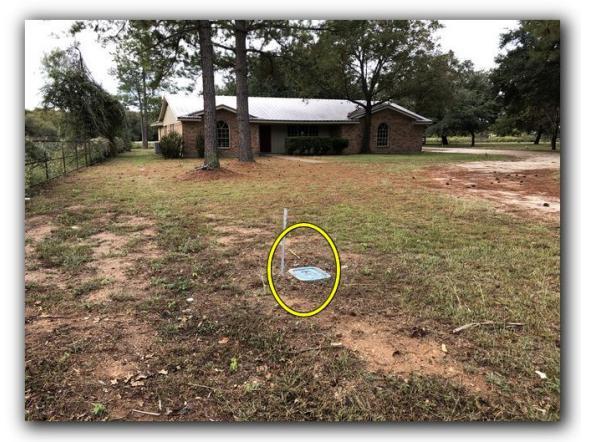
The water meter was located in the front yard near the street.

The main water supply valve is the water meter.

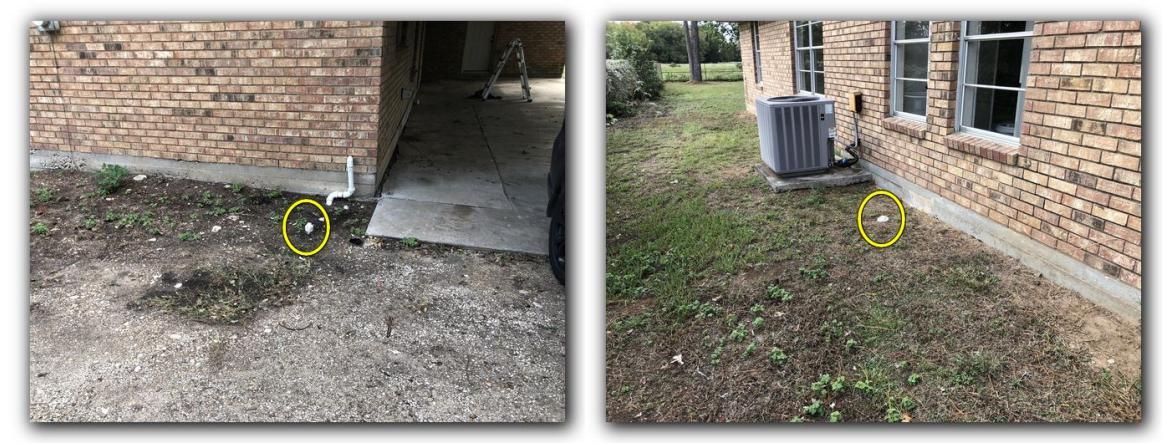
The main sewer clean outs were located on the left and right sides of the home.

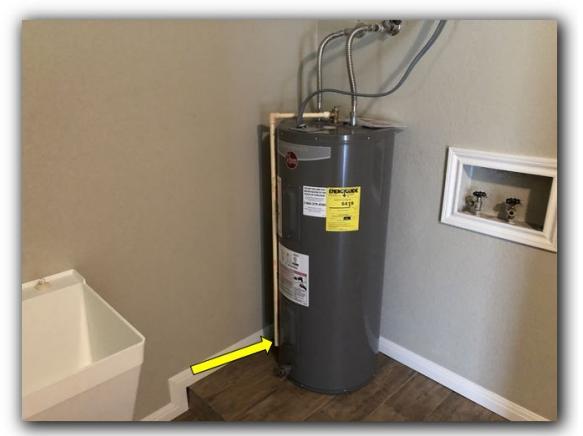
This report was prepared by Healymonster Home Inspections for Nichole Munday Page 31 of 40 The end of the TPRV (Temperature & Pressure Relief Valve) was correctly terminated.

TPRV must end either over a floor drain, into the water heater drain pan or to the exterior of the home.

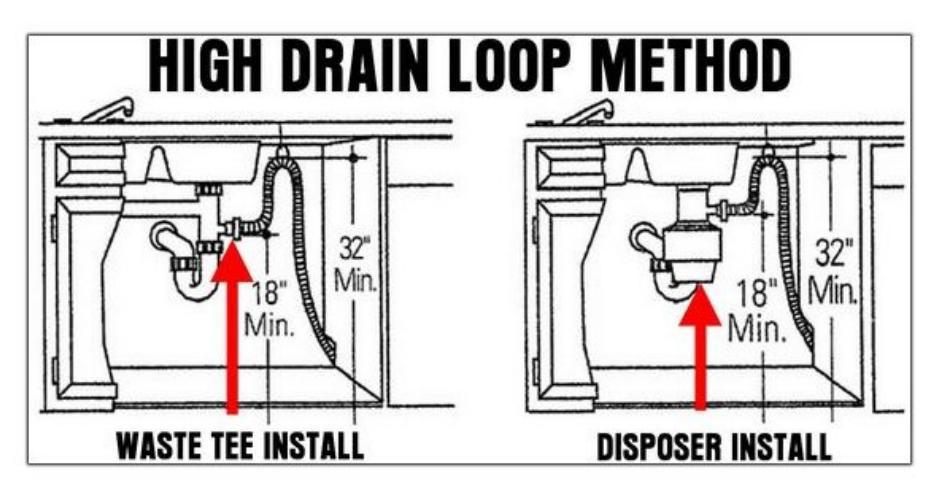
This is the correct drain line configuration known as a high drain loop.

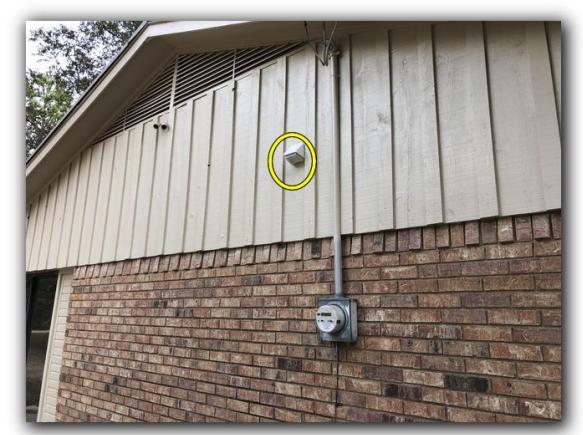
I=Inspected	NI=Not Inspected	NP=Not Present	D=Deficient	
I NI NP D				
	G. Garage Door Operators Comments:			
$\square \square \square \square$	H. Dryer Exhaust Systems Comments:			
	All locations are give	n as if facing the home.		
	The dryer vents throu	igh the right side wall.		
	The dryer vent has a s	screen over the opening

<u>Note:</u> Screens shall not be installed at the duct termination. Screens can cause a buildup of lint which can become a fire hazard.
