# *HHI LLC*

## Property Inspection Report

20318 S McNew Rd, Pretty Prairie, KS 67570  
Inspection prepared for: Kendra Kutcha  
Real Estate Agent: Kendra Kuchta - J. P. Weigand and Son's McPherson Branch

Date of Inspection: 8/4/2022 Time: 1:30 PM  
Age of Home: 2004 / 18 Years Size: 2670 Sq Ft  
Weather: Sunny / 96

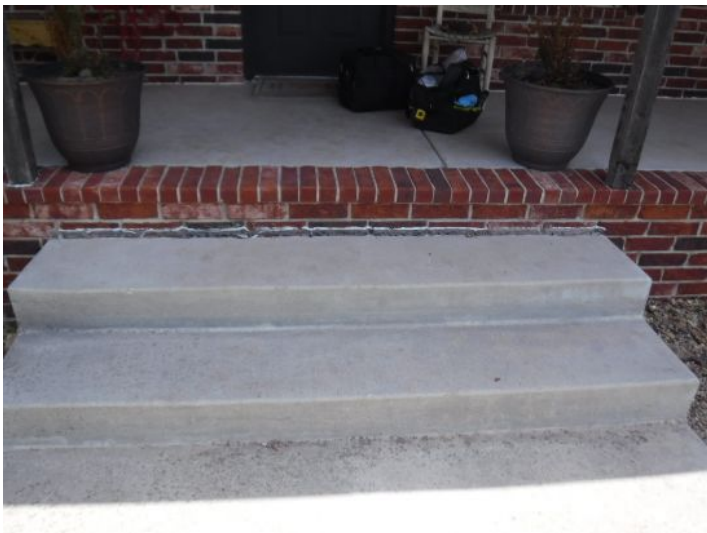
The front steps have settled

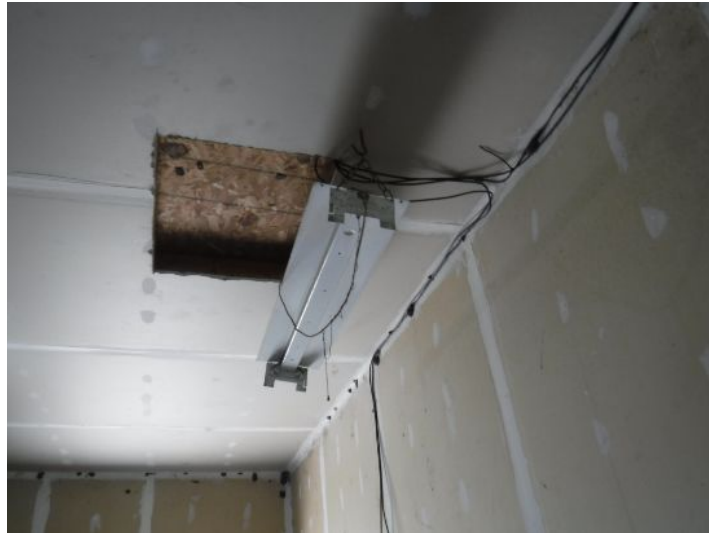
OSB covers for attic access are not a fire rated material
