**Phase I Environmental Site Assessment  
Burg Tract  
131 Elberta Street  
Stonewall, Texas 78671**

**Project No. 2561**

**June 10, 2021**

William K. Duran, P.G.  
Environmental Professional

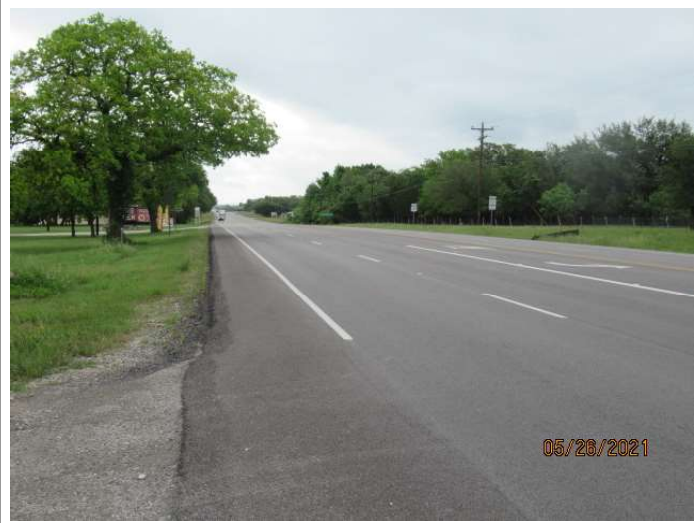
Viewing east along US Highway 290.

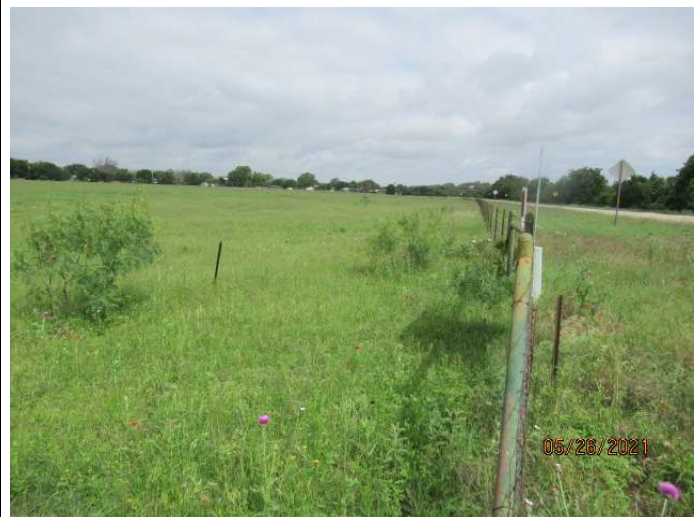
Viewing west along north property fence line.

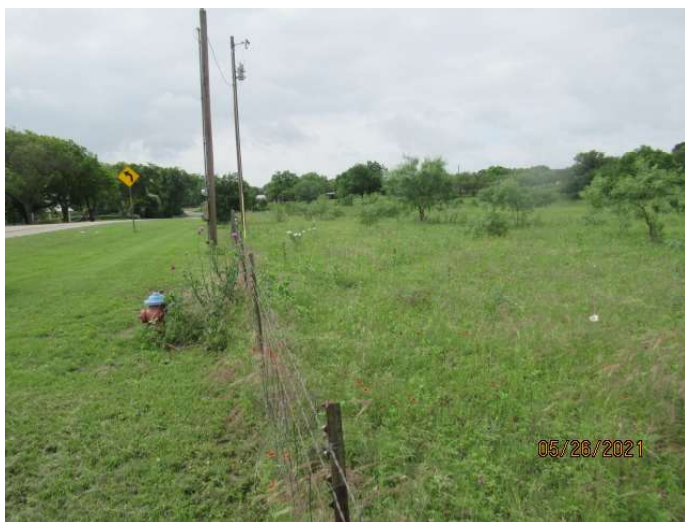
Viewing east along north property fence line.

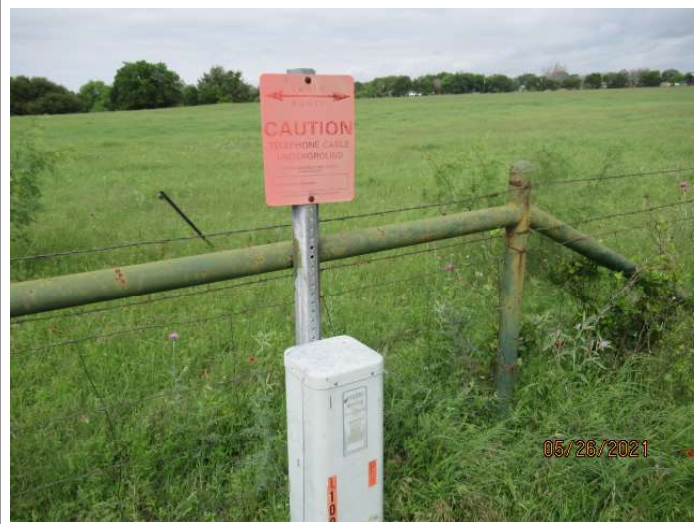
Telephone cable warning post located on north side.

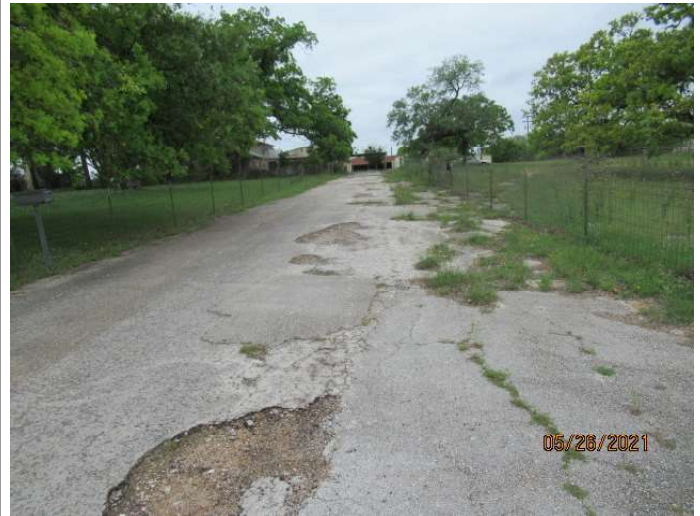
Driveway to home and buildings via Elberta Street.

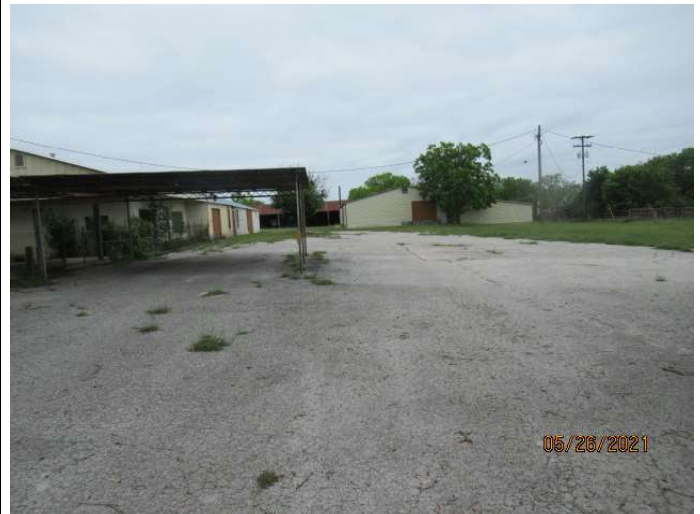
Parking area and canopy observed on the property.

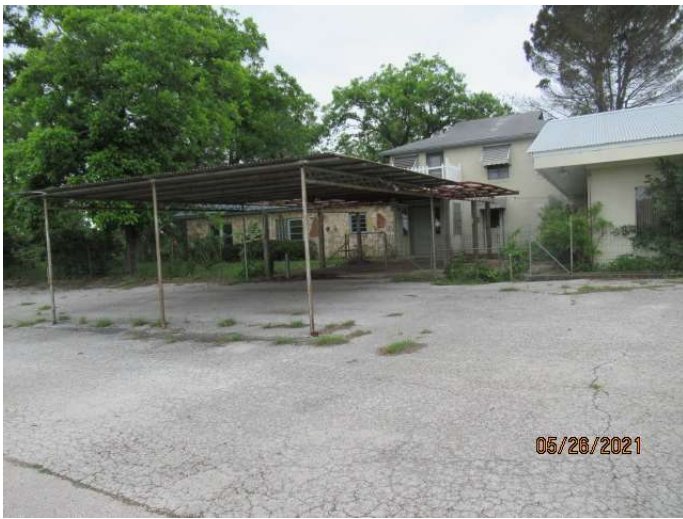
Front entrance into home under the metal canopy.

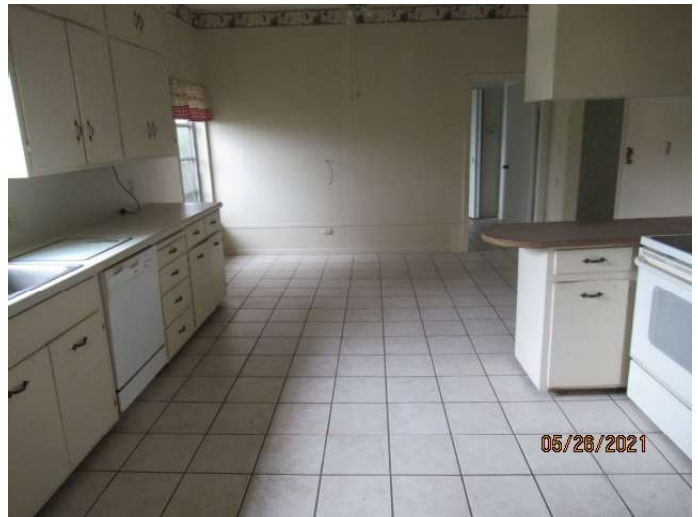
View of kitchen inside the vacant home.

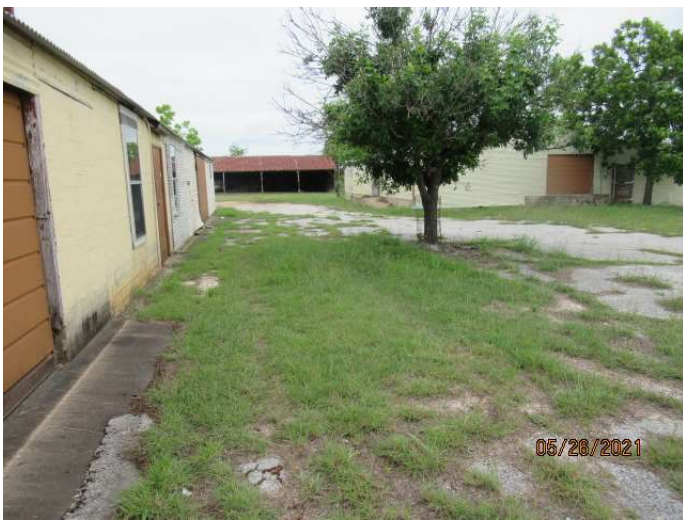
- Historical aerial photographs, interviews and historical city directories indicated the subject property had been previously developed with raising livestock along with agricultural sprayer repair shop called John Bean Sprayer and a tack shop.

Former sprayer shop located west of home.

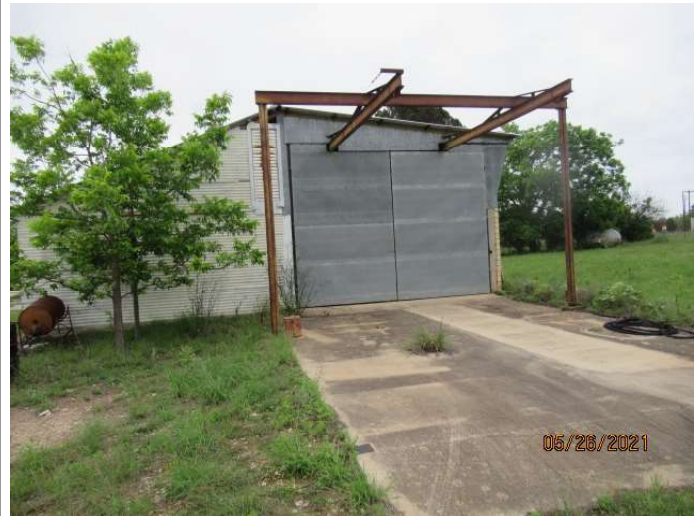
View of west side of vacant shop.

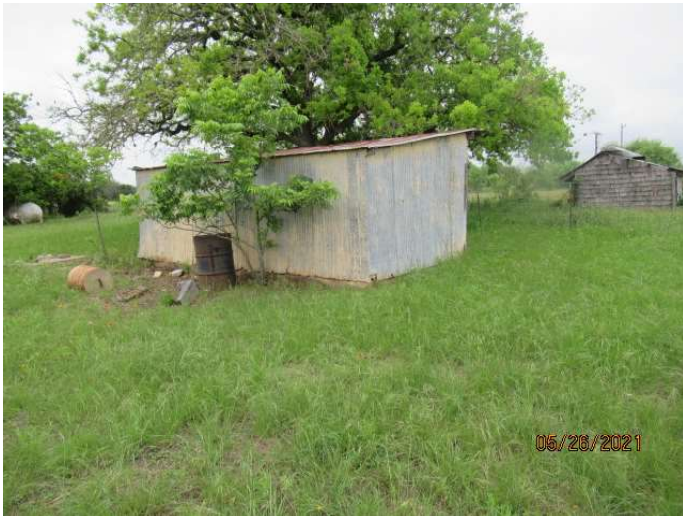
Storage shed observed on west side of property.

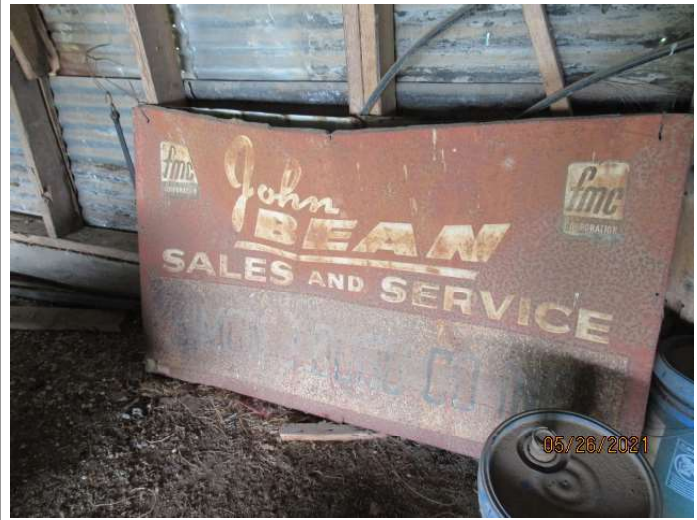
Former occupant sign observed in shed.

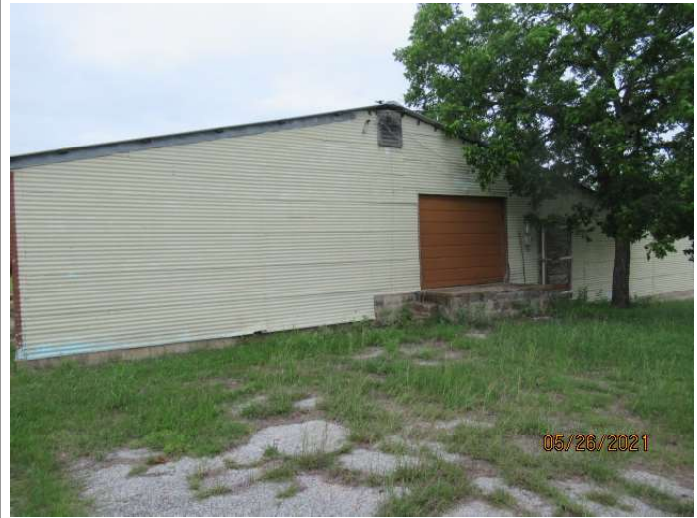
View of east side of chemical warehouse.
