## Structural Engineering

Re: Tier 1 Foundation Evaluation of a Residence at 15469 SH 135 S, Overton, Texas

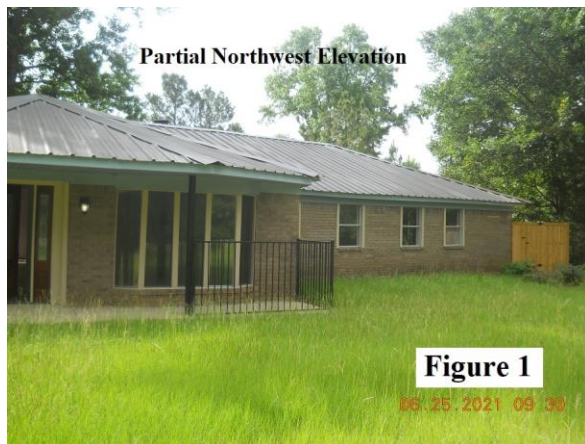
The residence (Figure 1) is a timber framed structure constructed on a monolithic cast-in-place reinforced concrete foundation with a modular masonry façade. The house was constructed in 1979 and faces approximately northwest. No geotechnical information regarding the engineering properties of the subsoil or structural drawings describing the construction of the concrete foundation were available.

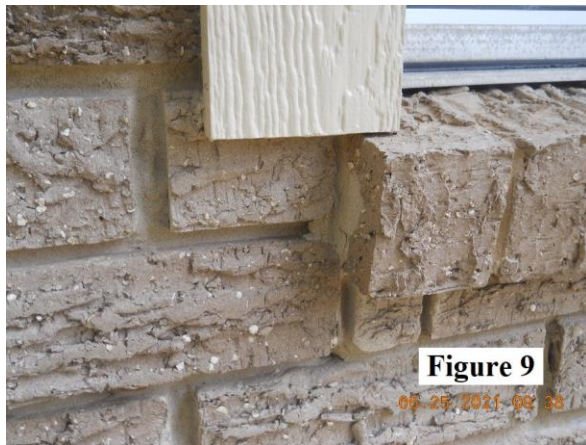
Figure 7 is an example of extremely minor additional movement after the suspected repairs were made. Figure 9 shows a possible example of a repair found along the southwest elevation in Figure 8.

As can be seen in several photographs, the foundation perimeter dimensions were greater than the architectural masonry dimensions. Refer to Figures 8, 13, 14, 17, 18, etc. for examples of this observation. Normally the masonry and the exterior of the foundation align vertically and there is no “step” of the foundation beyond the line of masonry. This can allow rainwater to dwell on this horizontal surface and potentially invade the interior. No evidence of this was seen on the interior but keep in mind that this interior had been recently painted. Please refer to my comments on this observation in the Conclusions section below.

The possible moisture incursion due to the "step" in the masonry/foundation interface (Figures 8, 13, 14, 17, 18, etc.) can be minimized by cleaning the area during a period of dry weather with a wire brush and compressed air and applying several coats of masonry/concrete sealant according to the particular

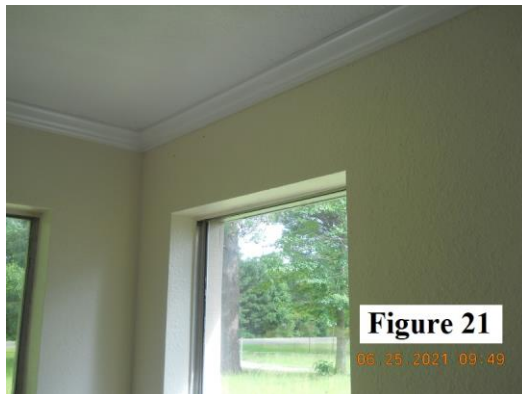
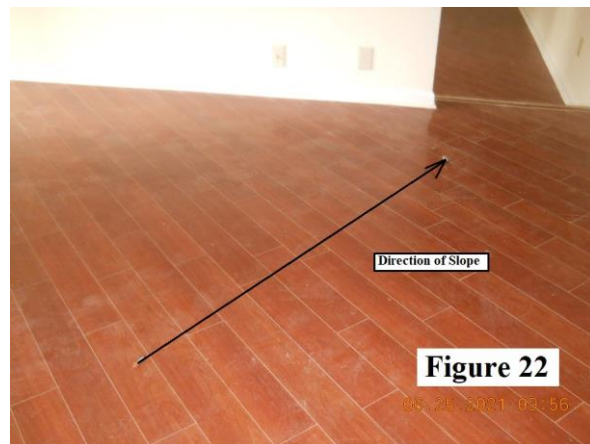
Figures 20 and 21 are examples of areas where this potential distress occurs. All similar details in the interior were examined with no evidence found of recently repaired distress.

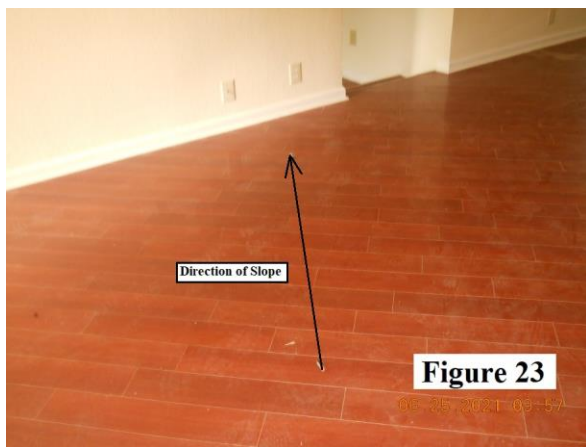
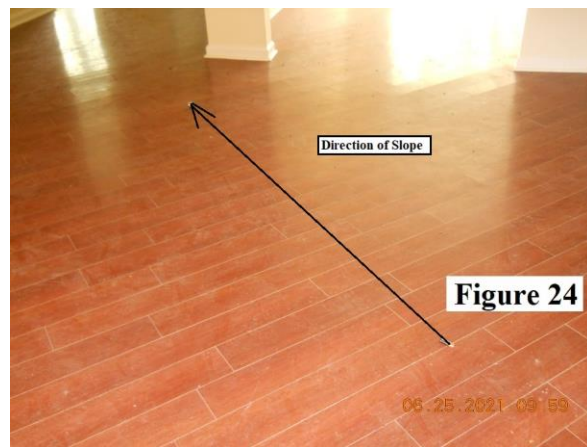
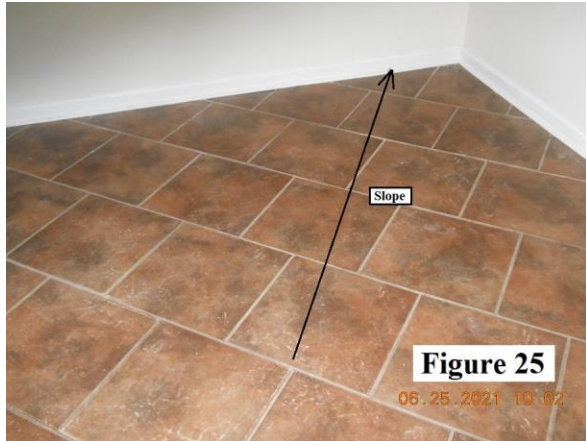
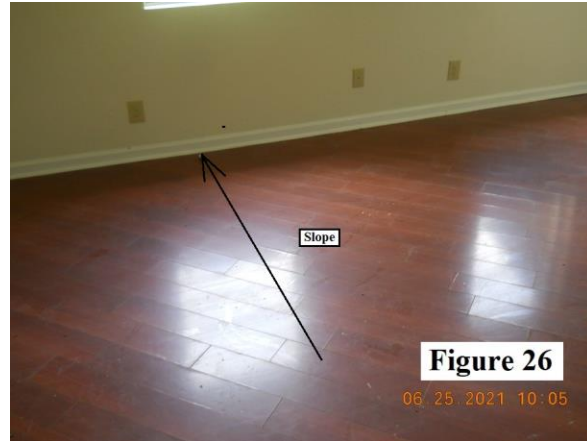
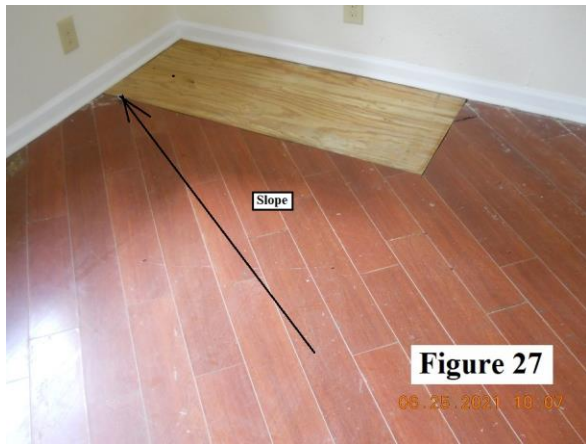
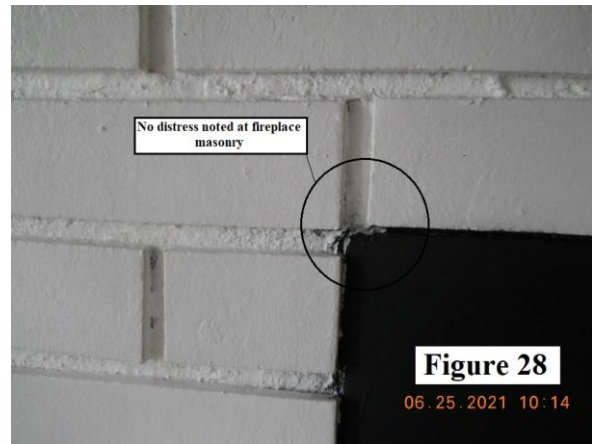
I then inspected the uneven flooring which was quite obvious throughout the residence but was much more noticeable in the entry and main living areas and immediately adjacent rooms. Please refer to my comments in the Conclusions section of this report for further discussion of this condition. Figures 22-27 document this unevenness and floor slope.

To conclude, I doubt very much that the differential movement of the foundation has had much effect on the unevenness of the interior flooring. A large portion of the unevenness can be attributed to very poor workmanship in the finishing of the slab. The topography of the interior floor indicates a general slope to the exterior. If there exists problematic soil below the interior, the swelling of this soil could possibly cause the effects observed but there was no indication of this in any of the exposed concrete substrate. Most of the substrate was covered by tile or wood flooring however.
