Lot # 2 and 18

# PERCOLATION TEST CERTIFICATION

(1) Physical location of lot 2 lots down on right side of Bay Elder Lane.

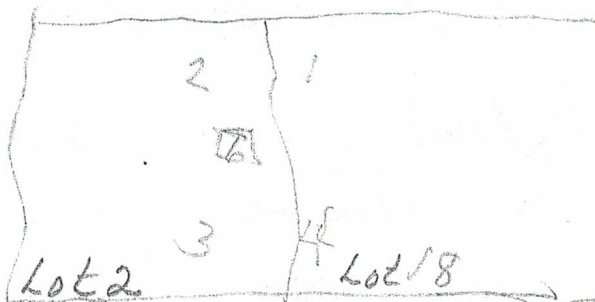
Location of Percolation Test/six foot hole on lot set in middle of both lots all holes are marked Lot 2

Village Rd

Box Elder Lane
