TO: Hardy County Health Department, Moorefield, W.V.

FROM: Name Hunter Co. of WV Phone 1-304-262-2770Address 1800 West King St. Martins WV 25401RE: Property Location Ashton Woods Sub.

Request is hereby made for a site investigation to determine the suitability of the subject property as a site for the small sewage system indicated below:

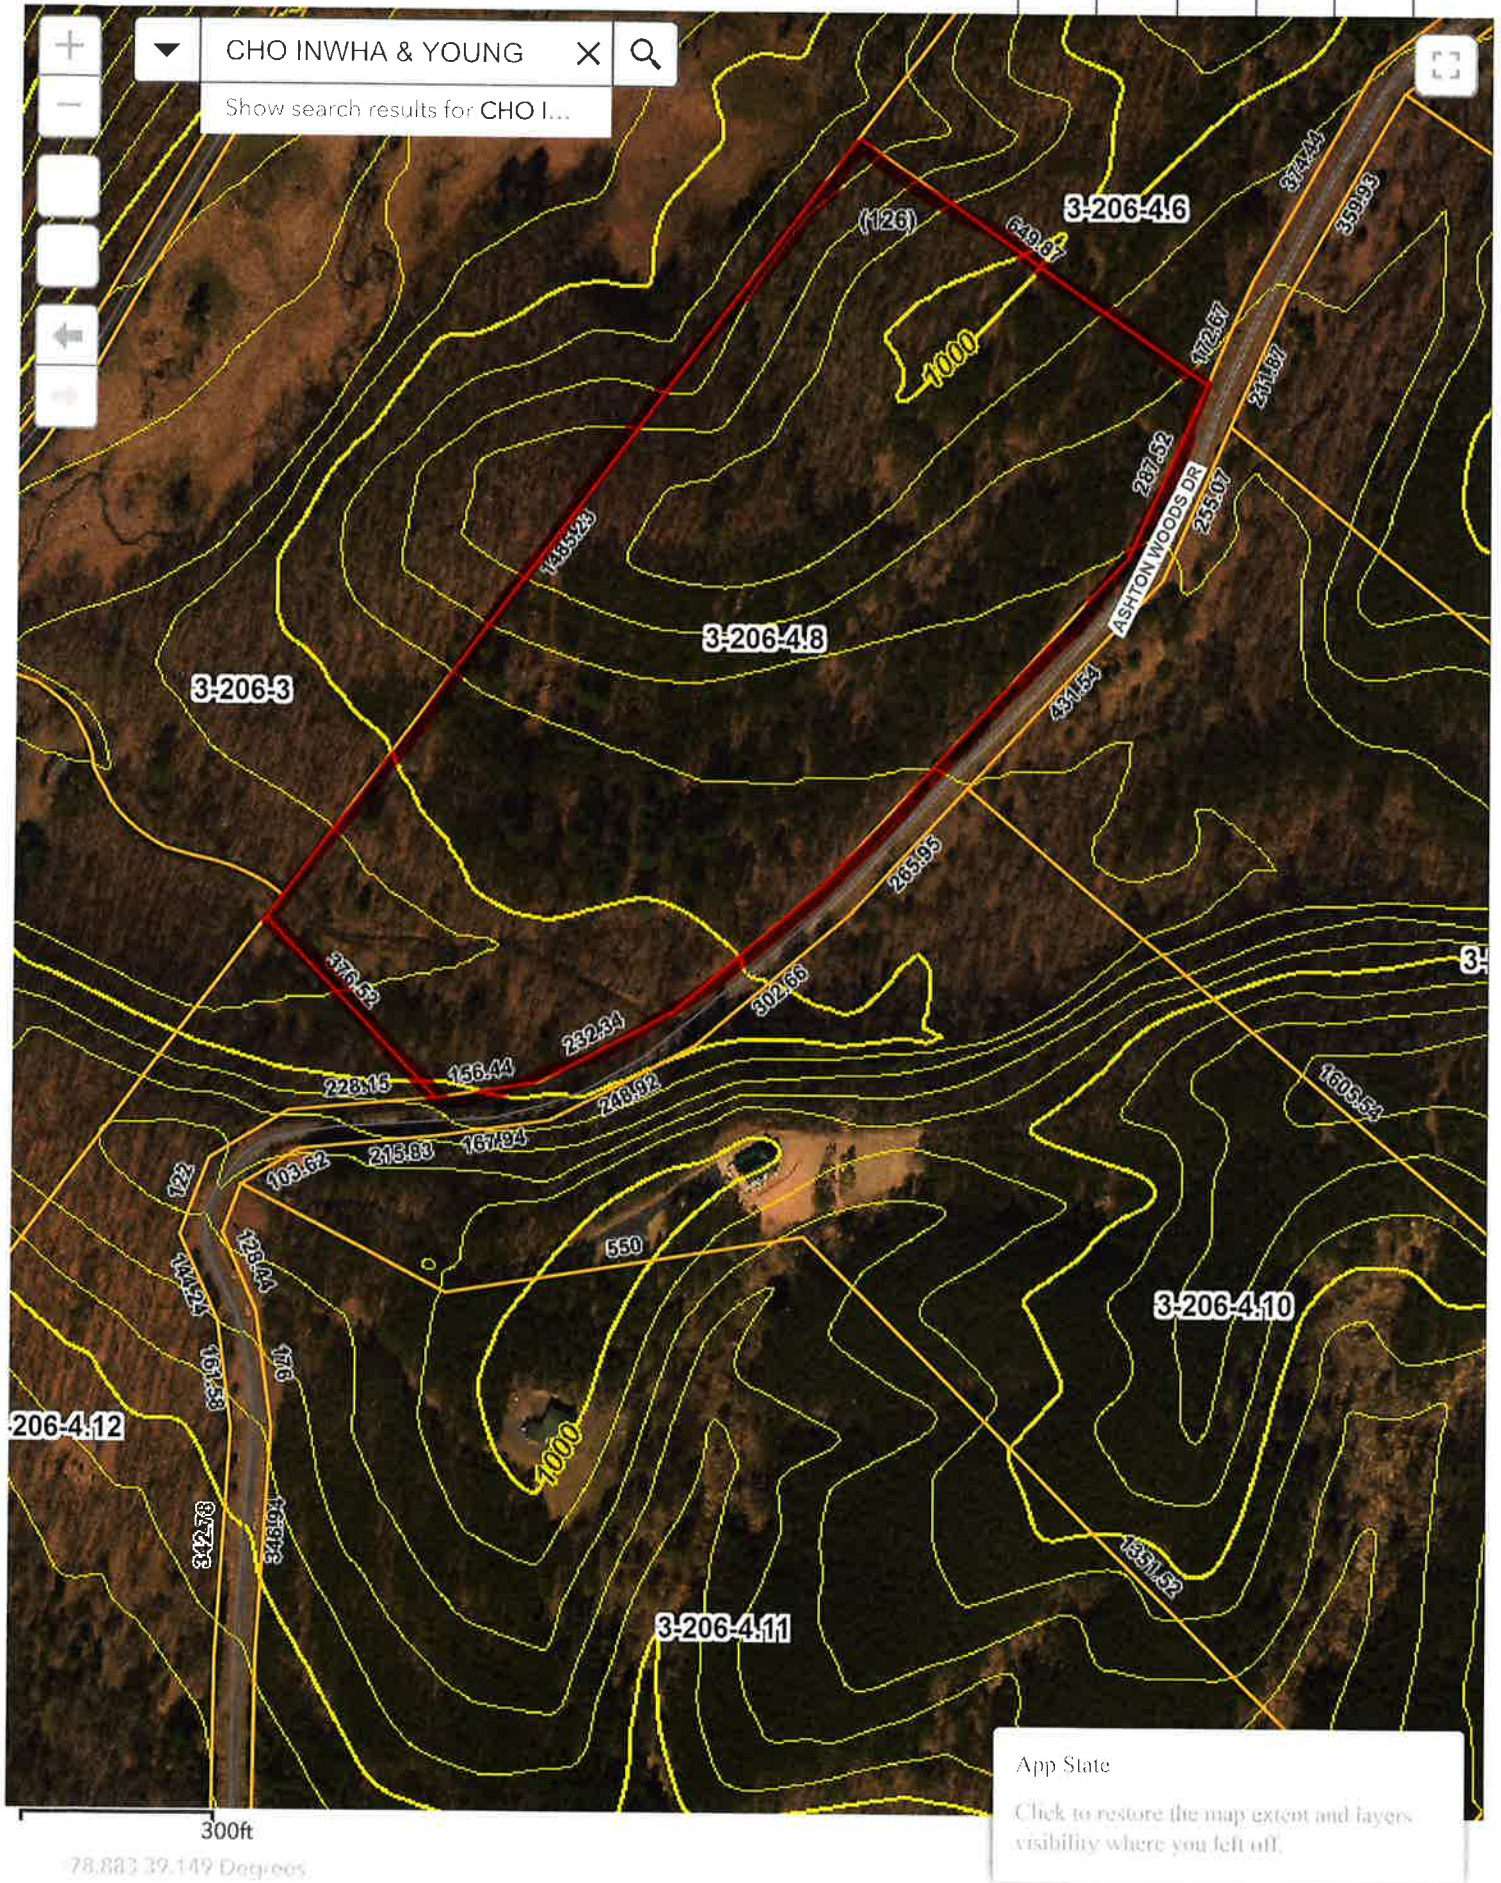
On the back of this form a plot layout has been sketched showing the property lines and relative locations of buildings, water supplies, percolation test holes, six ft. hole, and other pertinent features.
