# WOOD DESTROYING PESTS AND ORGANISMS INSPECTION REPORT

| Building No.<br>6320 | Street<br>Vineyard Dr. | City<br>Paso Robles | ZIP<br>93446 | Date of Inspection<br>08/27/2021 | Number of Pages<br>5 |

| GENERAL DESCRIPTION:<br>FURNISHED AND OCCUPIED ONE STORY WOOD SIDED RESIDENCE WITH ATTACHED GARAGE ON A RAISED FOUNDATION AND COMP ROOF | Inspection Tag Posted:<br>Meter Box<br>Other Tags Posted: |

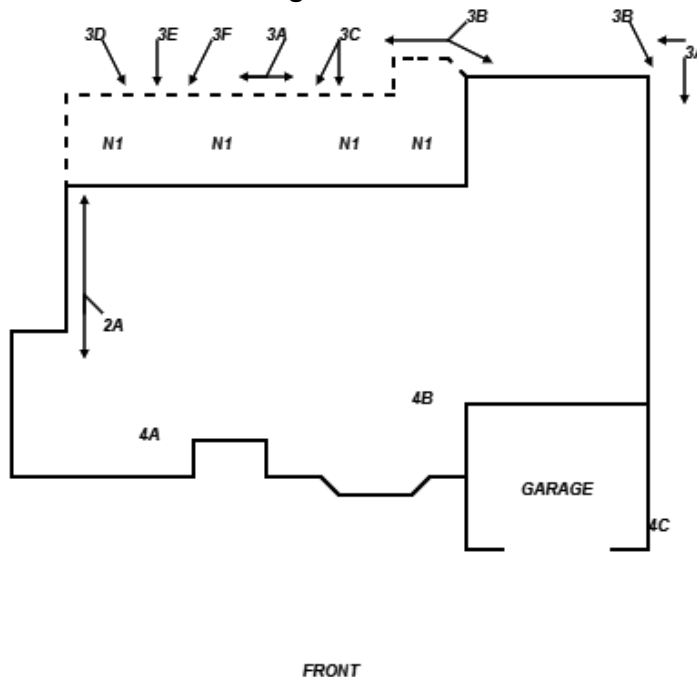
**Diagram Not To Scale**

An inspection has been made of the structure(s) shown on the diagram in accordance with the Structural Pest Control Act. Detached porches, detached steps, detached decks and any other structures not on the diagram were not inspected.

FINDING-Evidence of Drywood termite infestation noted at the substructure framing. Infestation appears to extend into inaccessible wall framing.
