SOIL ANALYSIS MAP FOR :  
Leon Slocumb

**Level 3 Soil Study****Owner Name:** Leon Slocumb**County:** Paulding**Site Address:** Tract 1 Browning Rd Villa Rica Ga**Date:** 5/9/2022**GPS Location:** 33°48'16"N 84°58'35"W**General Soil Profile Descriptions**

**Level 3 Soil Study****Owner Name:** Leon Slocumb**County:** Paulding**Site Address:** Tract 2 Browning Rd Villa Rica Ga**Date:** 5/9/2022**GPS Location:** 33°48'16"N 84°58'35"W**General Soil Profile Descriptions**

**Level 3 Soil Study****Owner Name:** Leon Slocumb**County:** Paulding**Site Address:** Tract 3 Browning Rd Villa Rica Ga**Date:** 5/9/2022**GPS Location:** 33°48'16"N 84°58'35"W**General Soil Profile Descriptions**

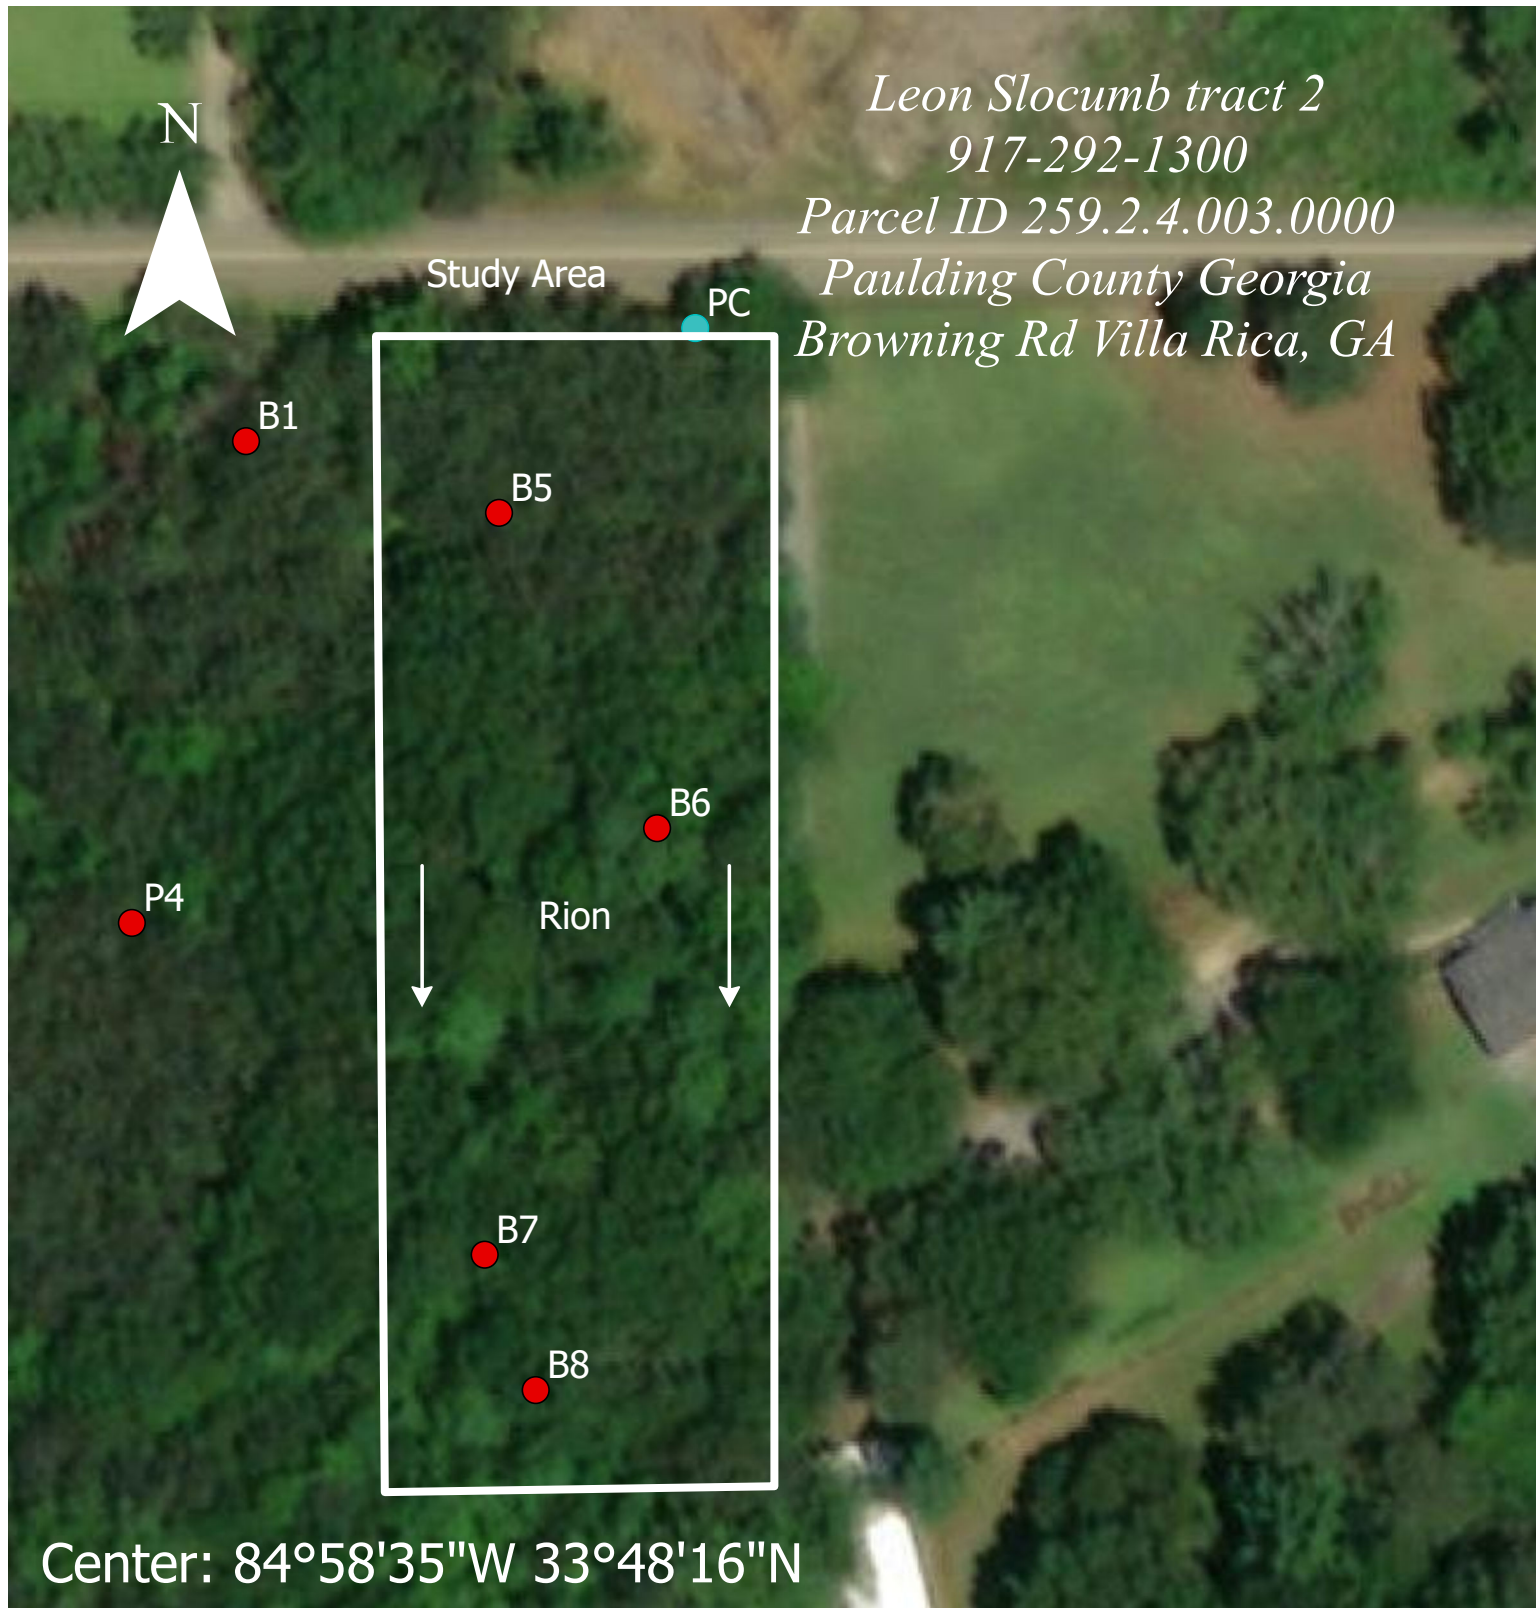
SOIL ANALYSIS MAP FOR : Leon Slocumb	
HENDON ENVIRONMENTAL 128 Berry Street Mentone, AL 35984 PHONE: (423) 463- 5216 EMAIL: Tony@hendonenvironmental.com	
Date Signed: 5/9/2022	Revision #:
File #:	Scale: 1 inch = 80 ft

Test Hole Number	5	6	7	8		
Slope (Percent)	6-10%	6-10%	6-10%	6-10%		
Closest Series	Rion	Rion	Rion	Rion		
Depth to Rock (In)	>60	auger refusal @20"	auger refusal @36"	auger refusal @28"		
Depth to Water Indicators (In)	not encountered	not encountered	not encountered	not encountered		
Estimated Perm. (min/in)	75	75	75	75		
Trench Depths	36	36	36	36		
Loading Rate						
Suitability Code	A	AB	A/B	A/B

These soils are suitable for installation of on-site systems with proper system design, installation, and maintenance. Position of the site or other soil and landscape considerations may require the drainfield area to be greater than the minimum and/or the drainfield design to require equal distribution or level field installation.

Some rock and or stony conditions were found. This soil should function as a suitable absorption field. Borings were advanced deep enough within the map unit to show adequate depth for installation as reported. These soil types commonly have rock inclusions throughout the soil profile which accounts for the reported auger refusal. Reported auger refusal is due to the stony conditions and not bedrock.
