# INSPECTION REPORT

For the Property at:  
**919 MAIN ST**  
BLANCO, TX 78606

Inspection Date: Thursday, May 20, 2021

Prepared by: Monica Baryo, PI# 24287

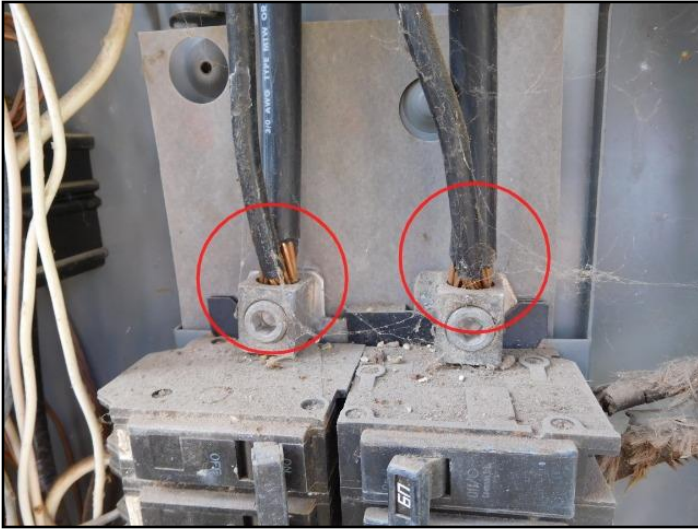
Service box: **Obsolete service box** Notes: **Not only is the main service disconnect a Challenger brand which is considered a fire hazard since they can fail to trip causing fires, there are double taps (two circuits connected to the same breaker or main terminal) there is cloth aluminum wiring going to the range which is also a fire hazard.**

7. Double taps

Service box: **Double Tap: Only way to fix this double tap is to add another breaker but this box cannot equip another breaker slot so the service box will have to be replaced.**

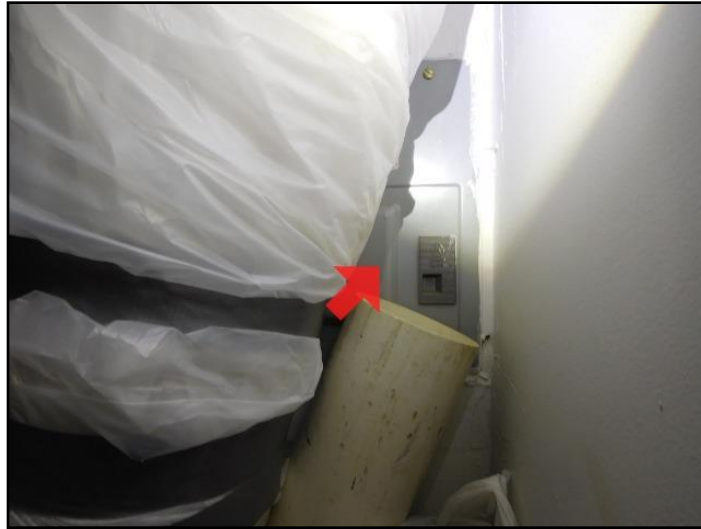
Distribution panel: **Poor location** Notes: **You may not have an electrical box located in a bedroom closet. This is a fire hazard.**

10. Poor location

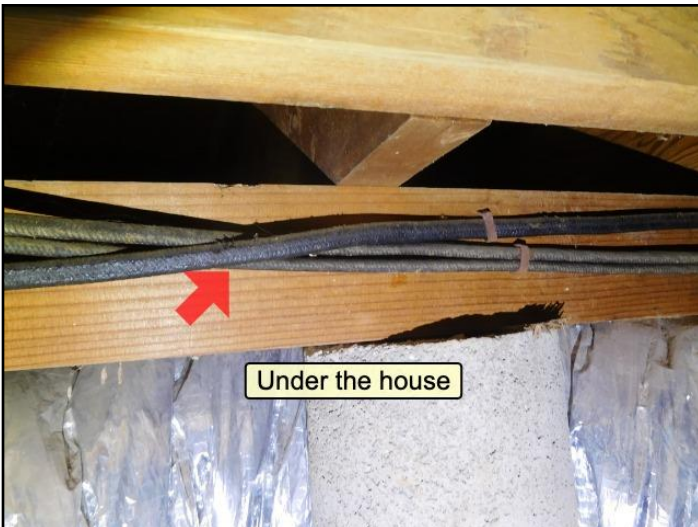
13. cloth wiring

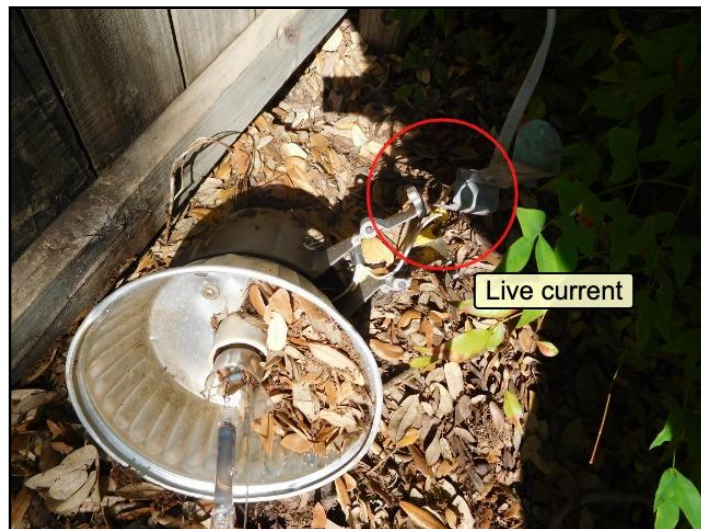
Outdoor wiring: **Wires not well secured to walls** Notes: **Outdoor lighting hanging off the wall with loose, LIVE and exposed wiring.**

16. Wires not well secured to walls

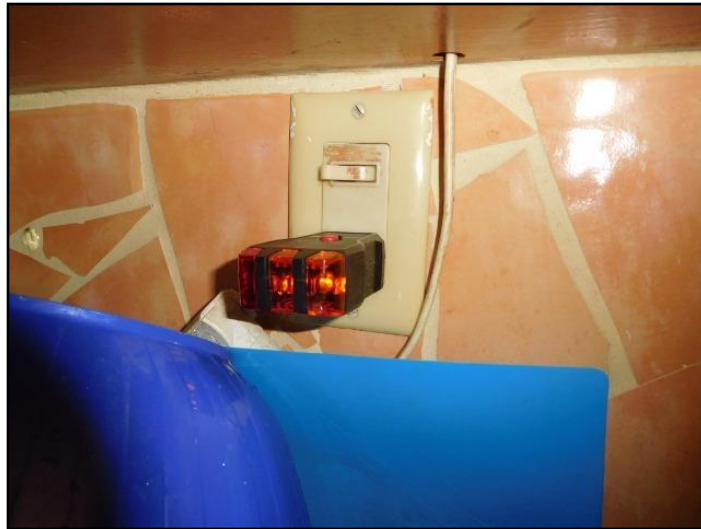
19. No GFCI/GFI (Ground Fault Circuit...

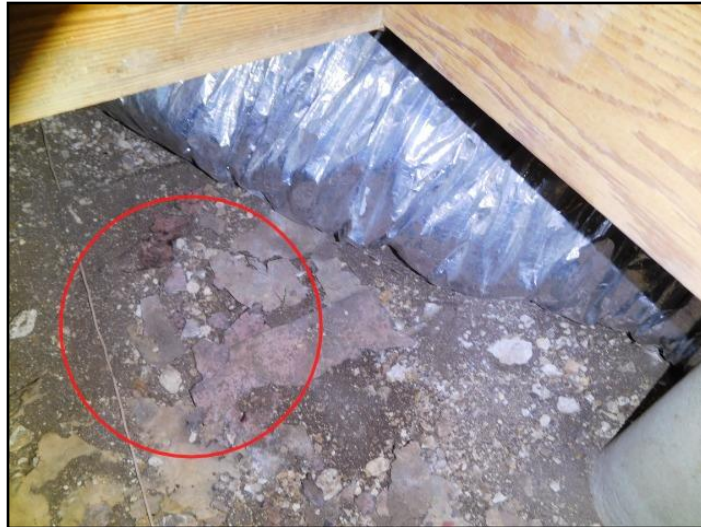
*23. No vapor barrier*

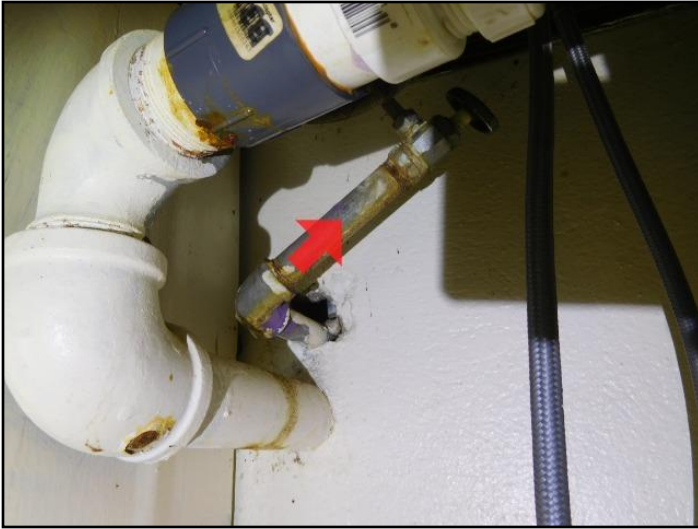
26. Galvanized steel

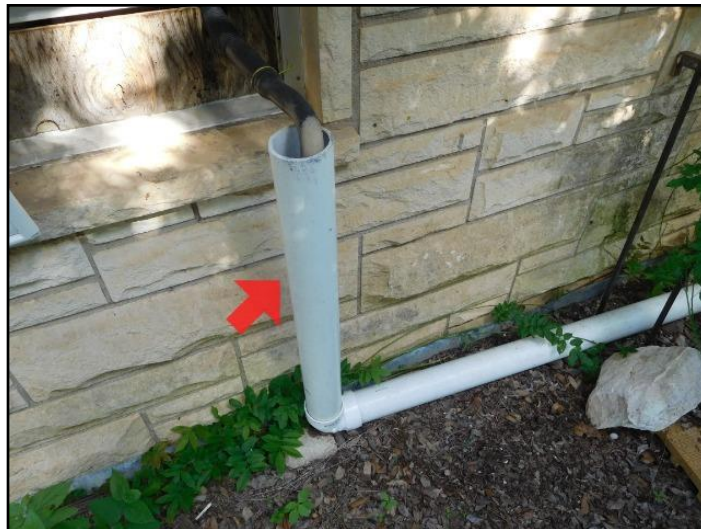
31. Washing machine waste pipe

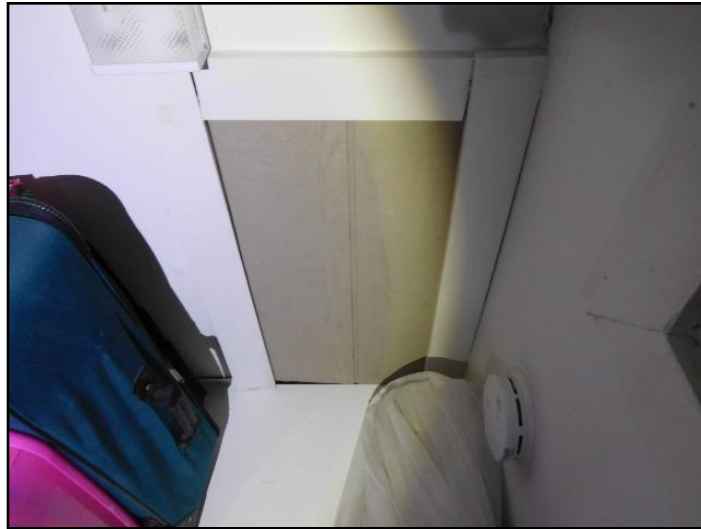
- Roof framing/attic viewed from attic
- No access was gained to the roof framing/attic Back house due to size of scuttle and storage blocking the access.

**43.** No access

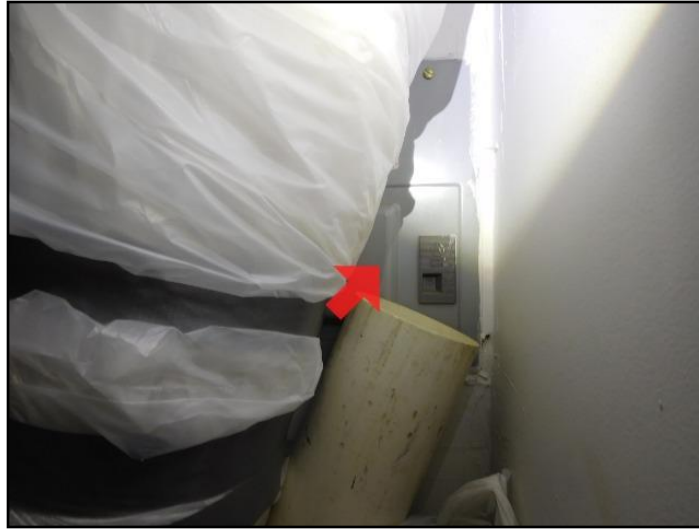
53. Poor location

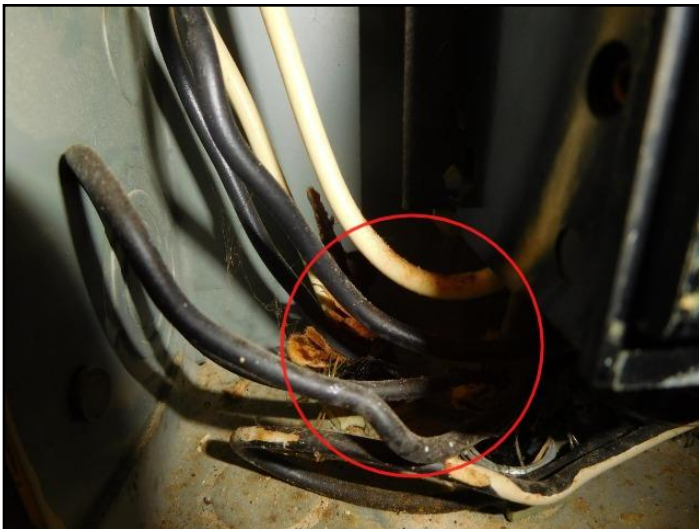
54. Ungrounded wiring - cloth

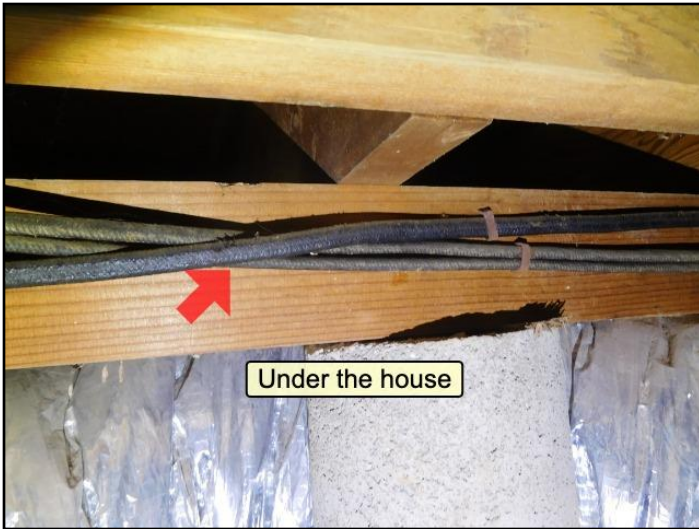
56. cloth wiring

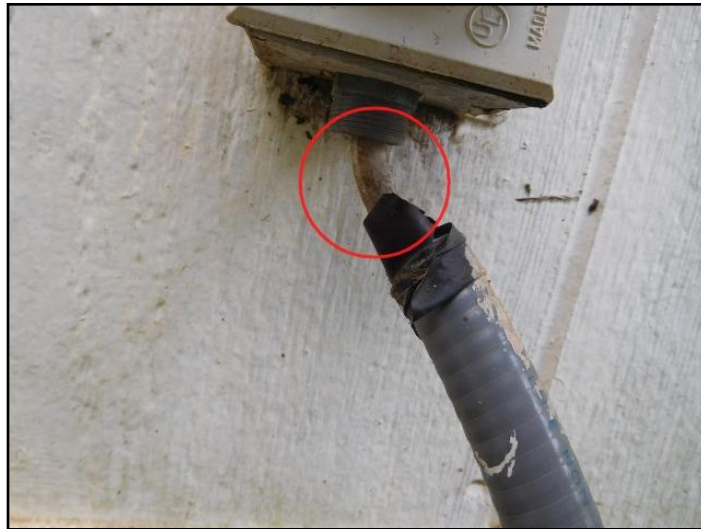
**62.** Wires not well secured to outlet box

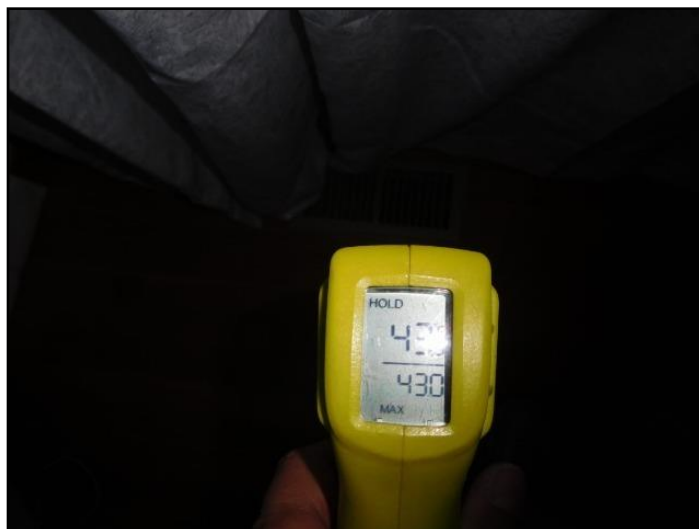
66. 43 degrees

**Supply temperature:** • 43 degrees

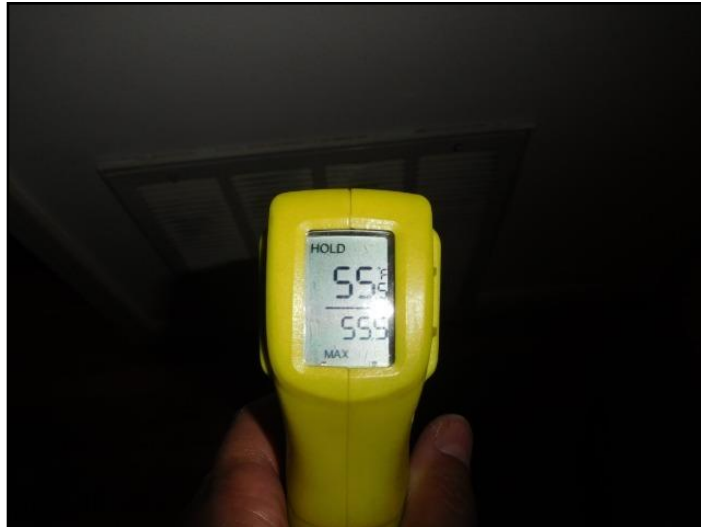
67.55°

**Return temperature:** • 55 degrees

**Temperature difference:** • This suggests performance issues. Service may be needed.

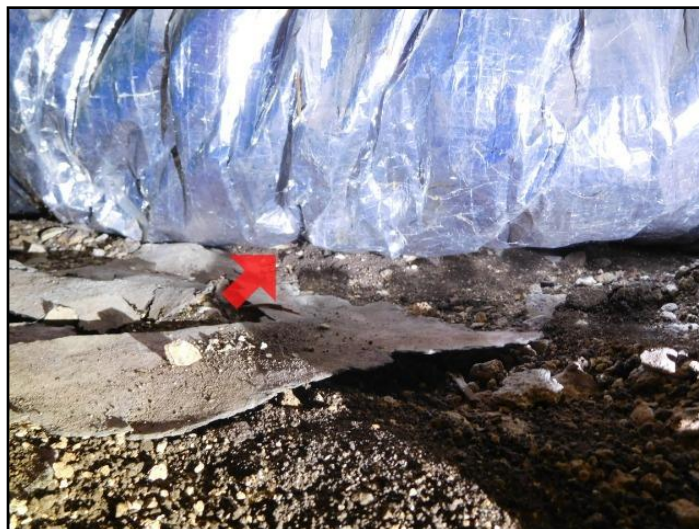
**18. Condition:** • Poor support

Ductwork should be supported off the ground due to moisture implications.

68. ductwork laying on the ground

**Task:** Correct

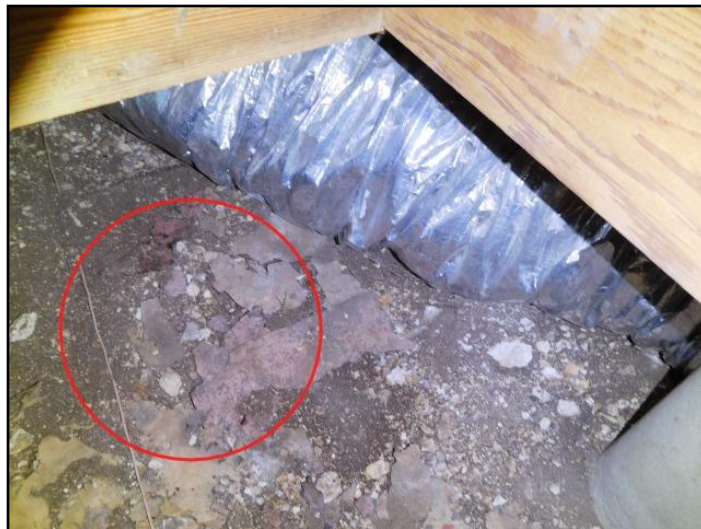
**20. Condition:** • No vapor barrier

**Implication(s):** Chance of condensation damage to finishes and/or structure

70. *No vapor barrier*

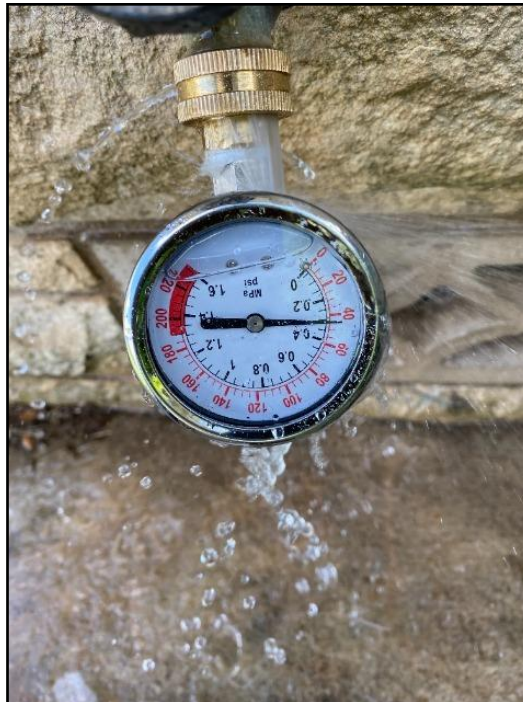
71. 45 psi

• 45 psi

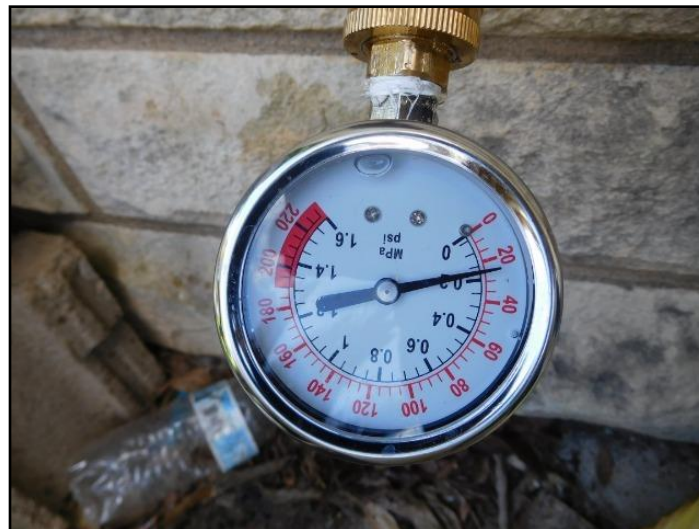
72.

**Static water pressure reading:** • 25 psi

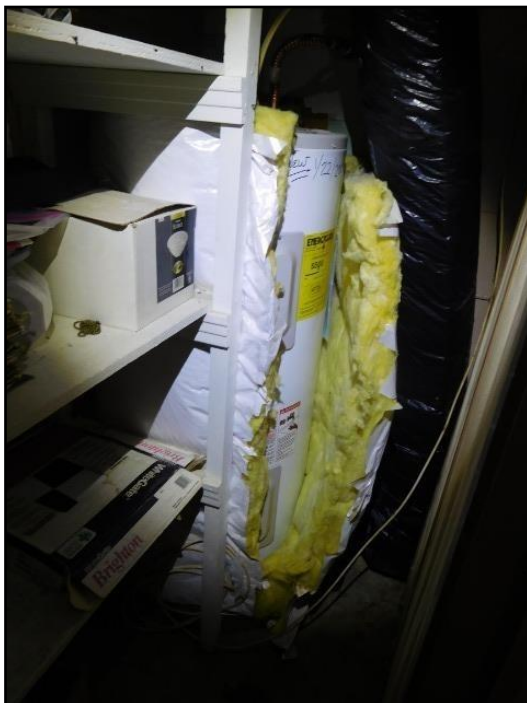
73. General Electric (GE)

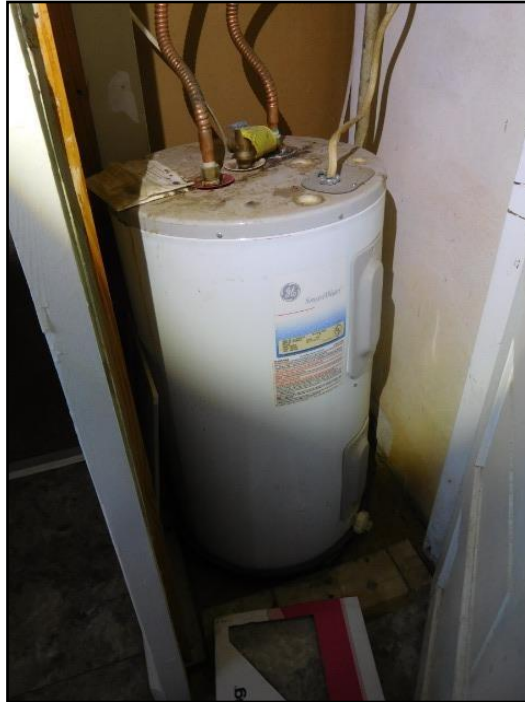
75. General Electric (GE)
