# *HHI LLC*

## Property Inspection Report

20318 S McNew Rd, Pretty Prairie, KS 67570  
Inspection prepared for: Kendra Kutcha  
Real Estate Agent: Kendra Kuchta - J. P. Weigand and Son's McPherson Branch

Date of Inspection: 8/4/2022 Time: 1:30 PM  
Age of Home: 2004 / 18 Years Size: 2670 Sq Ft  
Weather: Sunny / 96

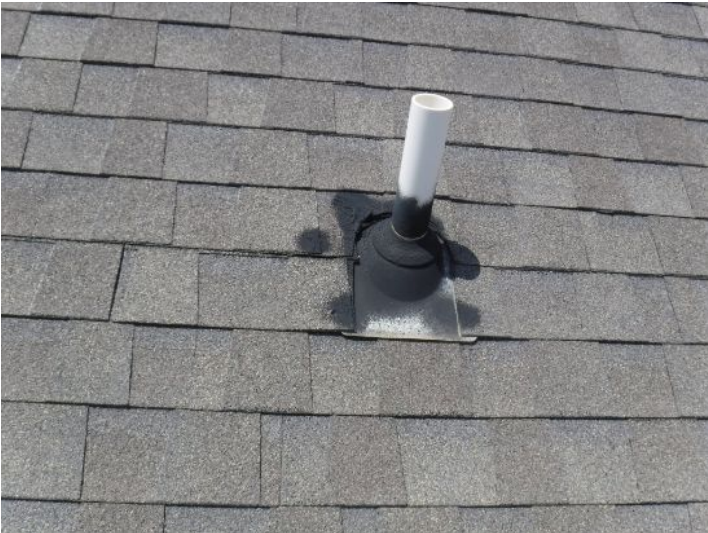
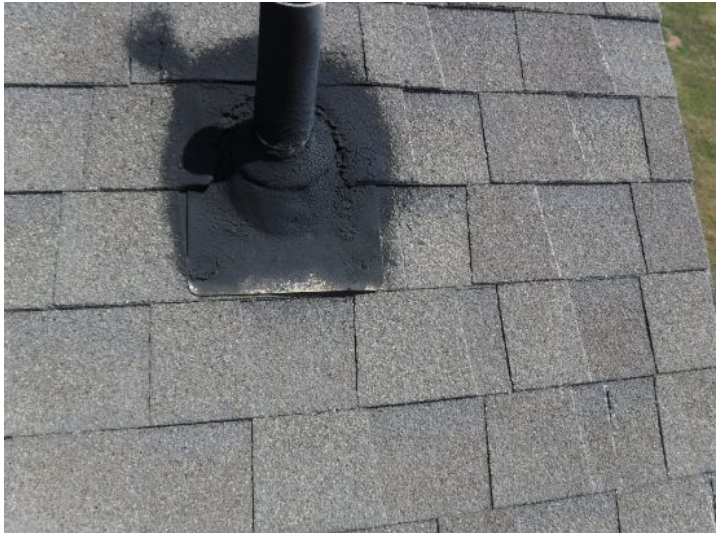
Spray sealant has been applied to the flashing around the roof, I wasn't able to determine the reason for the spray sealant but the sealant is beginning to weather check.

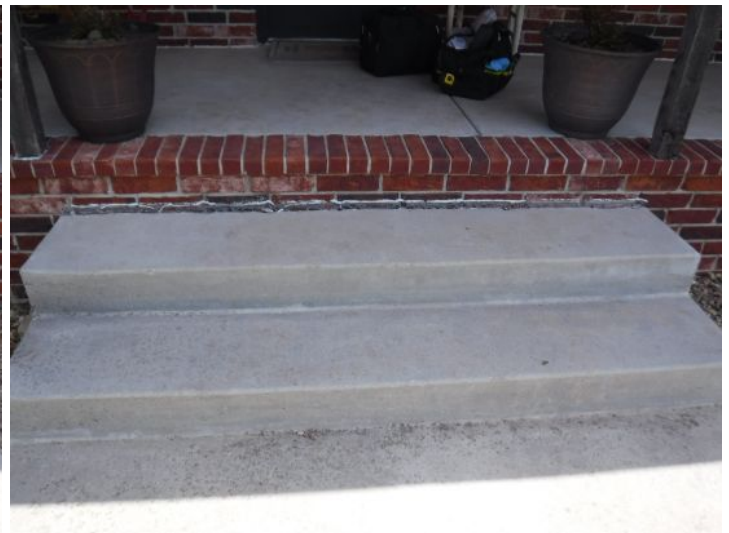
Some stair rises exceed 7 3/4"

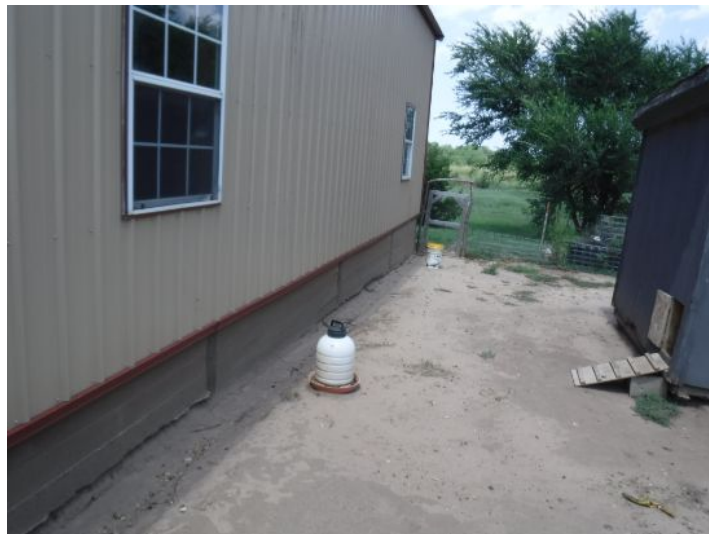
Maintain the erosion on the east side of the pole shed exterior to prevent fill sand washing out from under the floor slab.

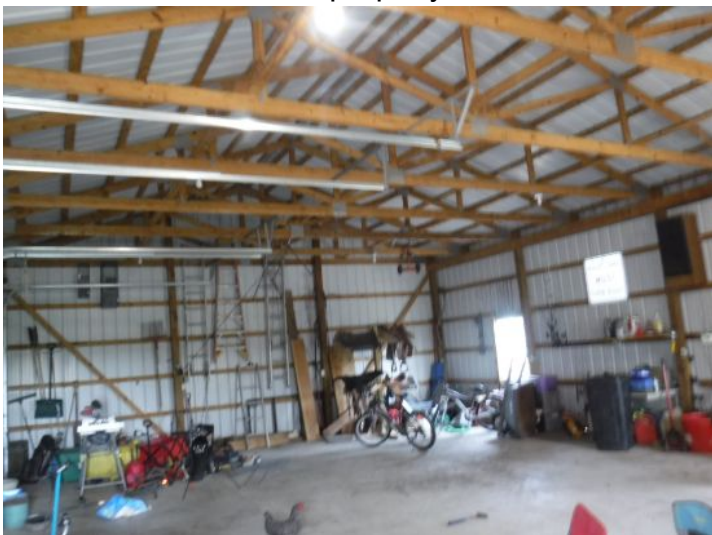
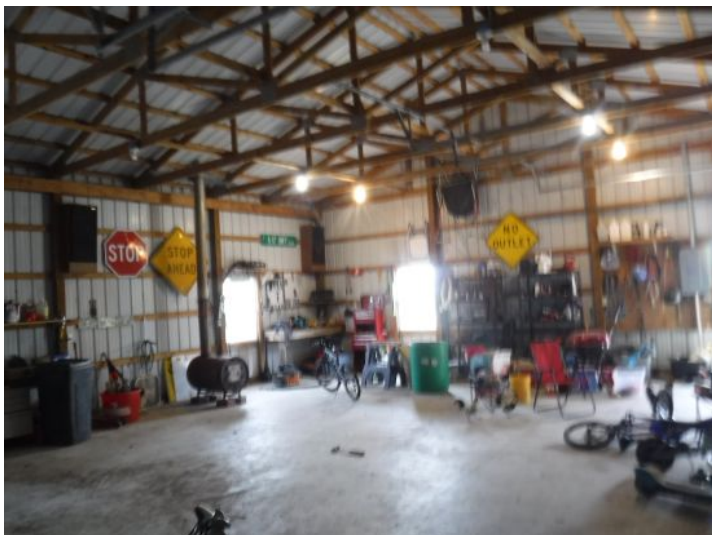
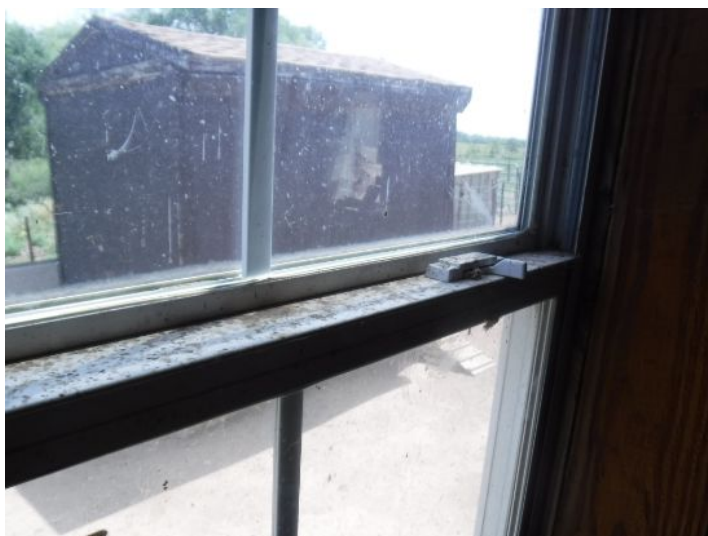
The pole shed windows will need cleaned and minor adjustment to latch properly

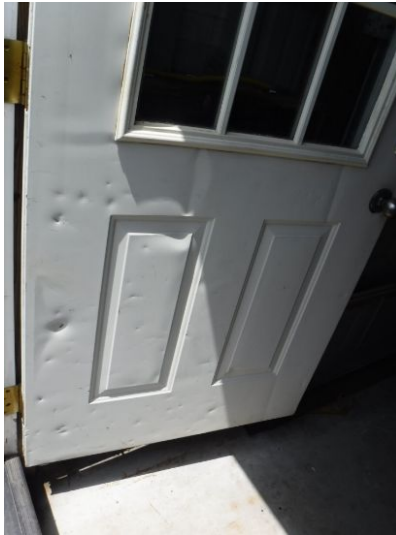
The door is dented.

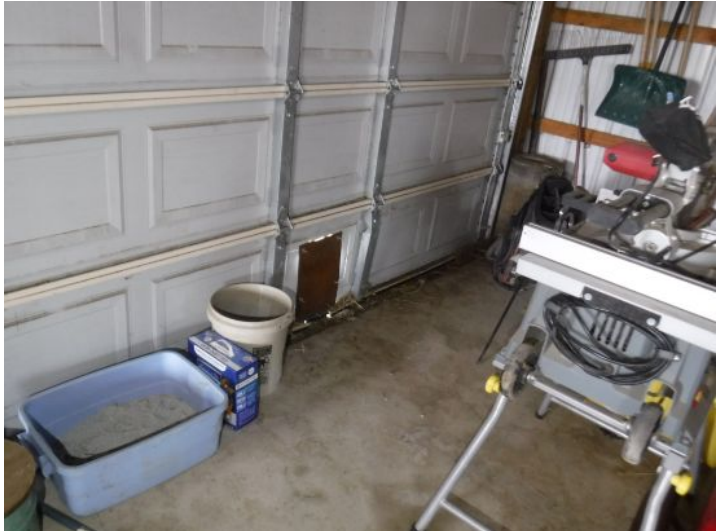
Damage noted on the lower door panels

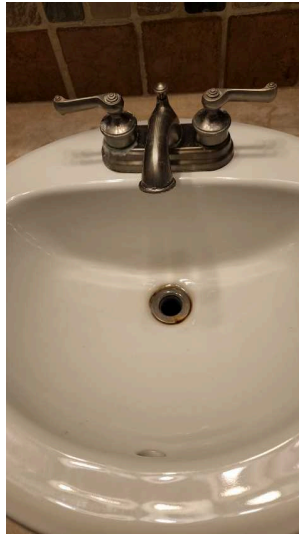
Stopper missing. Recommend screen to prevent clogging.

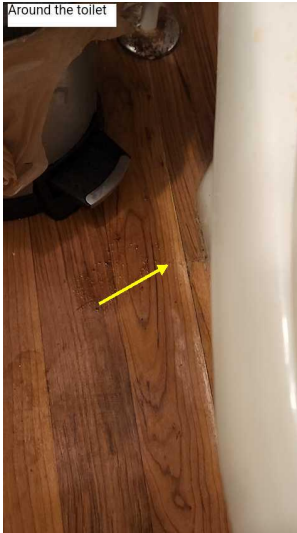
The flooring is buckled around the toilet. Most likely from moisture. No elevated moisture or leaking noted at the time of inspection.

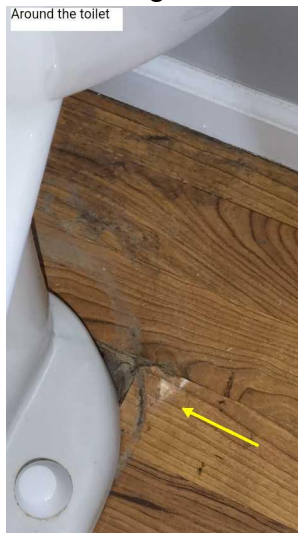
The flooring around the toilet is buckled. Most likely from moisture. No elevated moisture or leaking detected at the time of inspection.

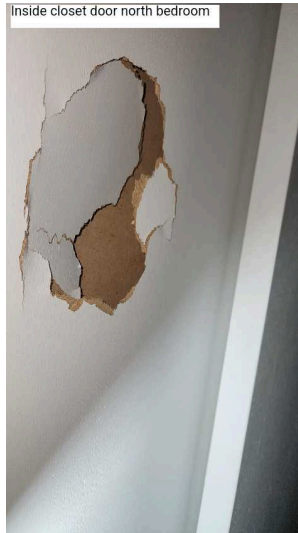
Damage noted to the inside of the closet door in the north basement bedroom.

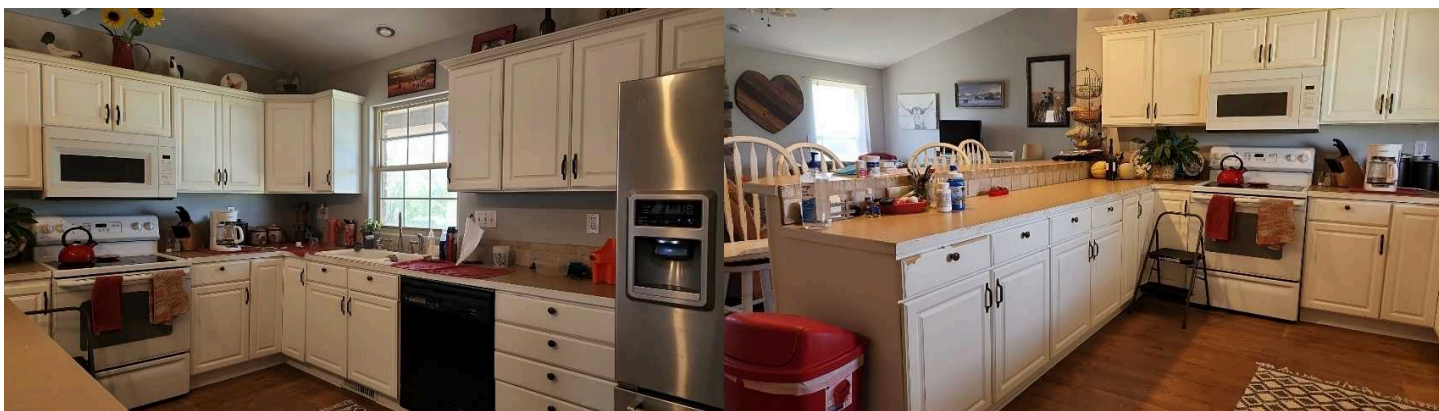
The RO faucet base is broken but operating.
