**Phase I Environmental Site Assessment  
Burg Tract  
131 Elberta Street  
Stonewall, Texas 78671**

**Project No. 2561**

**June 10, 2021**

William K. Duran, P.G.  
Environmental Professional

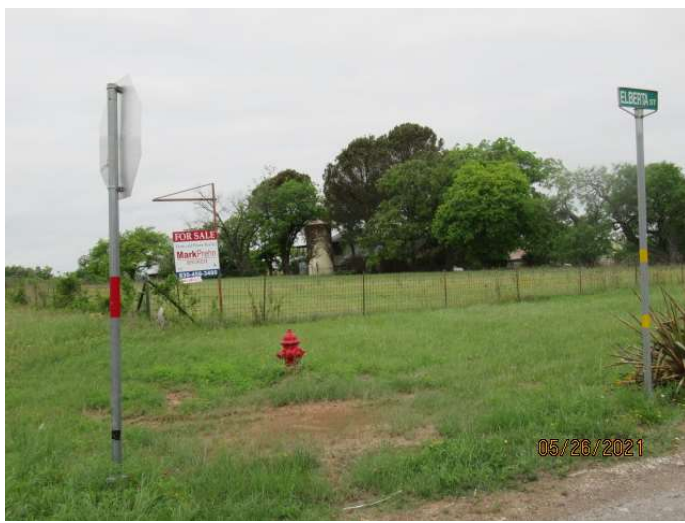
Subject property located at 131 Elberta Street.

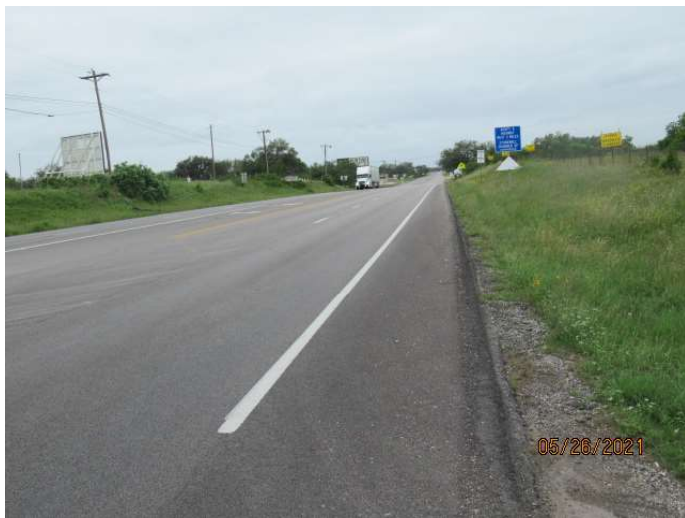
Viewing west along US Highway 290.

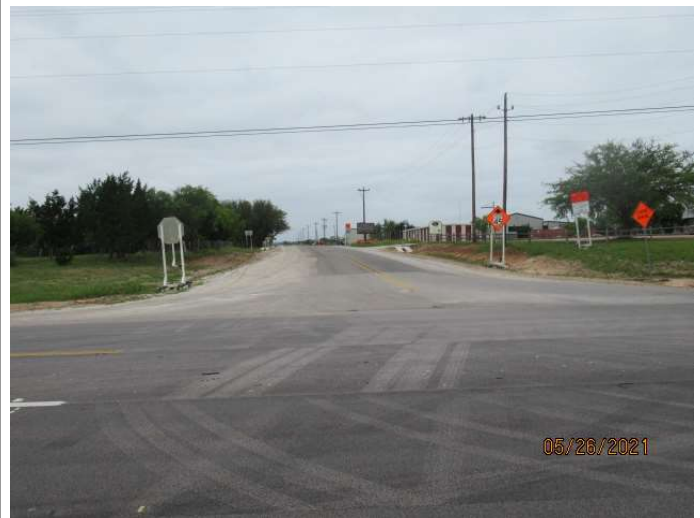
Viewing south along FM 1623.

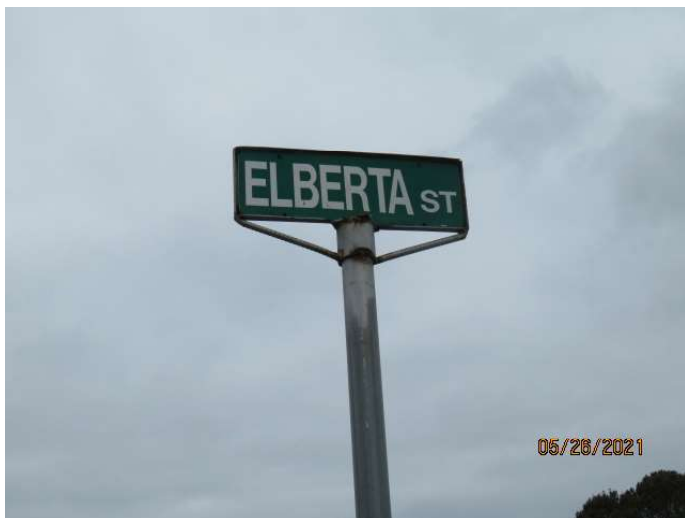
Sign located at street intersection.

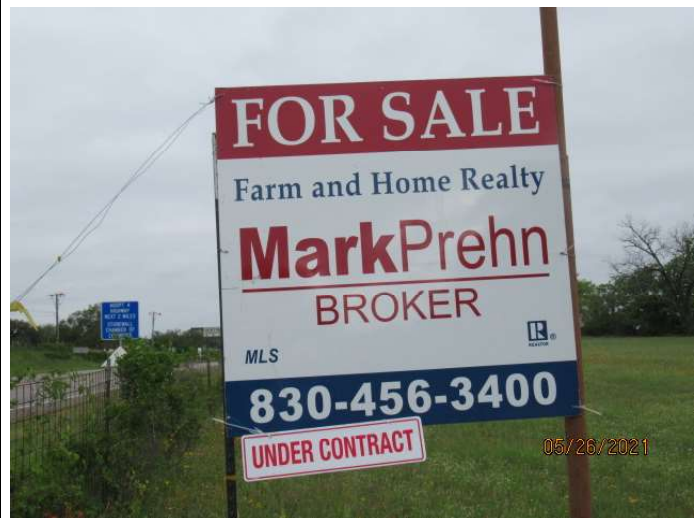
Broker sign located on south side of the property.

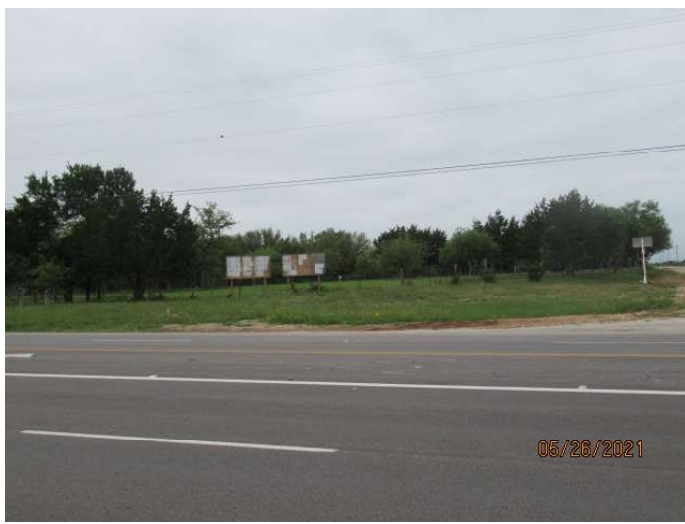
South adjacent property consisted of vacant land.

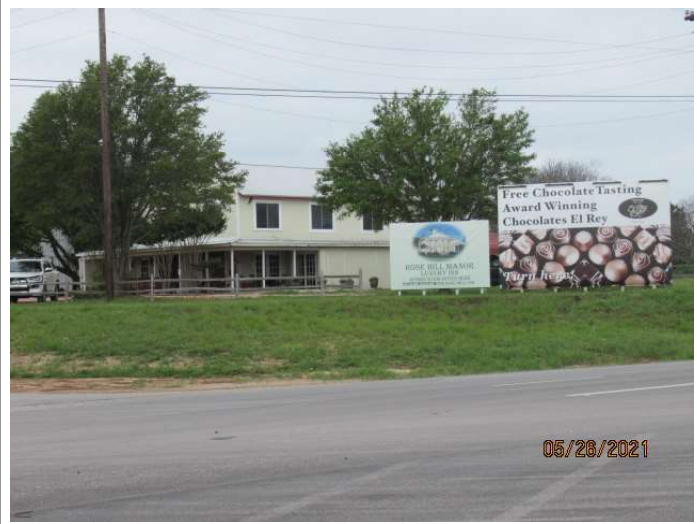
South adj. property consisted of Chocolates El Rey.

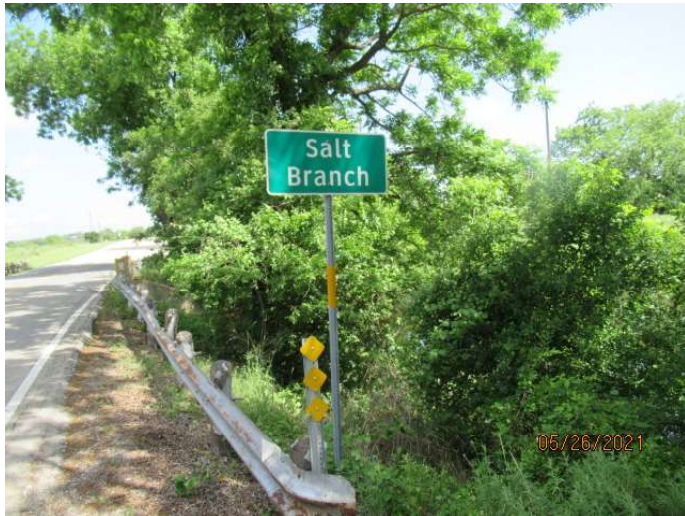
Salt Branch Creek crossing Ranch Road 1.

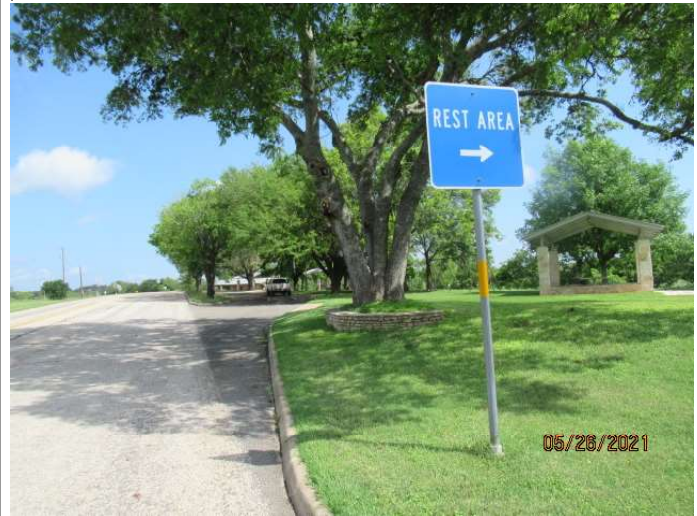
Rest area north across Ranch Road 1.

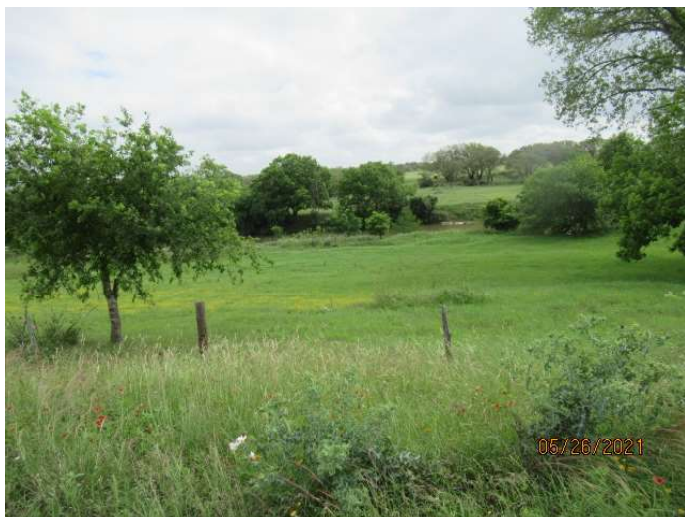
North adj. property consisted of Pedernales River.

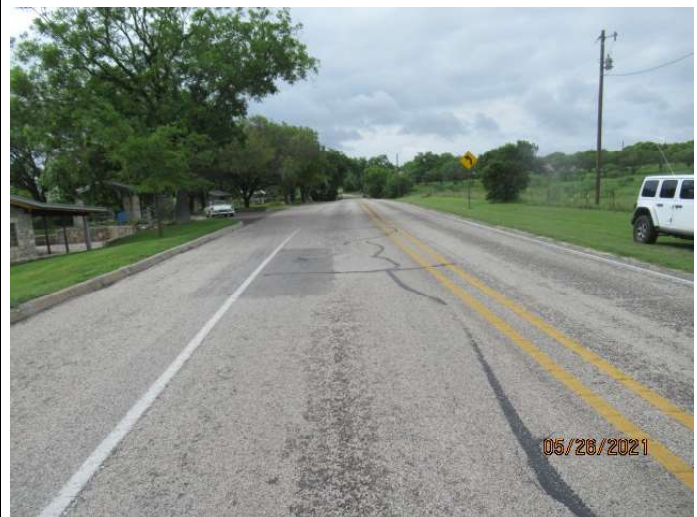
Viewing east along Ranch Road 1.

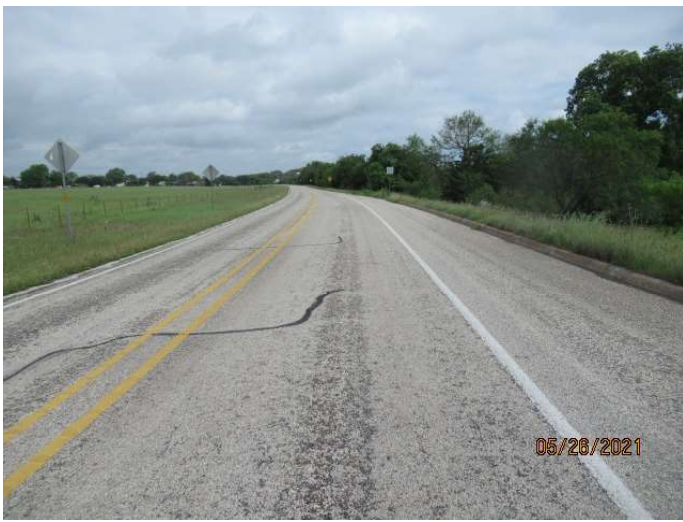
Viewing west along Ranch Road 1.

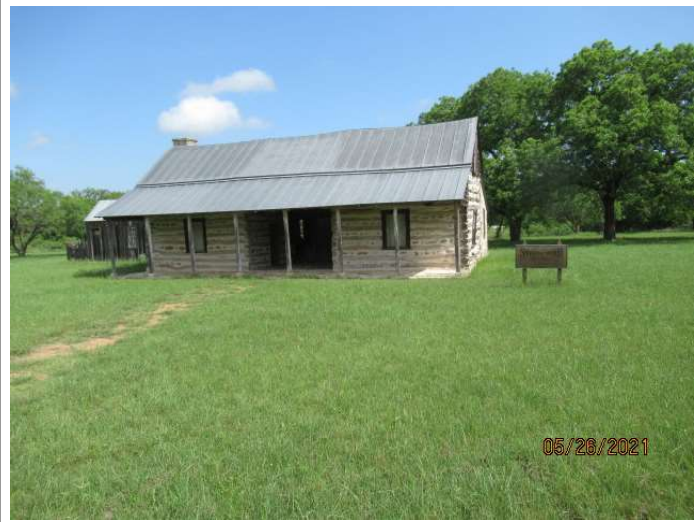
East adj. property was Stonewall historical society.

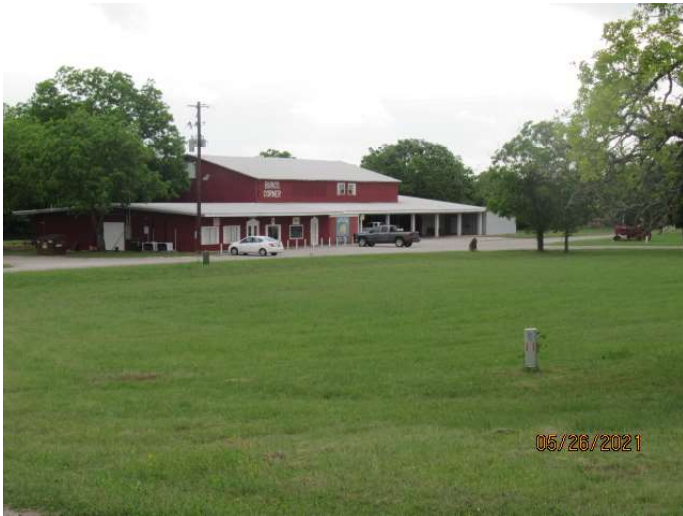
East adj. property was Burg's Corner fruit stand.

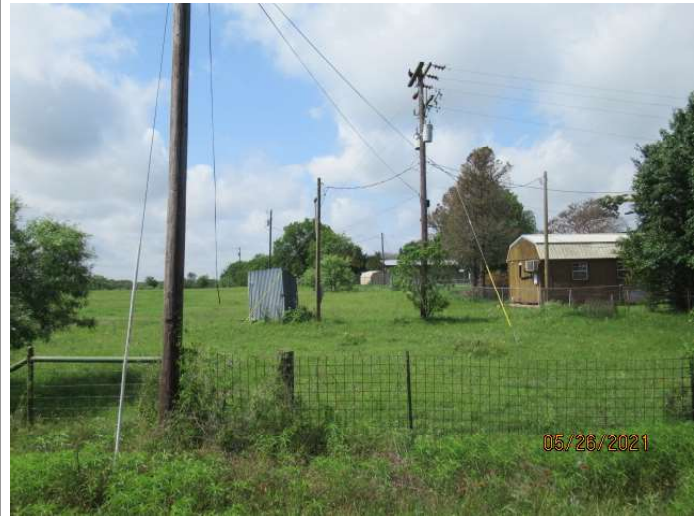
West adj. property consisted of residential homes.

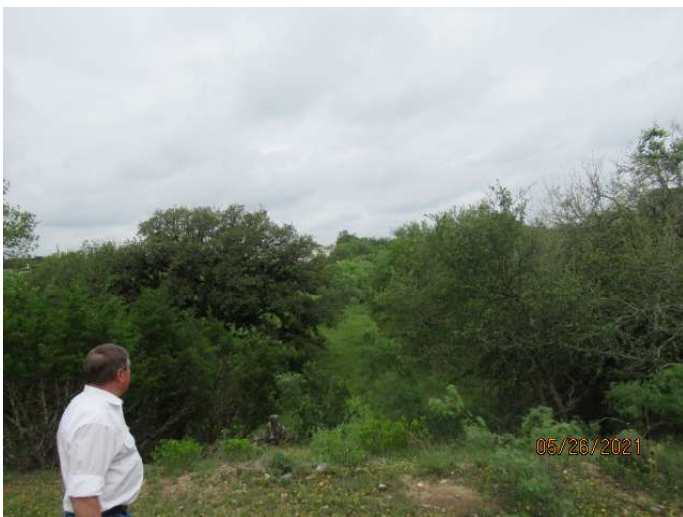
West adjacent property consisted vacant land.

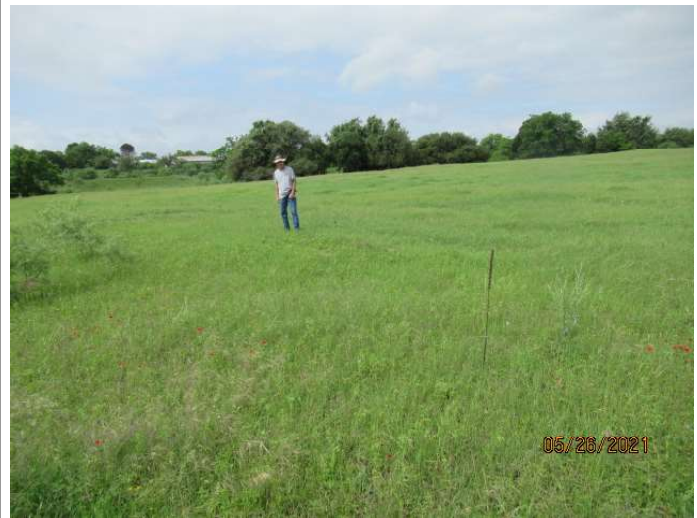
Pasture land located on north side of property.

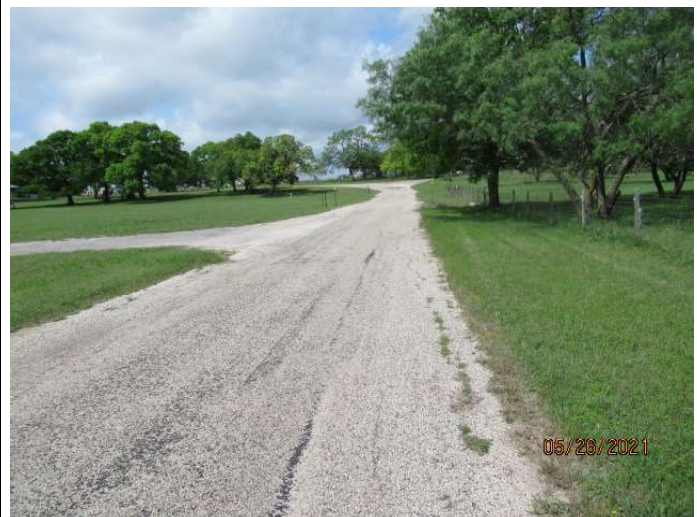
Viewing south Elberta Street.

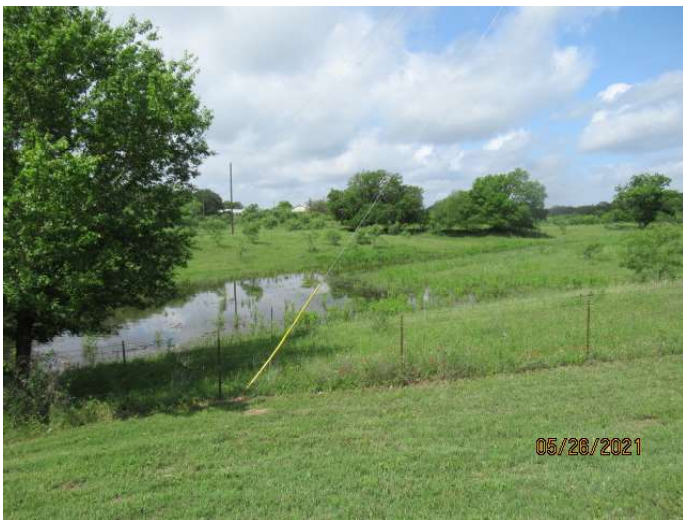
Livestock pond located on north side of property.

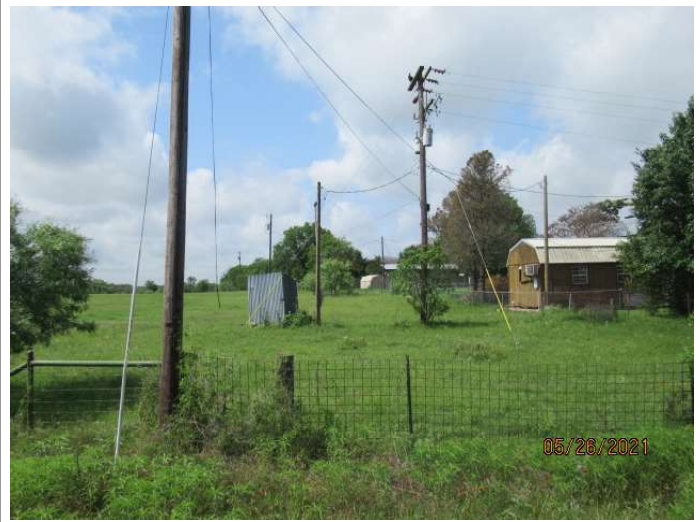
Former well & shed located on the NW corner of site.

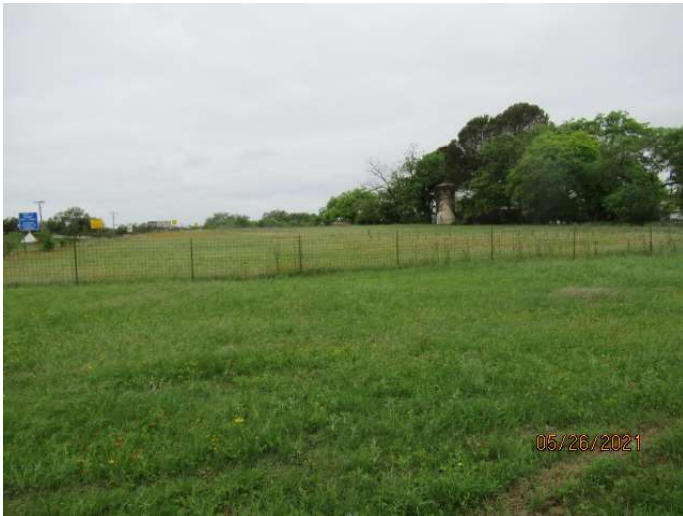
View of south side of property from Elberta Street.

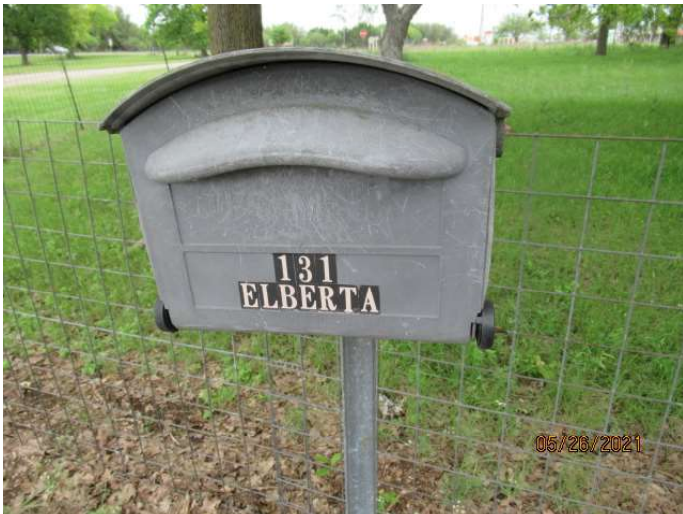
Mailbox of former occupant.

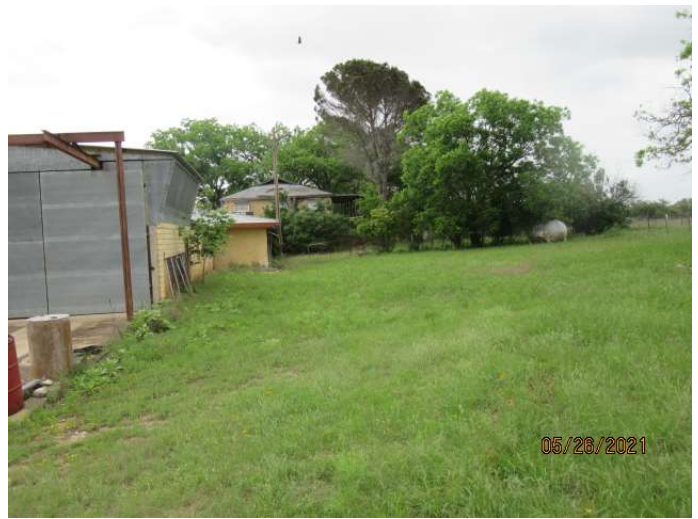
View of west side of the home.

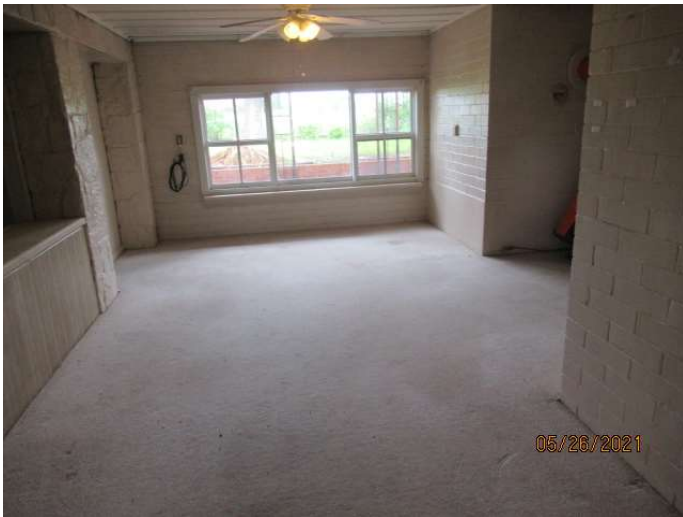
view of den inside the vacant home.

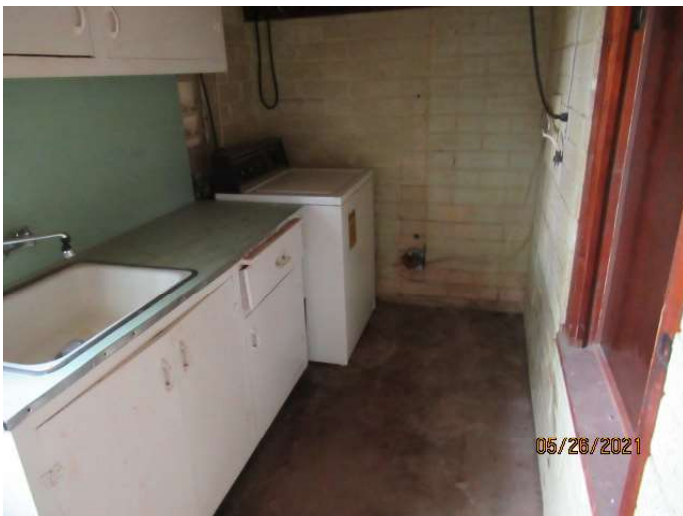
View of wash room in the laundry room.

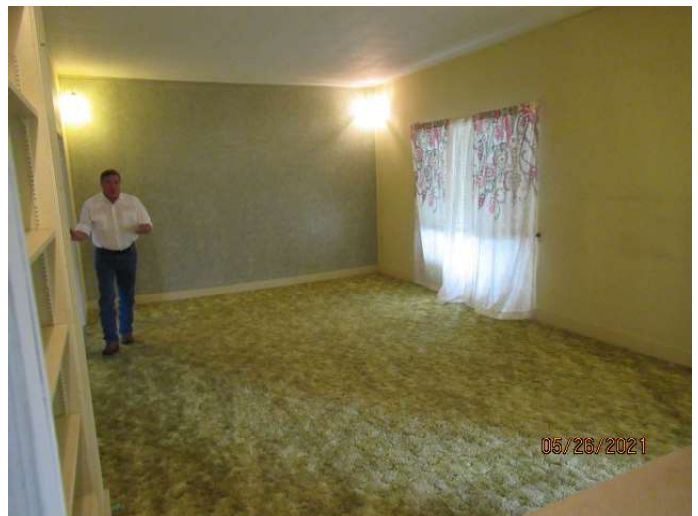
One of several bedrooms inside the vacant home.

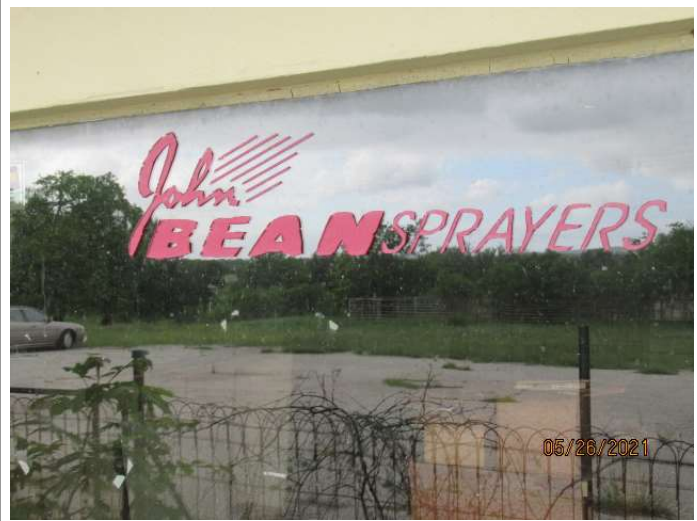
John Bean Sprayers former occupant inside shop.

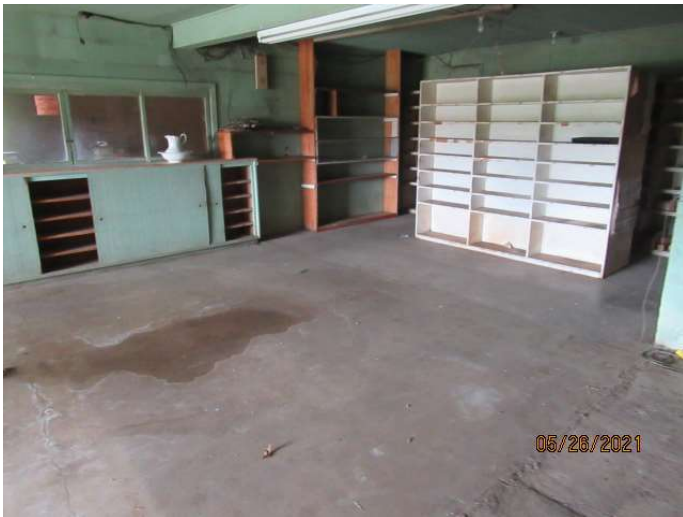
Interior view of John Bean Sprayers office.

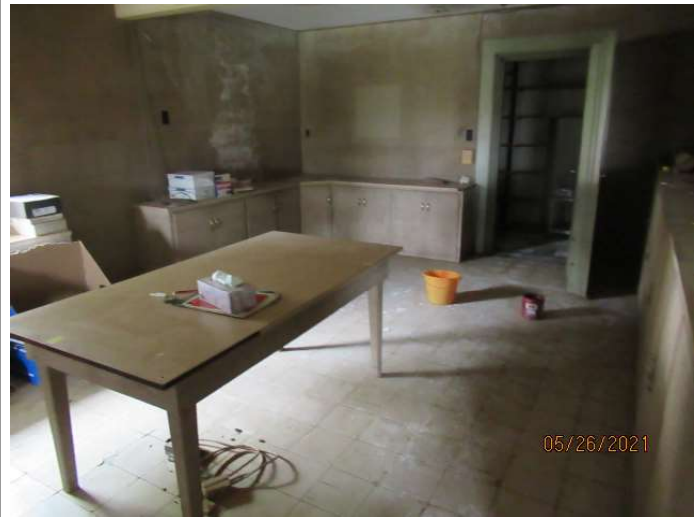
Staff kitchen observed inside the vacant shop.

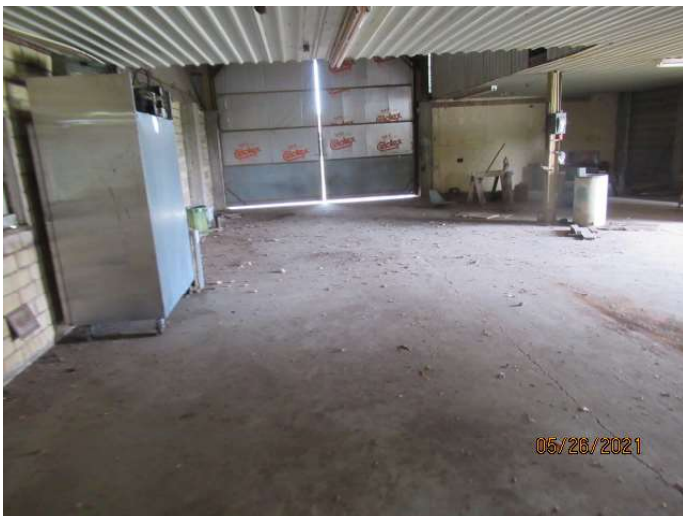
Warehouse observed inside the vacant shop.

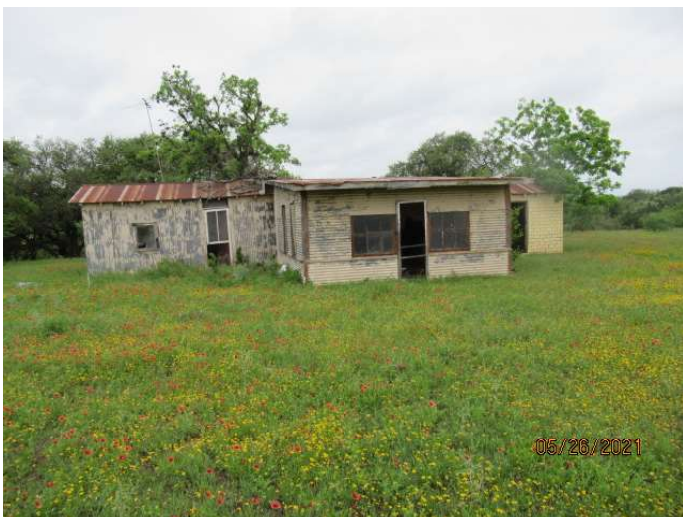
Ranch hands house located on west side of property.

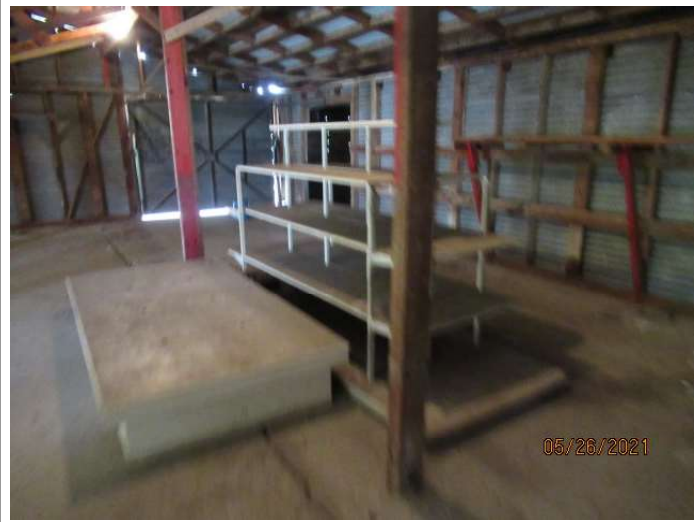
Former shelves and displays inside the warehouse.

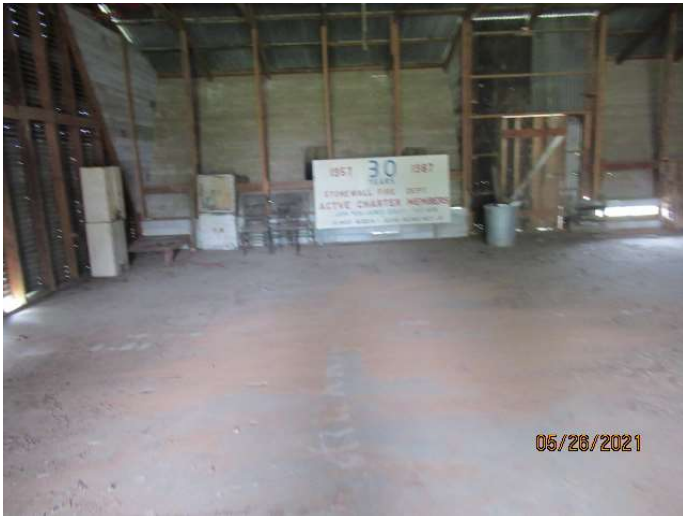
View inside the former chemical warehouse.
